CCR RULE COMPLIANCE

BOTTOM ASH PONDS HAZARD POTENTIAL CLASSIFICATION INITIAL ASSESSMENT REPORT

NRG Power Midwest LP
Cheswick Generating Station
Springdale, Pennsylvania

October 2016

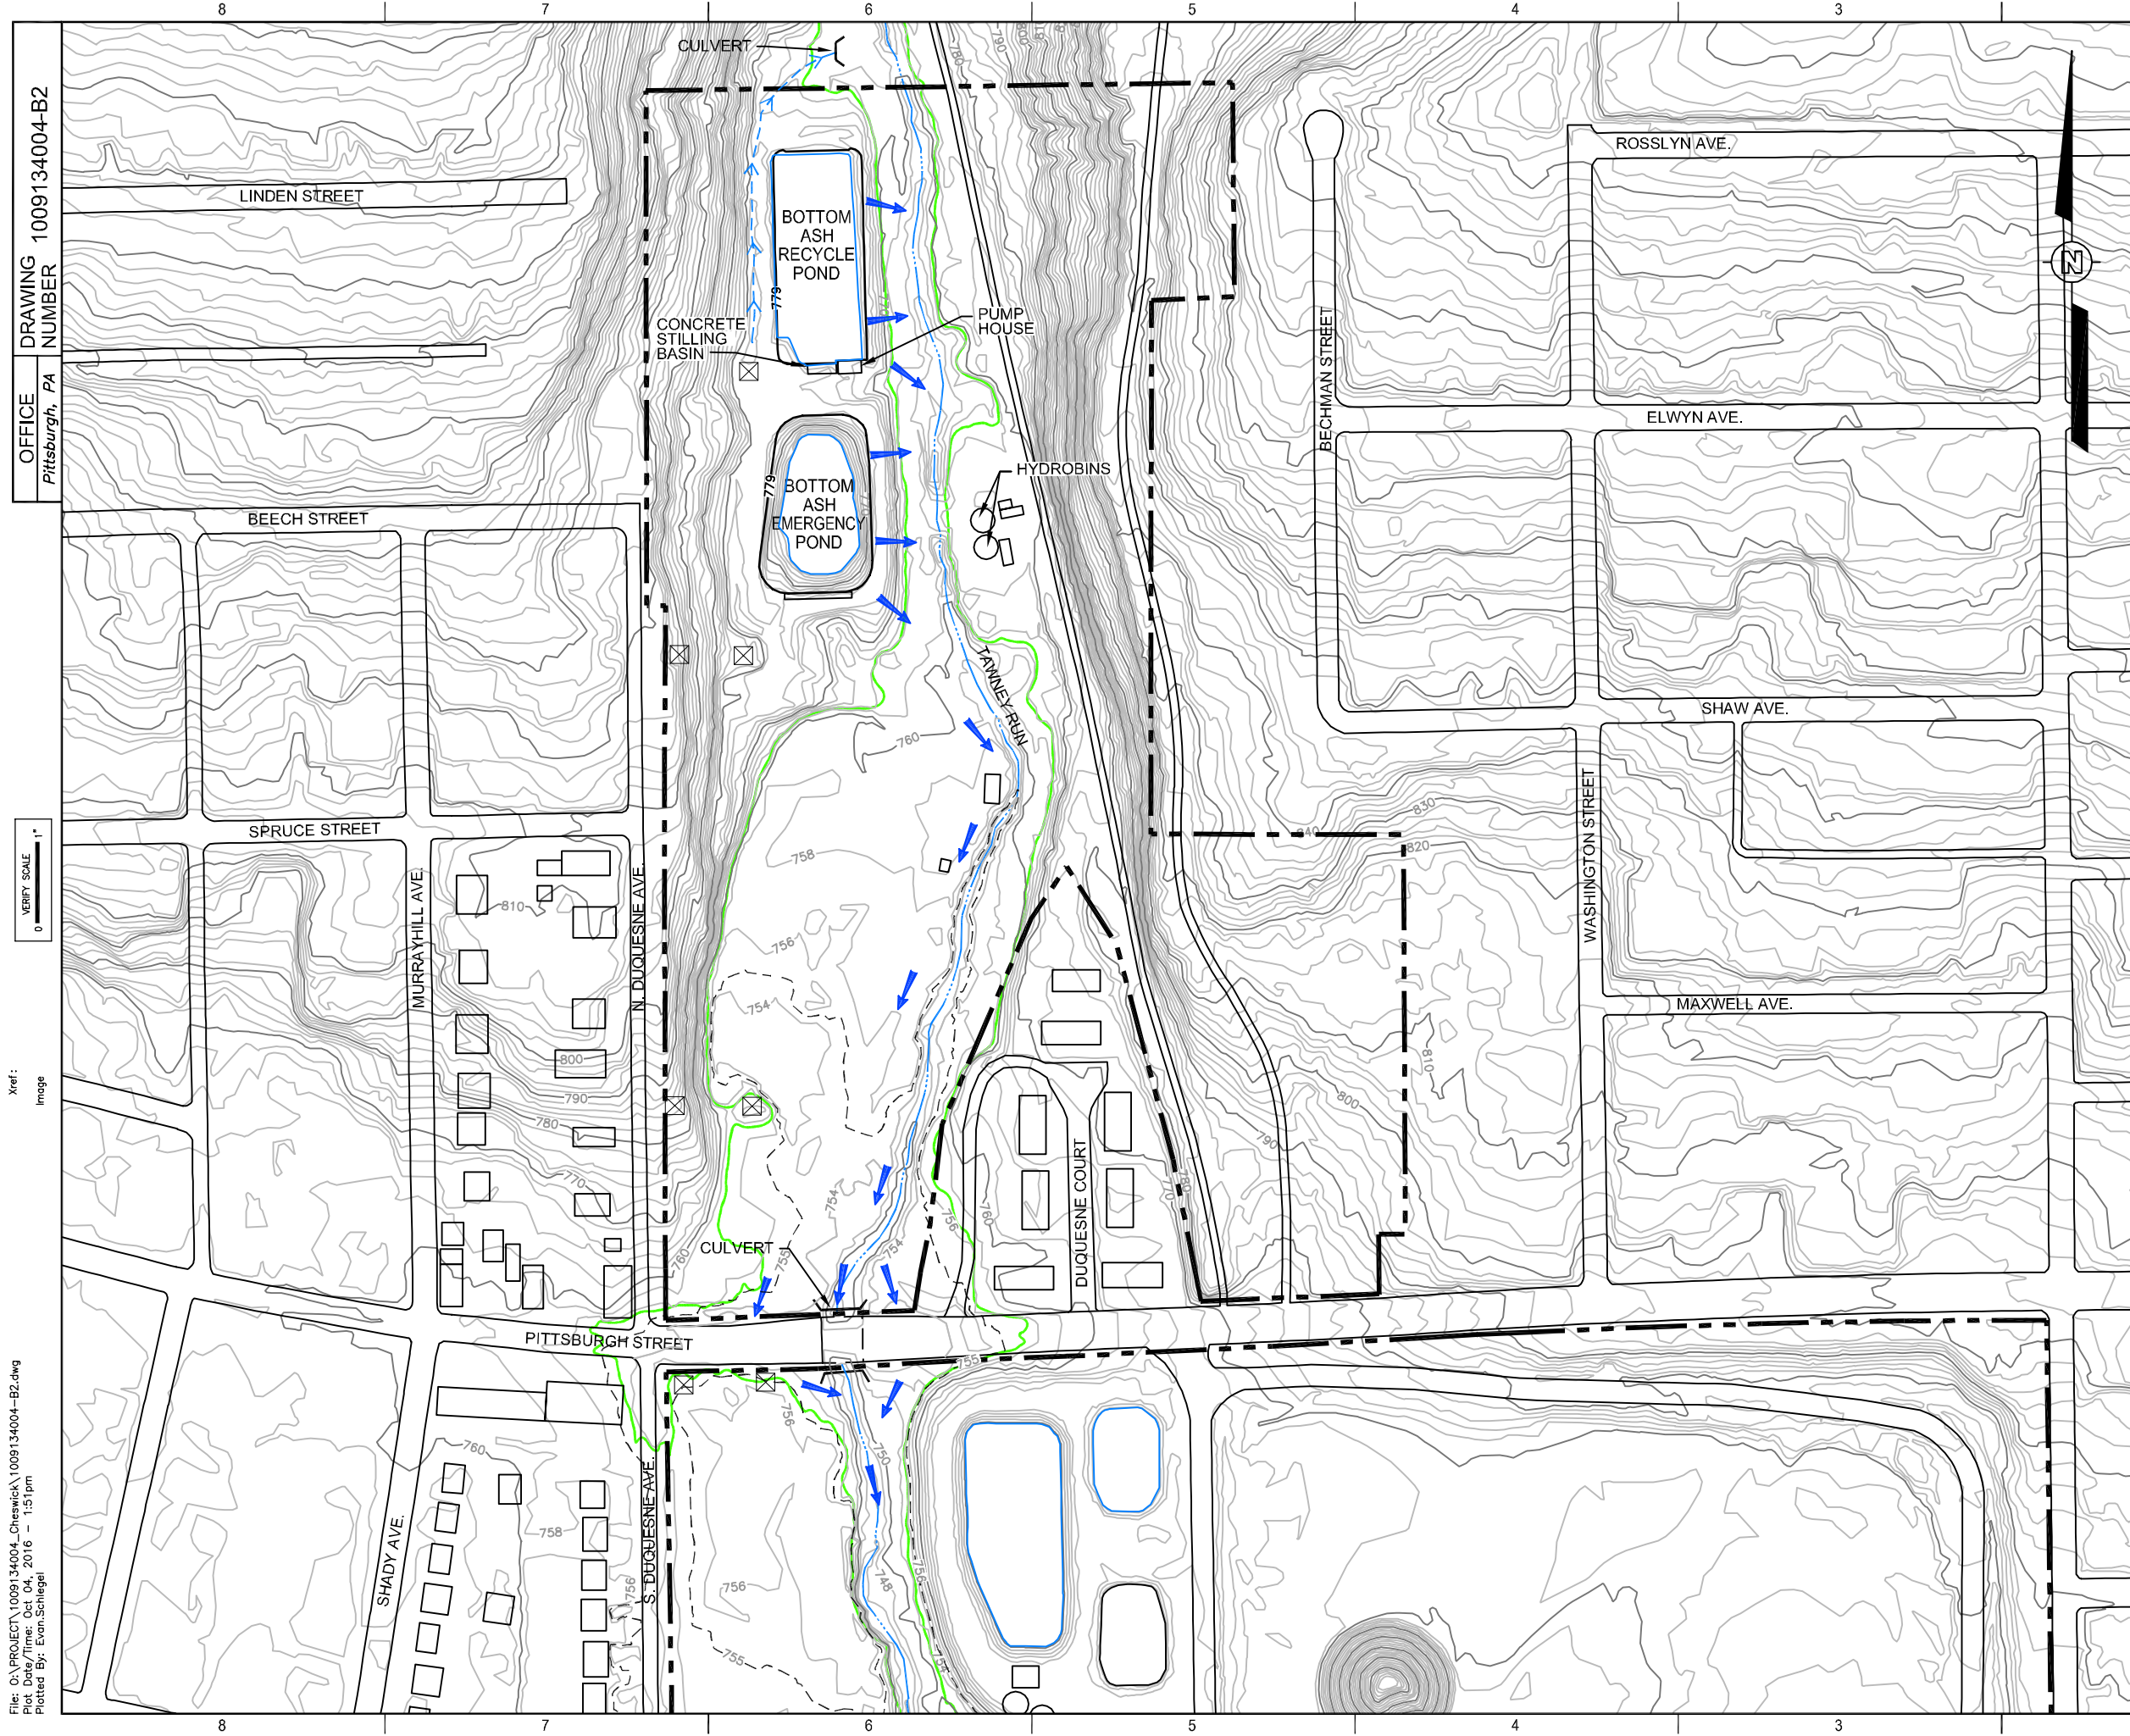
FIGURE 3
TOPOGRAPHIC AND FLOW DIRECTION MAP
CHESWICK GENERATING STATION
SPRINGDALE, ALLEGHENY COUNTY, PENNSYLVANIA

capacity of the stream channel and/or culvert under Pittsburgh Street, it would spread out across the valley. In general, the flow would be expected to spread into the lower lying areas that correspond to the FEMA flood hazard zone (shown on Figure 3). In the vicinity of Pittsburgh Street, this flood zone corresponds reasonably well to the area enveloped by the 755 ft msl contour. Due to the large area contained by this contour, it is reasonable to expect that extension of the inundation area above an elevation of 755 ft msl would be unlikely, and that the flow would likely have dissipated substantially if it were to cross Pittsburgh Street. Any such crossing is expected to be brief and unlikely to cause damage or lasting impacts. The flow would continue southward on the NRG property south of Pittsburgh Street, toward the Allegheny River. Little appreciable flow would be expected to exit the NRG property via an overland pathway, and a modest increase in flow from Tawney Run to the River would be expected. No appreciable or lasting impacts to the River or adjacent properties are anticipated.
