## Inspection Report

**To:** Jill Buckley (Cheswick Generating Station)  
**From:** Richard Southorn, P.E., P.G., CPSWQ  
**Re:** Cheswick Ash Disposal Site – Annual CCR Unit Inspection Report No. 2  
**Inspection Date:** November 18, 2016  
**Report Date:** January 16, 2017

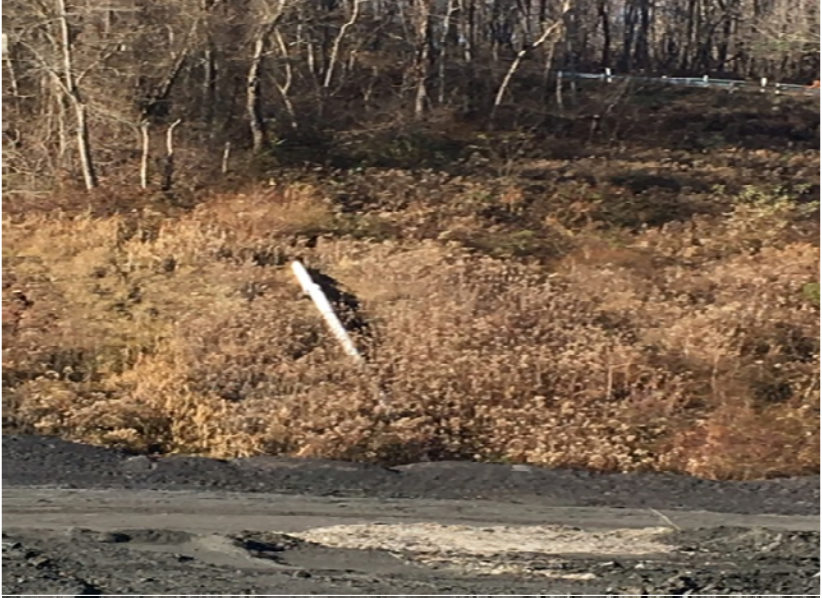
<p><b>Photograph No. 5</b></p> <p><b>Date:</b> November 18, 2016</p> <p><b>Direction:</b> West</p>

<p><b>Description:</b> "Non-contact" stormwater pipe along western side slope. No evidence of erosion or sloughing.</p>

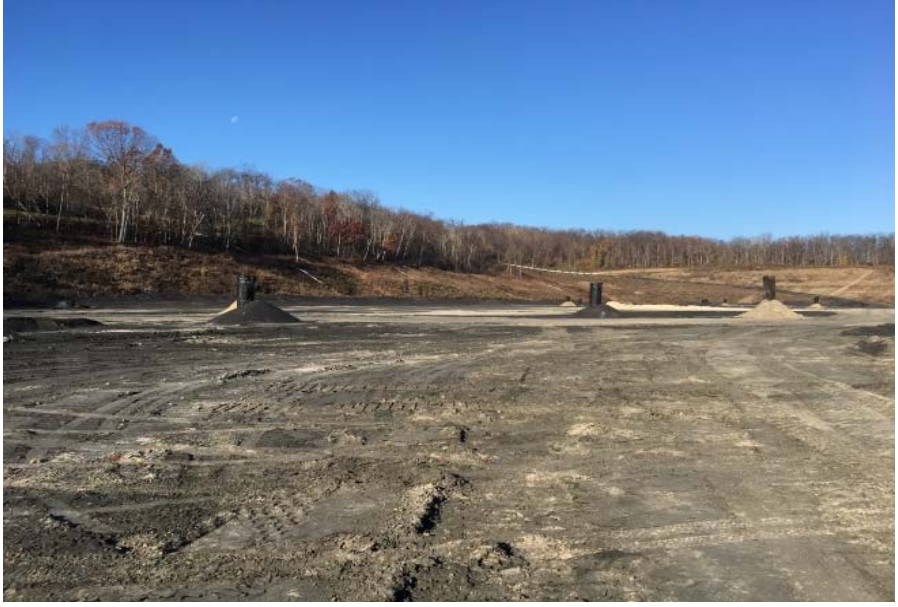
<p><b>Photograph No. 6</b></p> <p><b>Date:</b> November 18, 2016</p> <p><b>Direction:</b> Northwest</p>

<p><b>Description:</b> Active filling area with leachate and "contact" stormwater collection manholes.</p>

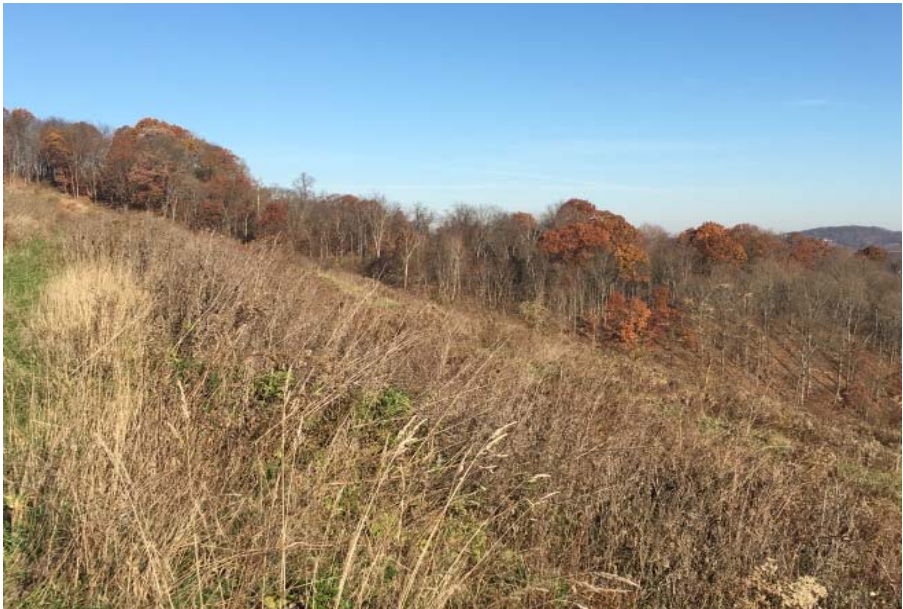
<p><b>Photograph No. 10</b></p> <p><b>Date:</b> November 18, 2016</p> <p><b>Direction:</b> North</p>

<p><b>Description:</b> Final cover system along eastern side slope. Vegetation is well established and maintained. No evidence of erosion or sloughing.</p>

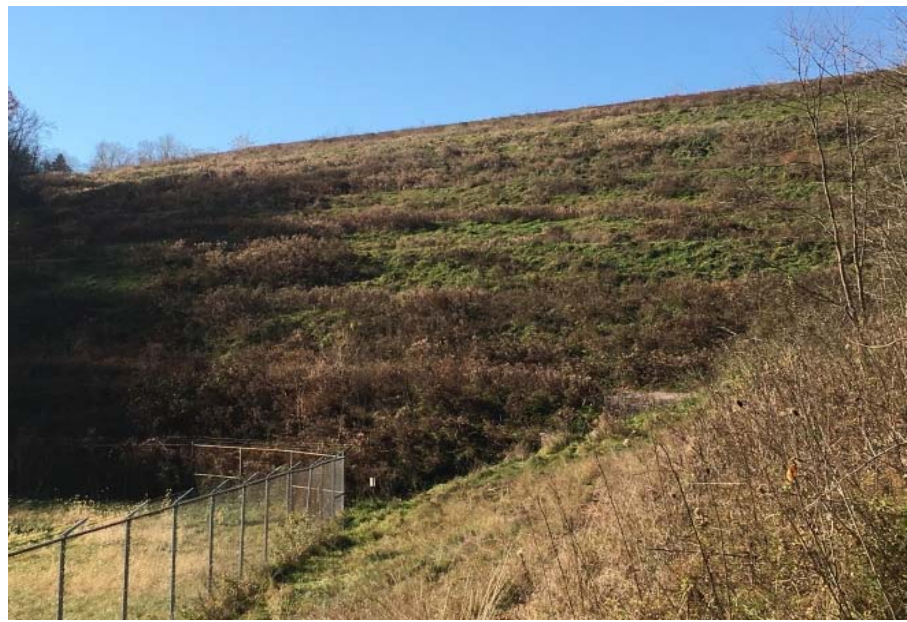
<p><b>Photograph No. 13</b></p> <p><b>Date:</b> November 18, 2016</p> <p><b>Direction:</b> Southwest</p>

<p><b>Description:</b> Final cover system along the lower half of the landfill. Vegetation is well established and maintained. No evidence of erosion or sloughing. No slope stability issues identified.</p>

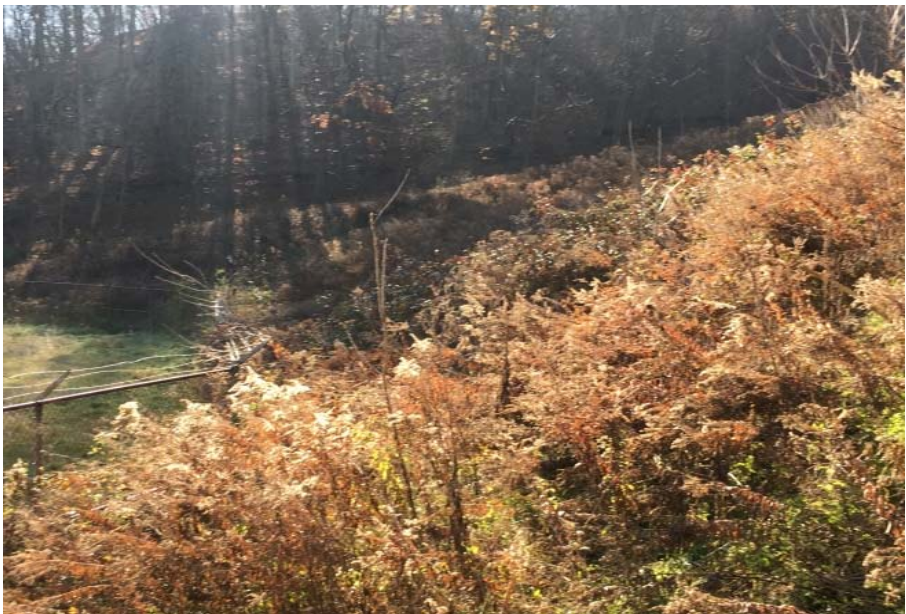
<p><b>Photograph No. 15</b></p> <p><b>Date:</b> November 18, 2016</p> <p><b>Direction:</b> South</p>

<p><b>Description:</b> Eastern slope final cover. No evidence of erosion or sloughing.</p>
