Inspection Report

To: Jill Buckley (Cheswick Generating Station)
From: Richard Southorn, P.E., P.G., CPSWQ
Re: Cheswick Ash Disposal Site – Annual CCR Unit Inspection Report
Inspection Date: October 17, 2017
Report Date: January 16, 2018

**CHESWICK GENERATING STATION
SPRINGDALE, PENNSYLVANIA**

Project: 2017 Cheswick Annual Inspection

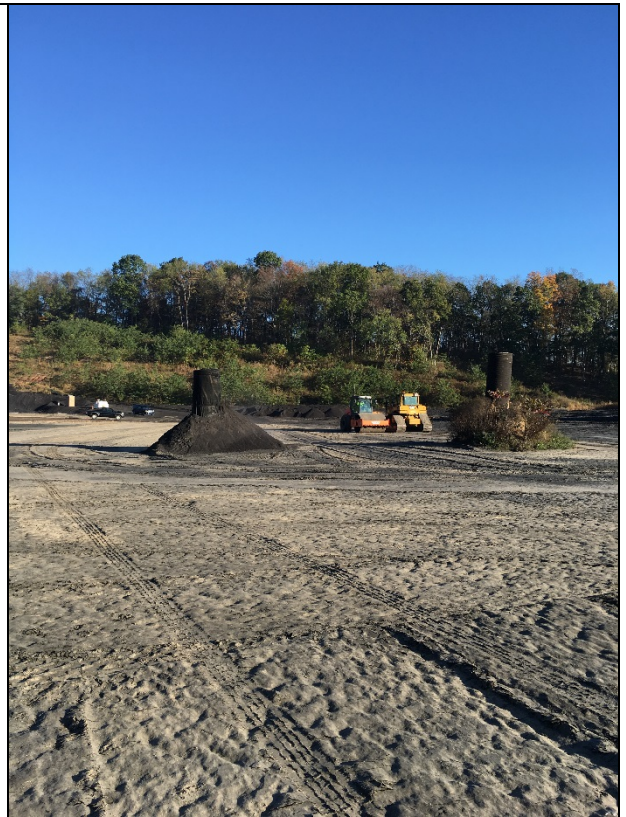
Photograph No. 1**Date:**

Active filling area. A perforated contact-water (leachate) risers is shown on the left. This riser is wrapped in filter fabric and surrounded with bottom ash. A non-contact water (stormwater) non-perforated riser is shown on the right. This riser will be extended to final cover elevation and will accept stormwater after final cover is in place.

The active area is well maintained with no ponding water. CCR material is spread and rolled shortly after being received.

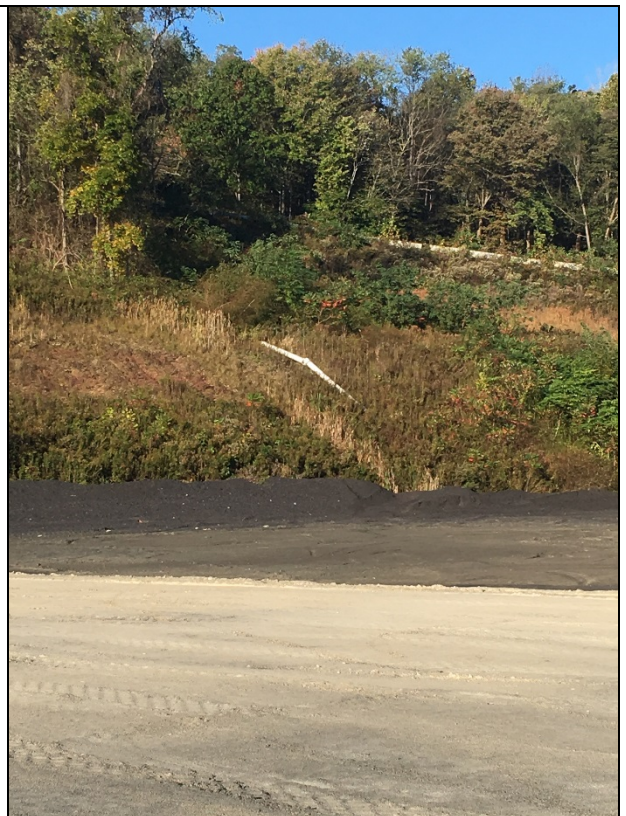
**Photograph No. 2****Date:**

Non-contact stormwater pipe along western sideslope. No evidence of erosion or sloughing.

Active area is shown in foreground (gypsum and bottom ash).

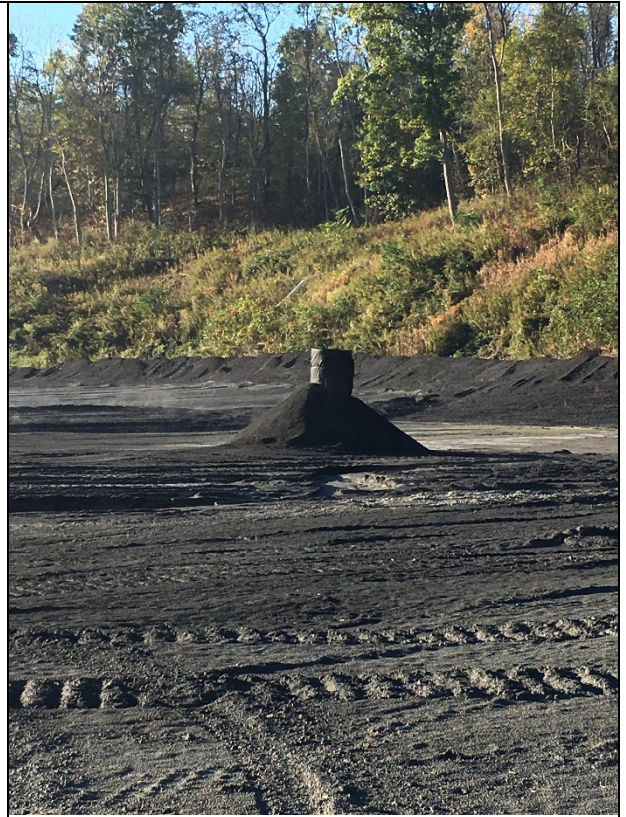
Photograph No. 3**Date:**

Active area near western limits. Contact water riser is shown in center, surrounded by bottom ash. The active area is well maintained.

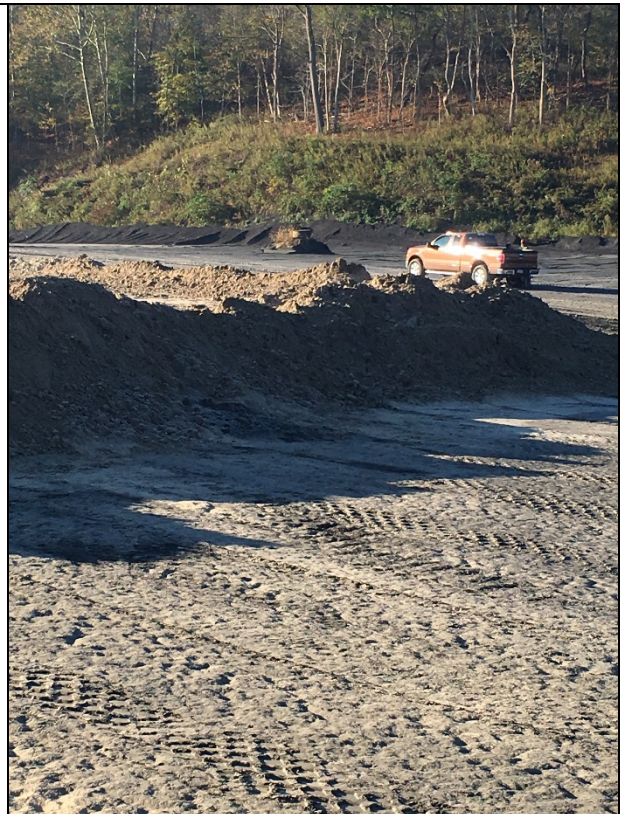
**Photograph No. 4****Date:**

Active area. CCR material has been received and is being placed in a new lift.

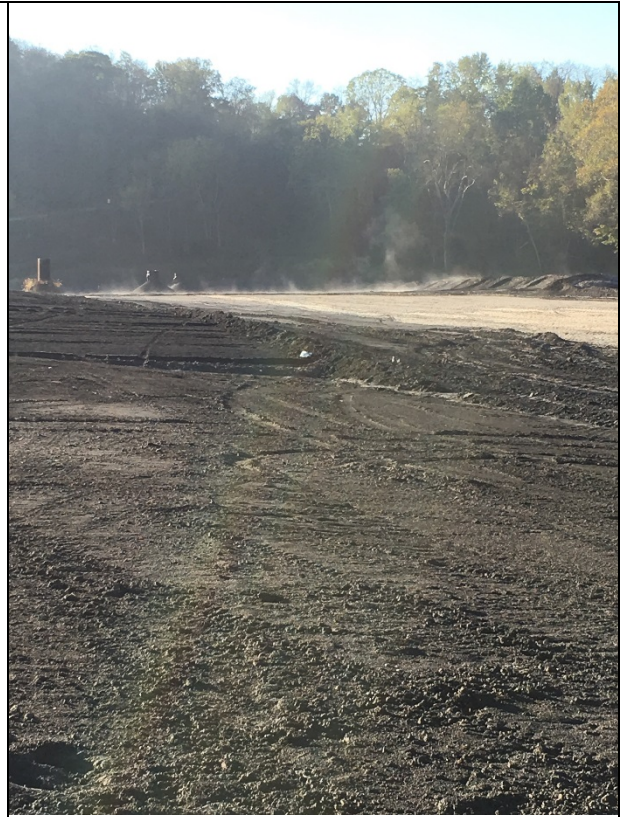
Photograph No. 5**Date:**

Active area. Well maintained, no ponding water. Material is placed in even lifts that are spread and compacted.

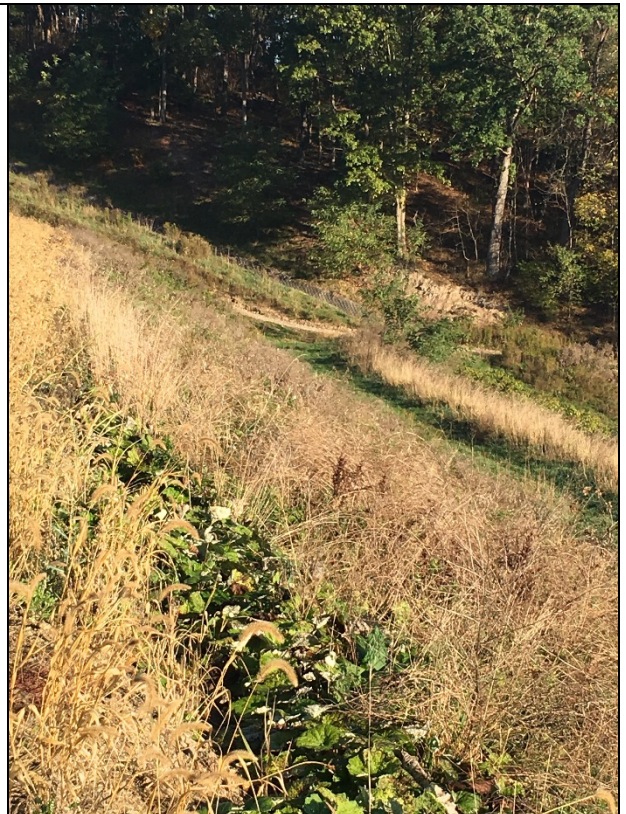
**Photograph No. 6****Date:**

Sideslope near active face. Vegetation is healthy and present across the entire sideslope. No evidence of erosion, sloughing, or indications of stability issues.

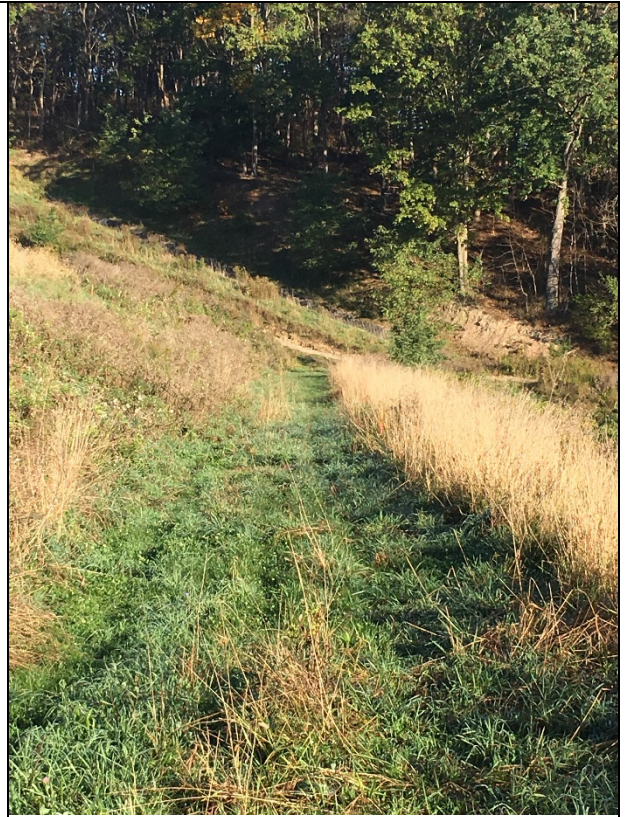
Photograph No. 7**Date:**

Typical slope terrace. Terraces are well maintained with no evidence of sloughing or erosion. Vegetation is healthy.

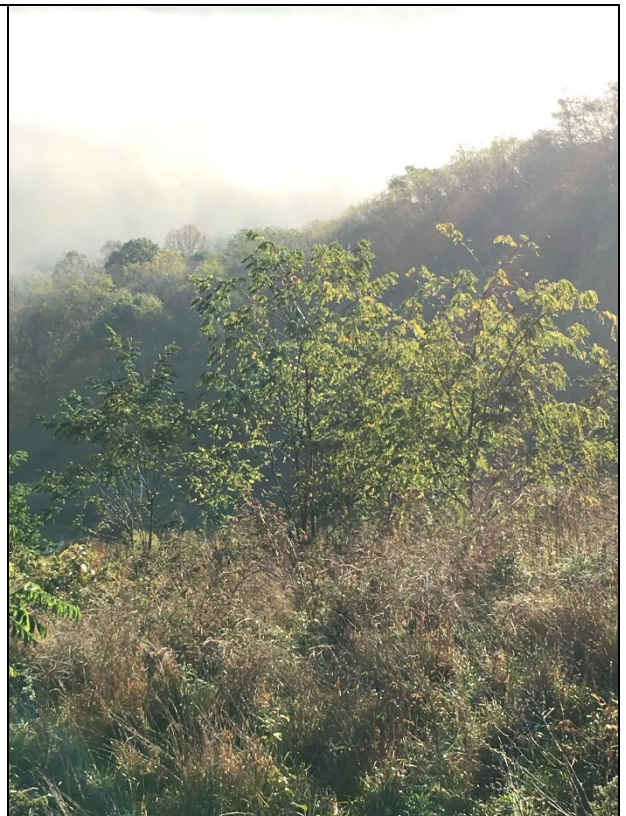
**Photograph No. 8****Date:**

Vegetation on sideslope looking downslope. Vegetation is well established. No evidence of erosion or sloughing.

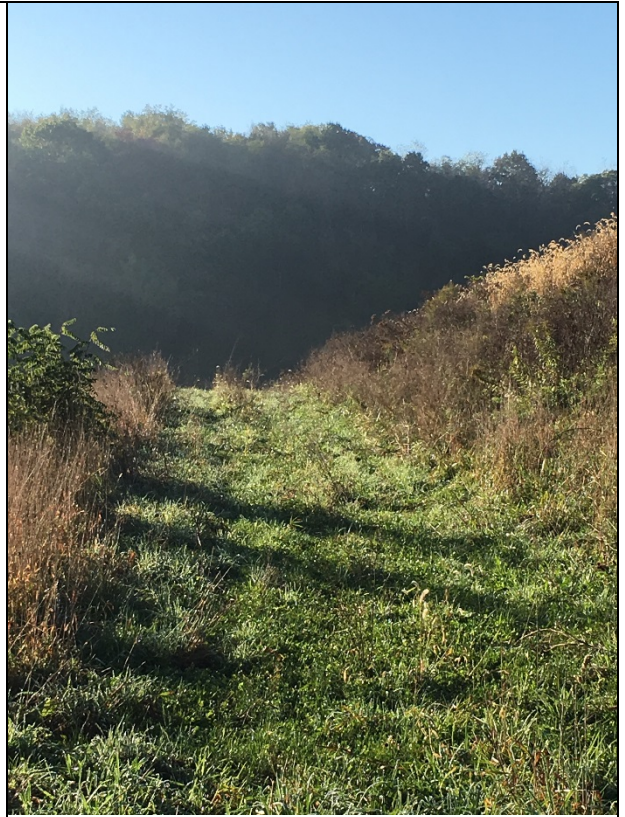
Photograph No. 9

Slope terrace. Terraces are well maintained with no evidence of sloughing or erosion. Vegetation is healthy.

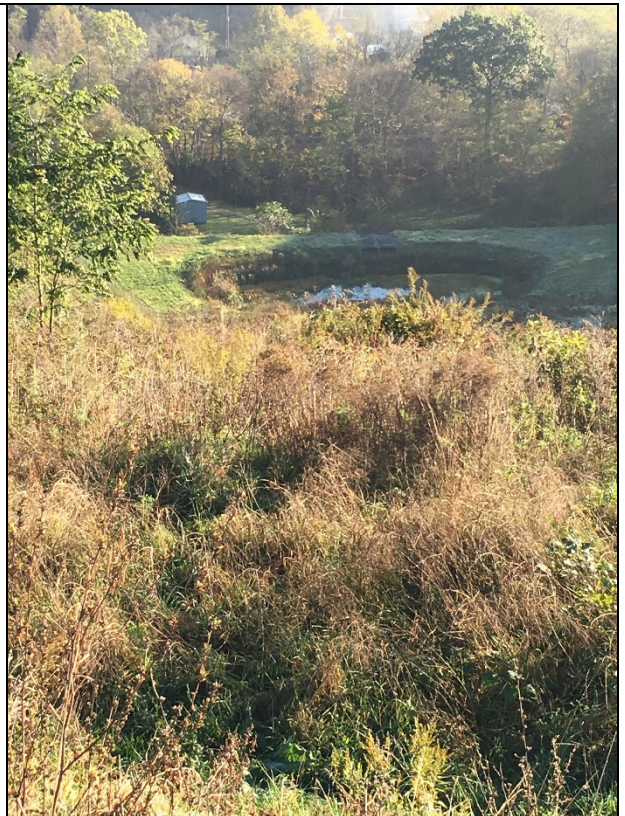
Photograph No. 10

Sedimentation Pond (non-contact stormwater) from upslope. Healthy vegetation.

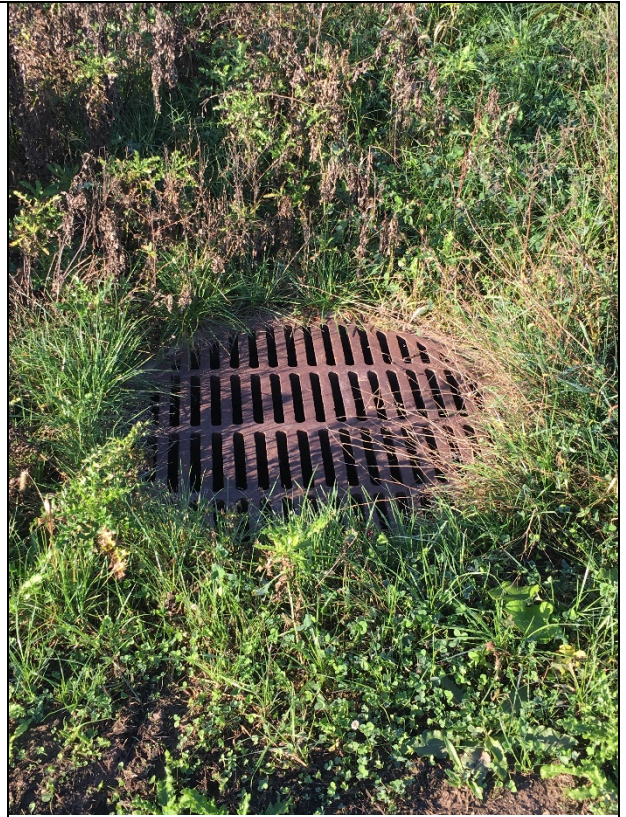
Photograph No. 11**Date:**

Stormwater inlet installed in final cover on terrace bench. Culvert is free of obstructions. There is no evidence of scour around inlet. This manhole is representative of the final conditions of the non-contact riser shown in Photograph No. 1.

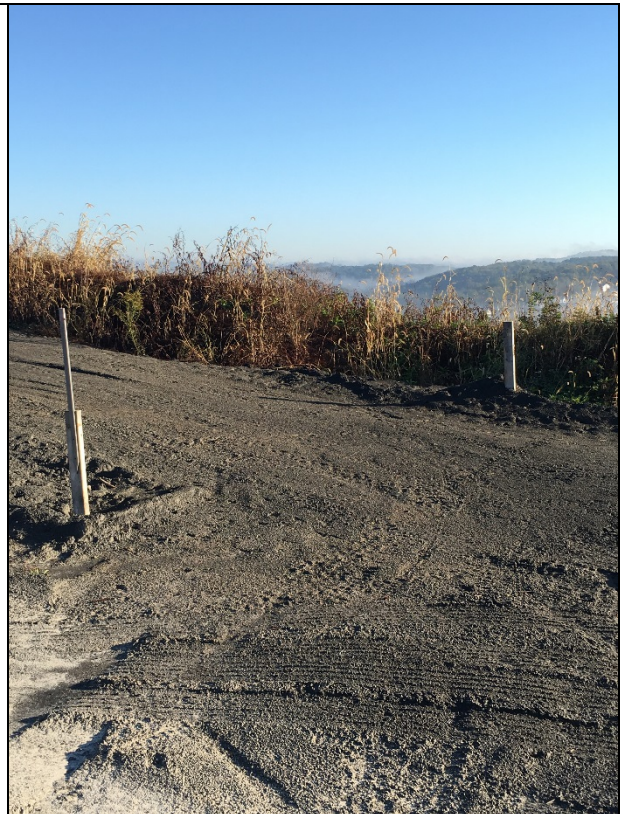
**Photograph No. 12****Date:**

Staking has been placed to represent the location and final target CCR elevation for the next terrace bench. Once final CCR material grades are achieved, final cover will be installed.

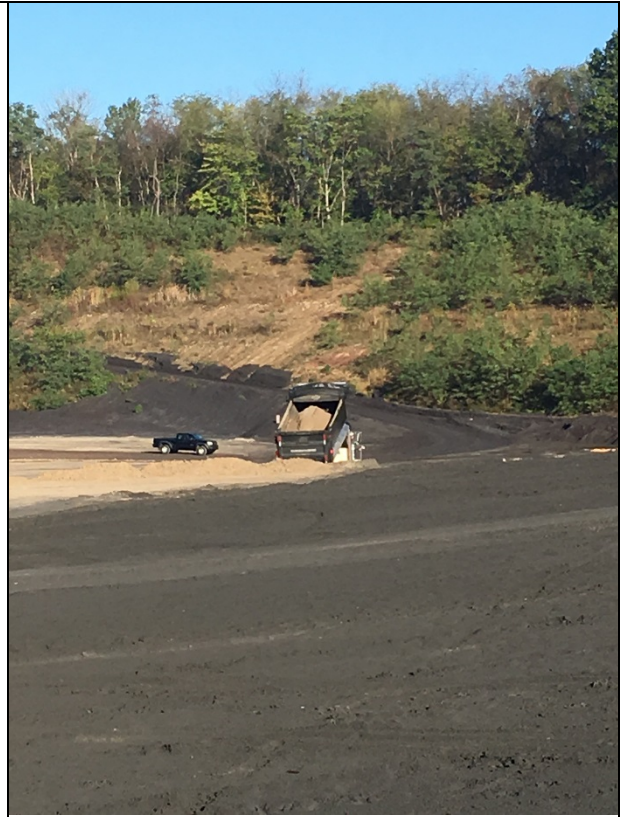
Photograph No. 13

Unloading CCR material (gypsum) at active face.

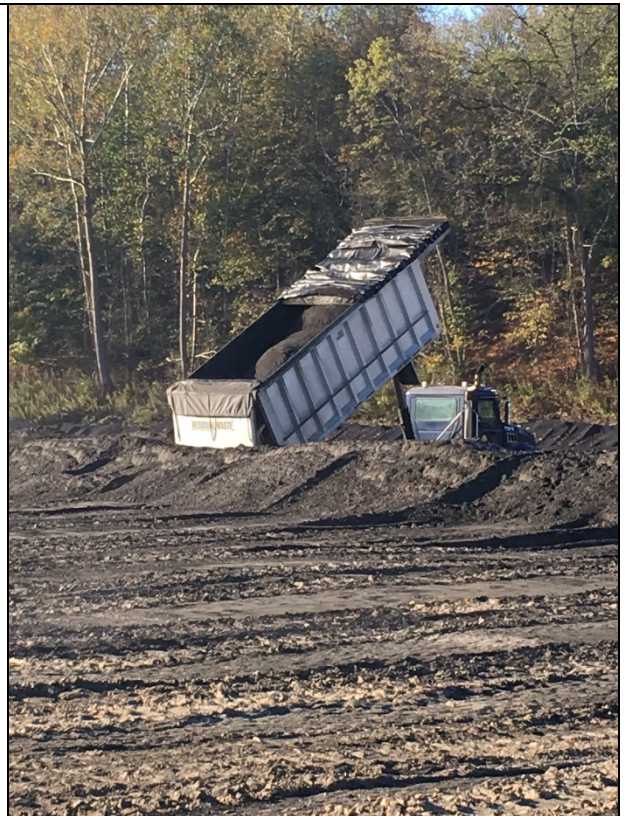
Photograph No. 14

Unloading CCR material (bottom ash) at active face.

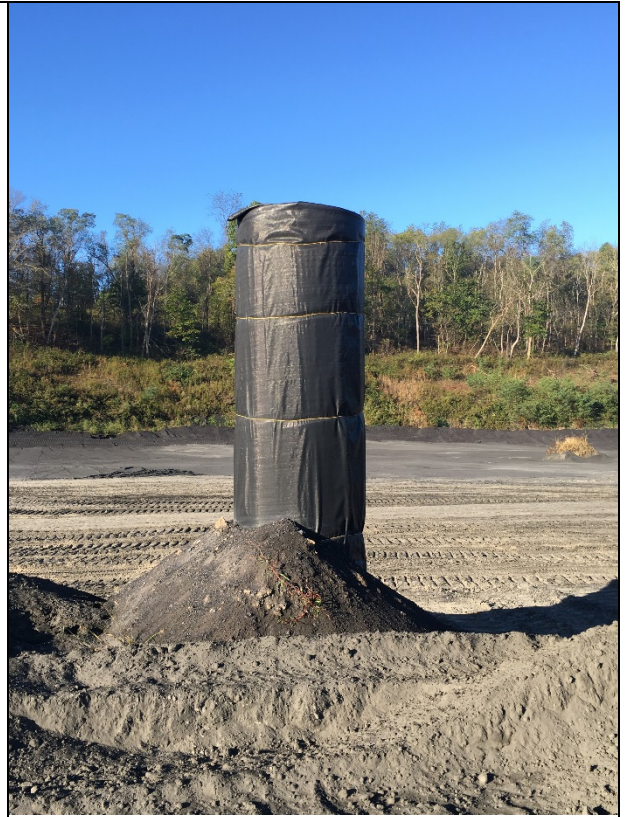
Photograph No. 15

Contact water (leachate) riser.

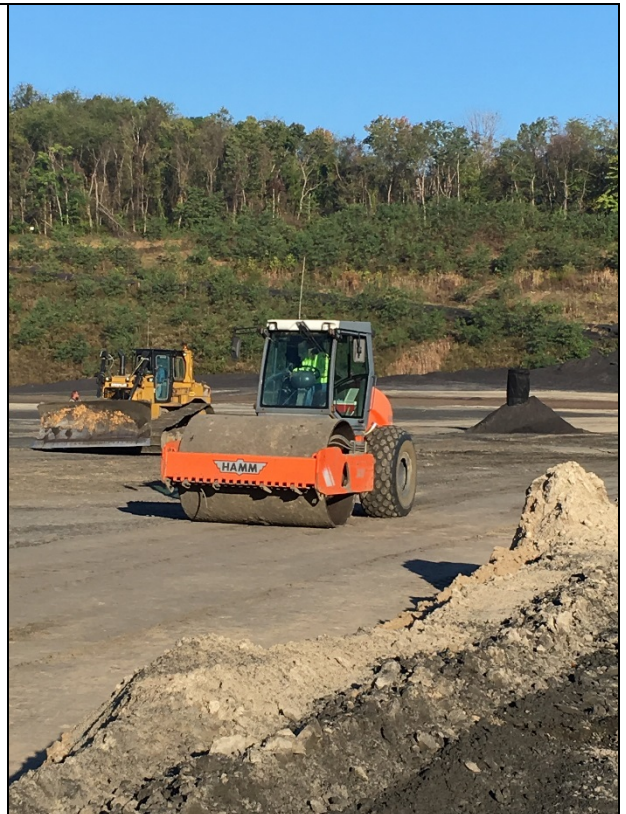
Photograph No. 16

Dozer is spreading gypsum in background while roller is smoothing surface on active face. Material is placed in even lifts following appropriate operational measures.

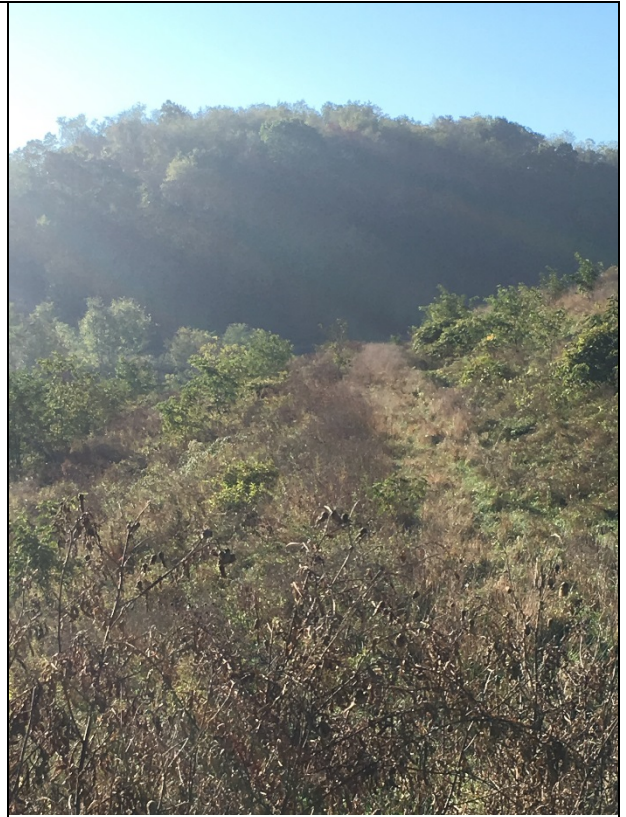
Photograph No. 17

Sideslope on midslope area. Healthy vegetation with no evidence of erosion, sloughing or instability.

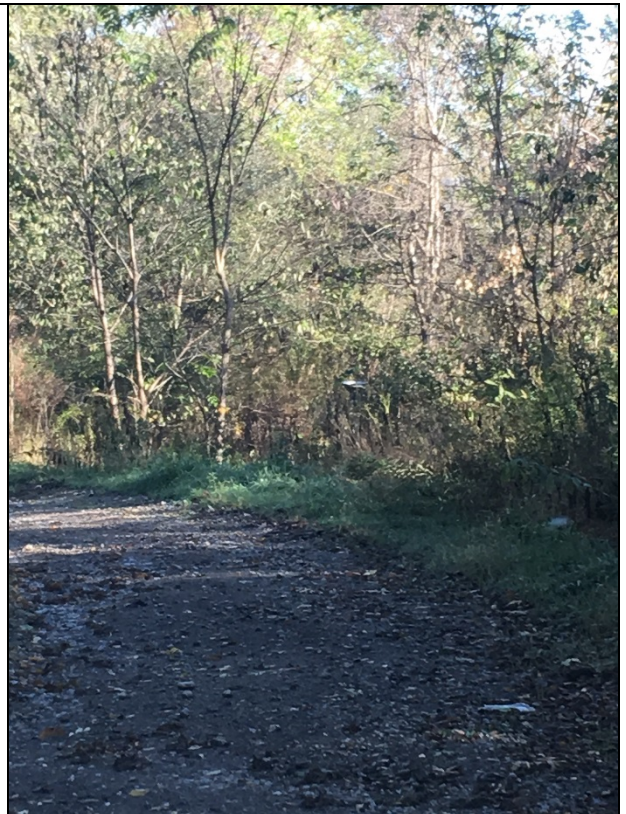
Photograph No. 18

Access road.

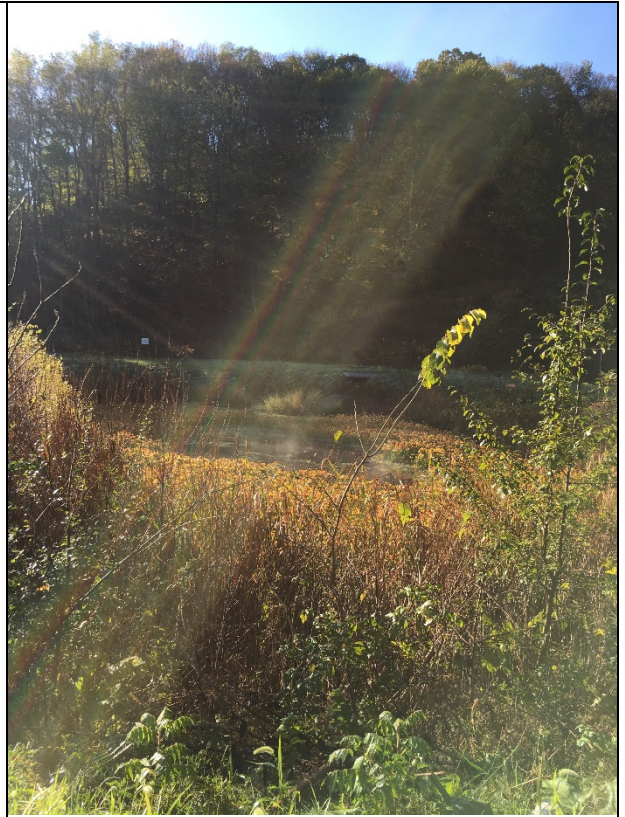
Photograph No. 19

Sedimentation Pond. Healthy vegetation on pond sideslopes. No trash or debris noted on water surface or in surrounding vegetation.

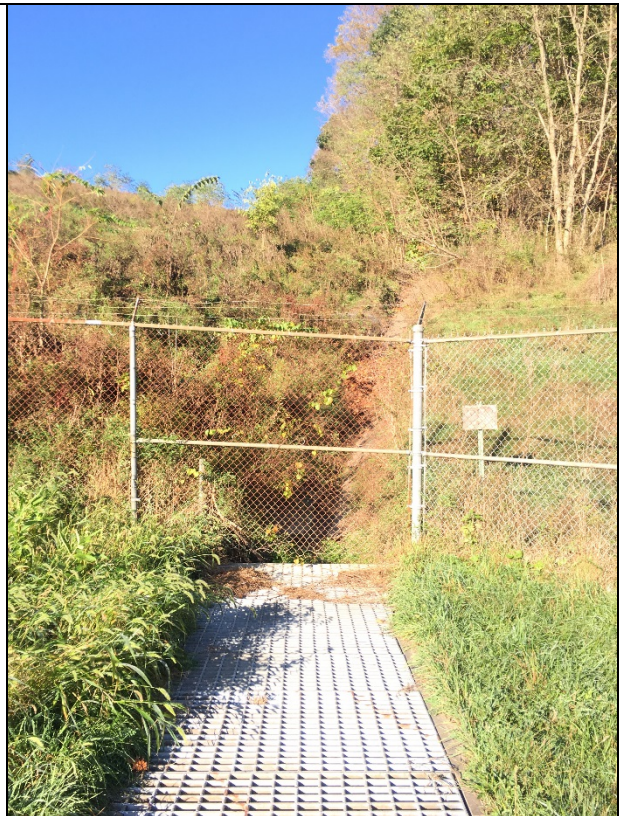
Photograph No. 20

North non-contact water channel at entry point into Sedimentation Pond (looking upslope). Free of debris and functioning as intended.

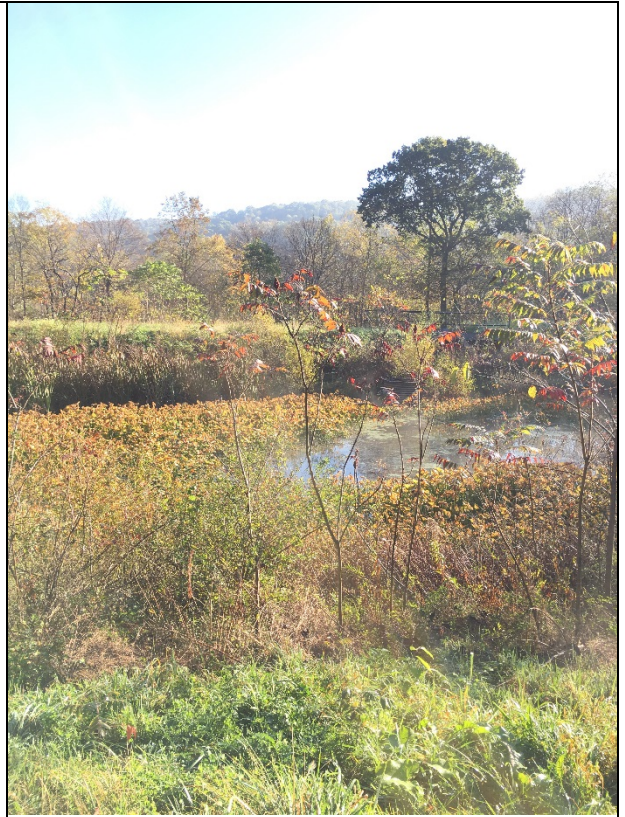
Photograph No. 21

Sedimentation Pond. Healthy vegetation on sideslopes.

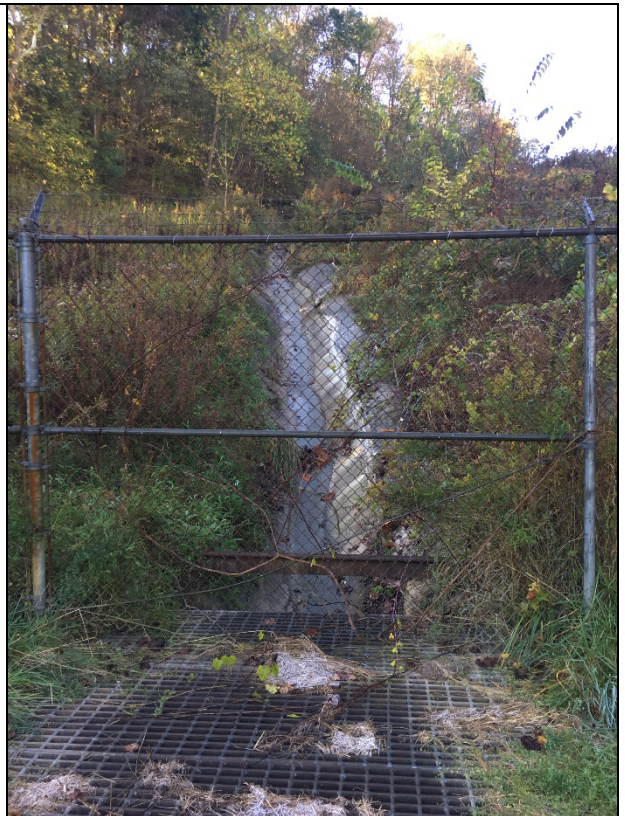
Photograph No. 22

South non-contact water channel at entry point into Sedimentation Pond (looking upslope). Free of debris and functioning as intended.

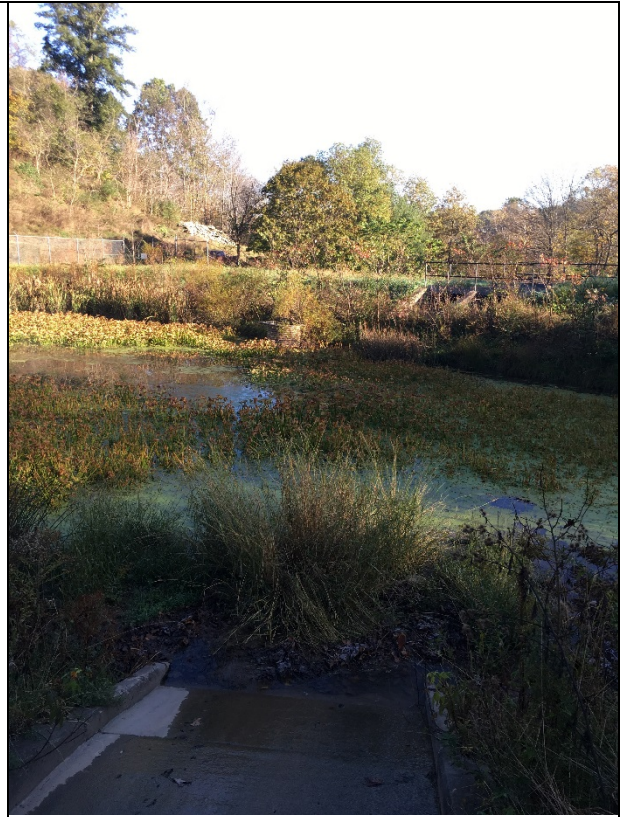
Photograph No. 23**Date:**

South non-contact water channel at entry point into Sedimentation Pond (looking toward pond). Channel is free of debris.

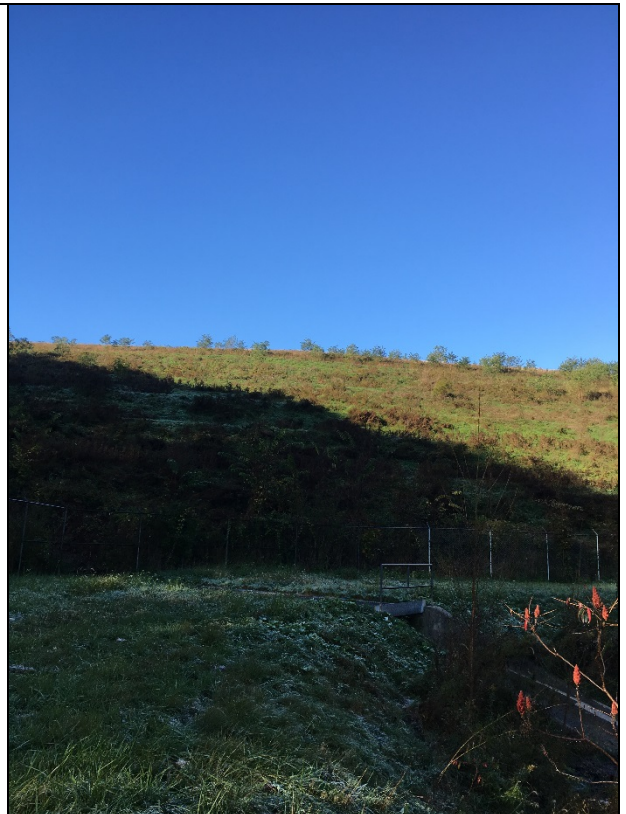
**Photograph No. 24****Date:**

Looking toward landfill sideslopes to give overview of healthy vegetation. No evidence of erosion, sloughing, or instability.

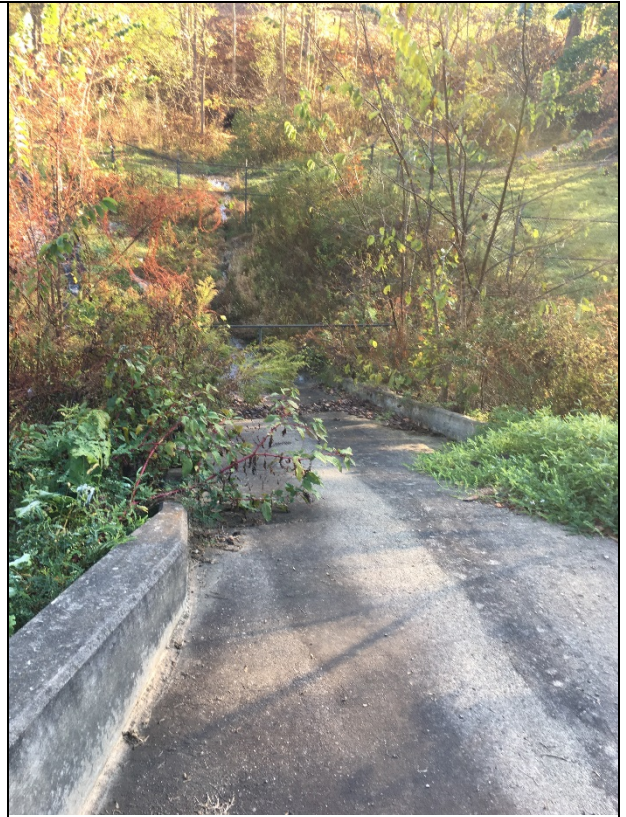
Photograph No. 25

Spillway. Clear of debris. No cracking or evidence of structural damage.

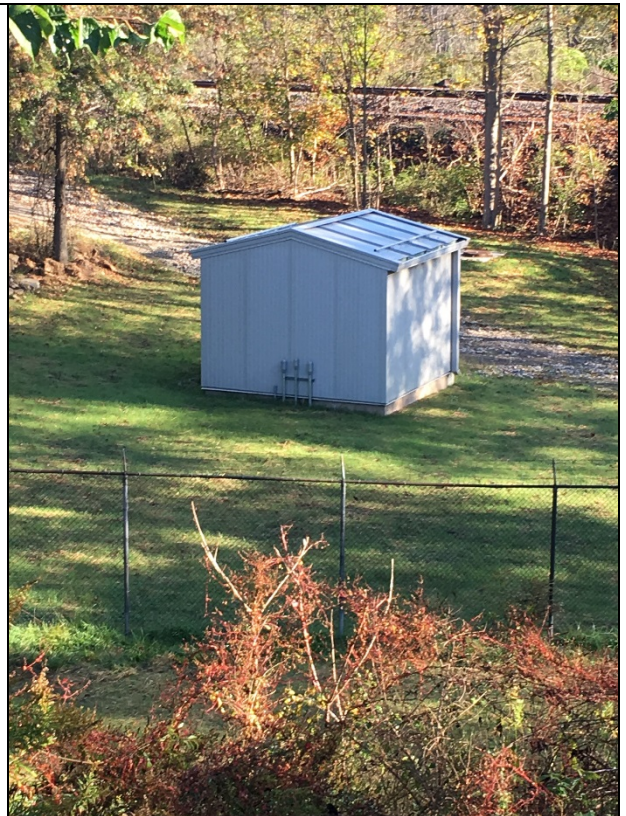
Photograph No. 26

Newly installed leachate pumphouse (2017).

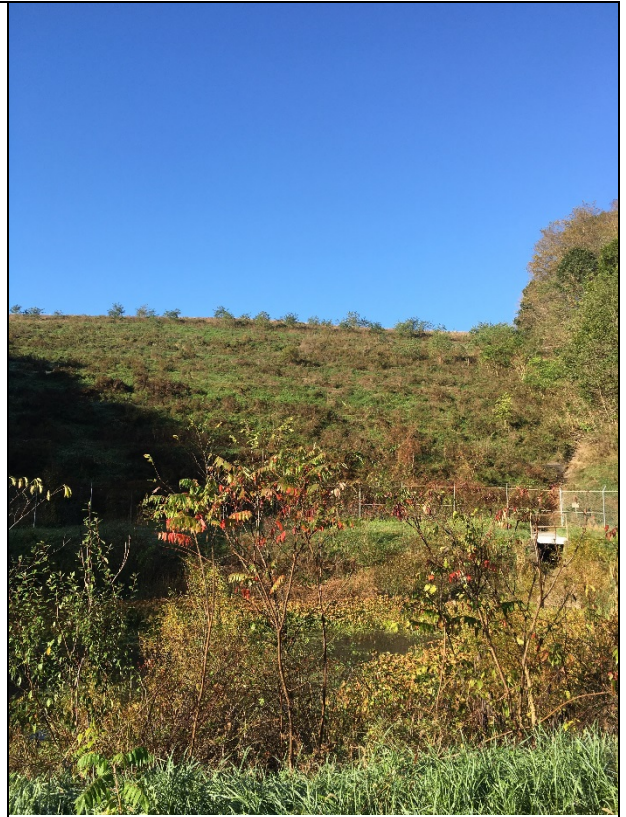
Photograph No. 27**Date:**

Looking toward landfill sideslopes with Sedimentation Pond in foreground. Vegetation is healthy, no signs of erosion, scour, or instability.

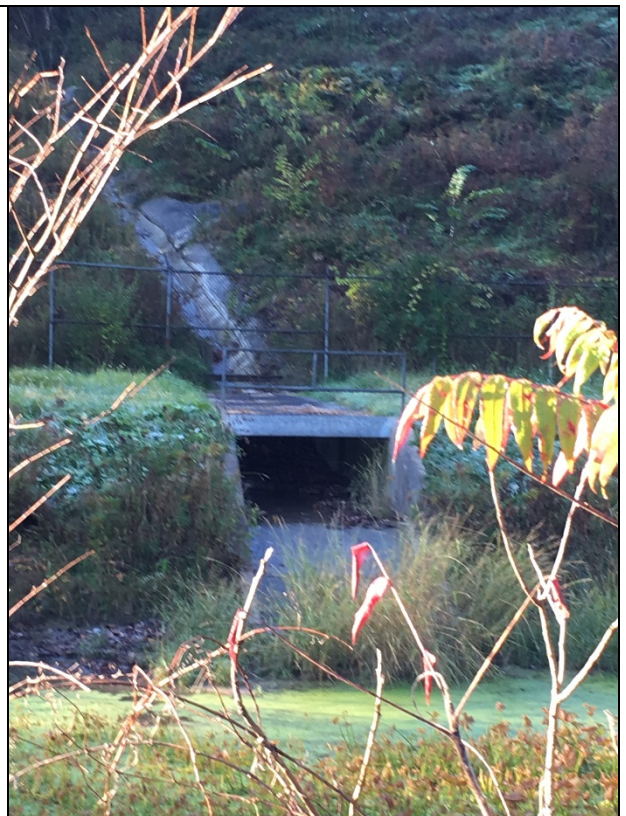
**Photograph No. 28****Date:**

South non-contact water channel inlet to Sedimentation Pond.

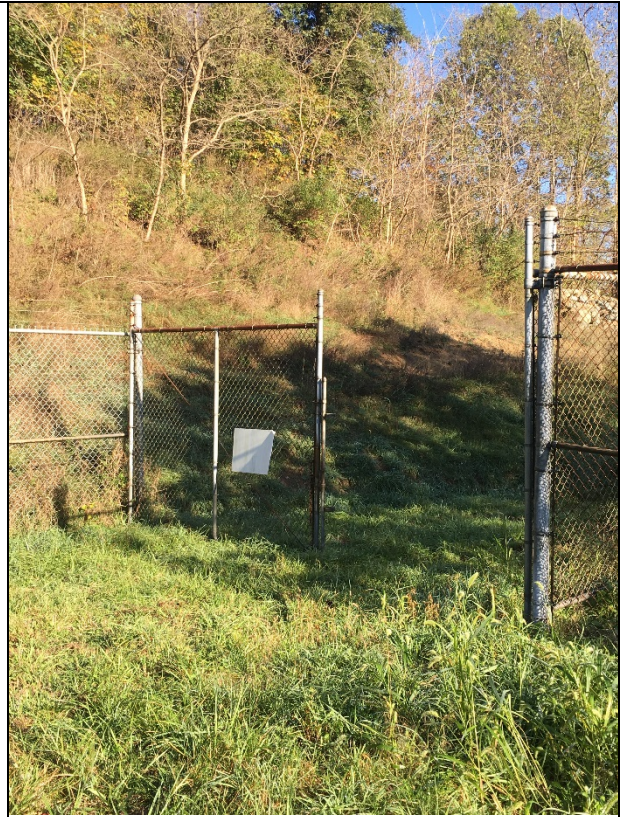
Photograph No. 29

Security fence around Sedimentation Pond.
