Inspection Report

To: Bill McGraw (Cheswick Generating Station)
From: Richard Southorn, P.E., P.G.
Re: Cheswick Ash Disposal Site – Annual CCR Unit Inspection Report
Inspection Date: October 22, 2018
Report Date: January 16, 2019

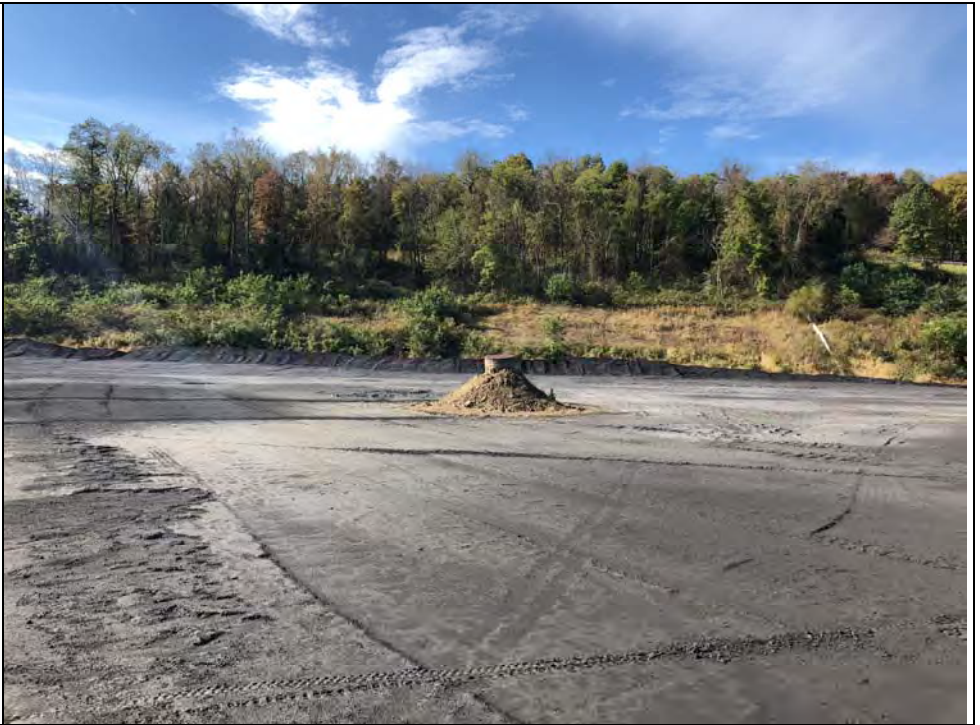
Image: 2394
Date: 10/22/2018
Time: 10:40 AM
Direction: Southwest

A non-contact water (stormwater) non-perforated riser will be extended to final cover elevation and will accept stormwater after final cover is in place.

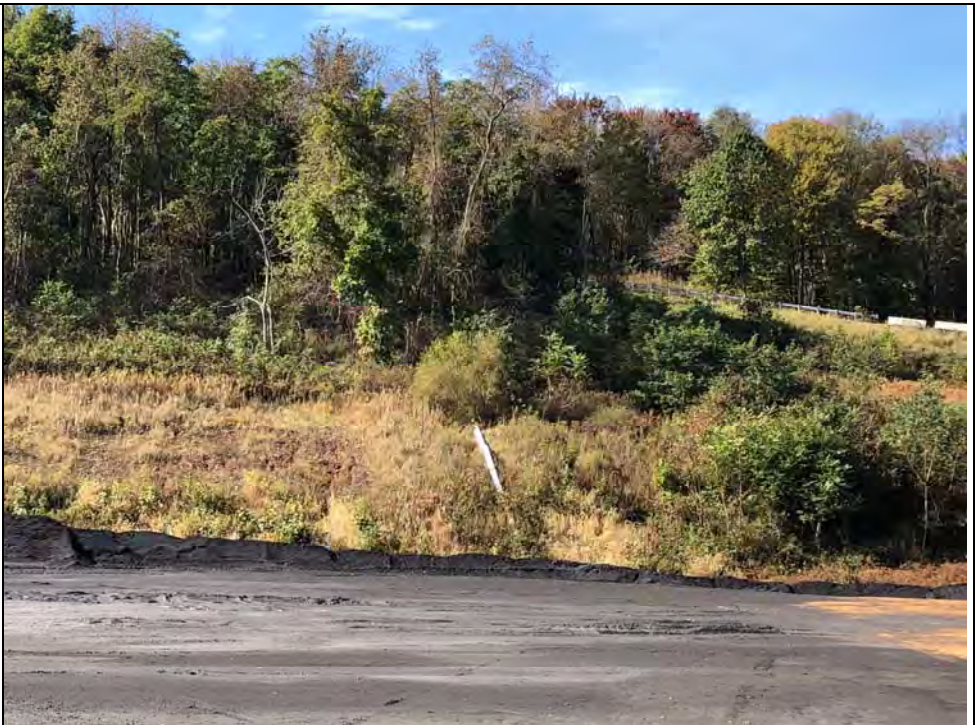
Image: 2396
Date: 10/22/2018
Time: 10:41 AM
Direction: West

Non-contact stormwater pipe along western sideslope. No evidence of erosion or sloughing.

Active area is shown in foreground (spread and compacted bottom ash).

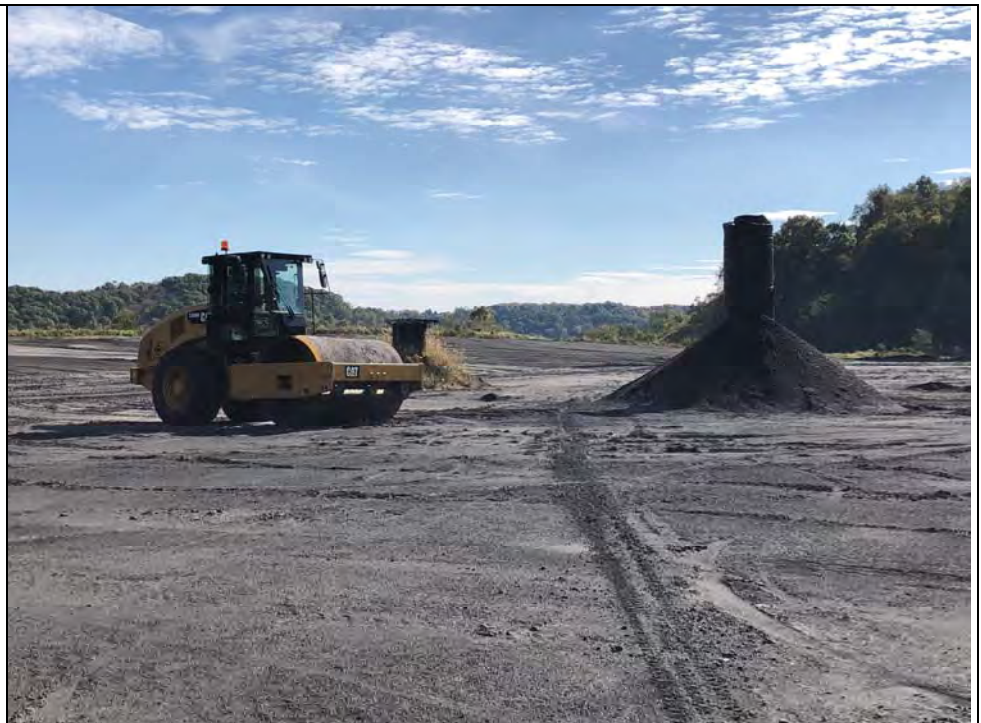
Image: 2398
 Date: 10/22/2018
 Time: 10:42 AM
 Direction: Southeast

The active area is well maintained with no ponding water. CCR material is spread and rolled shortly after being received.

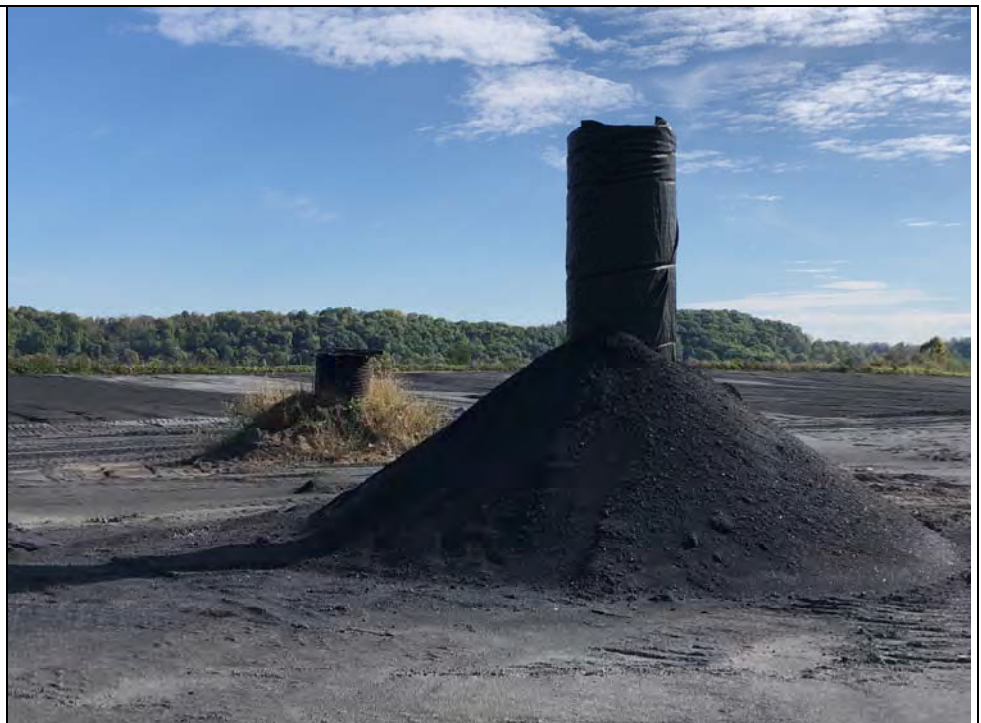
Image: 2400
 Date: 10/22/2018
 Time: 10:43 AM
 Direction: Northeast

A perforated contact-water (leachate) riser is shown in foreground. This riser is wrapped in filter fabric and surrounded with bottom ash. A non-contact water (stormwater) non-perforated riser is shown in the background. This riser will be extended to final cover elevation and will accept stormwater after final cover is in place.

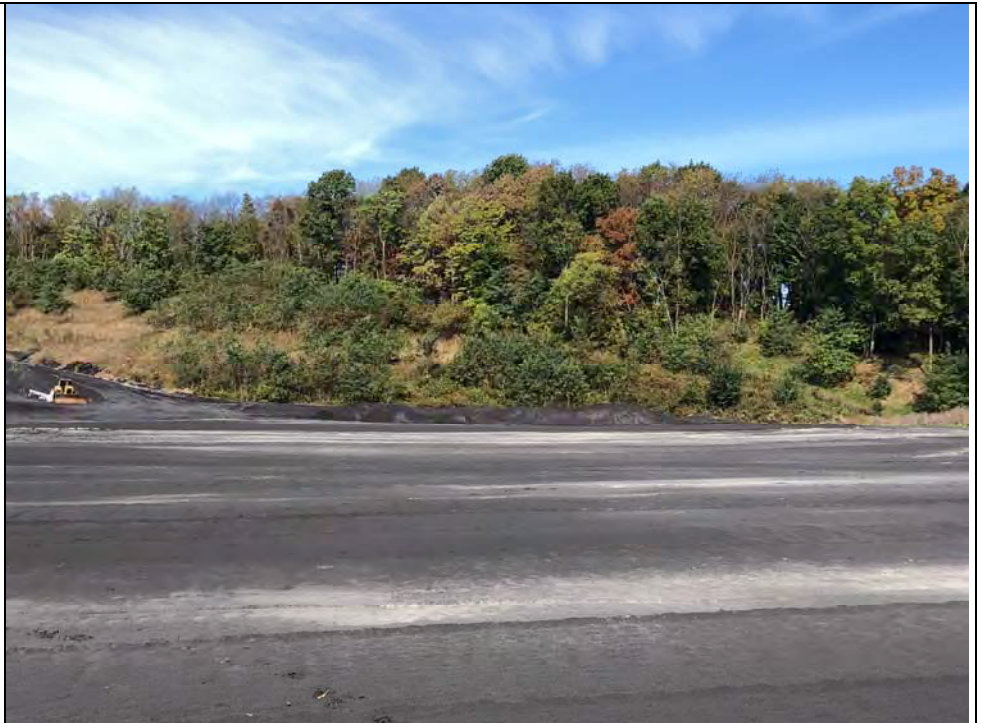
Image: 2402
Date: 10/22/2018
Time: 10:46 AM
Direction: North

The active area is well maintained with no ponding water. CCR material is spread and rolled shortly after being received.

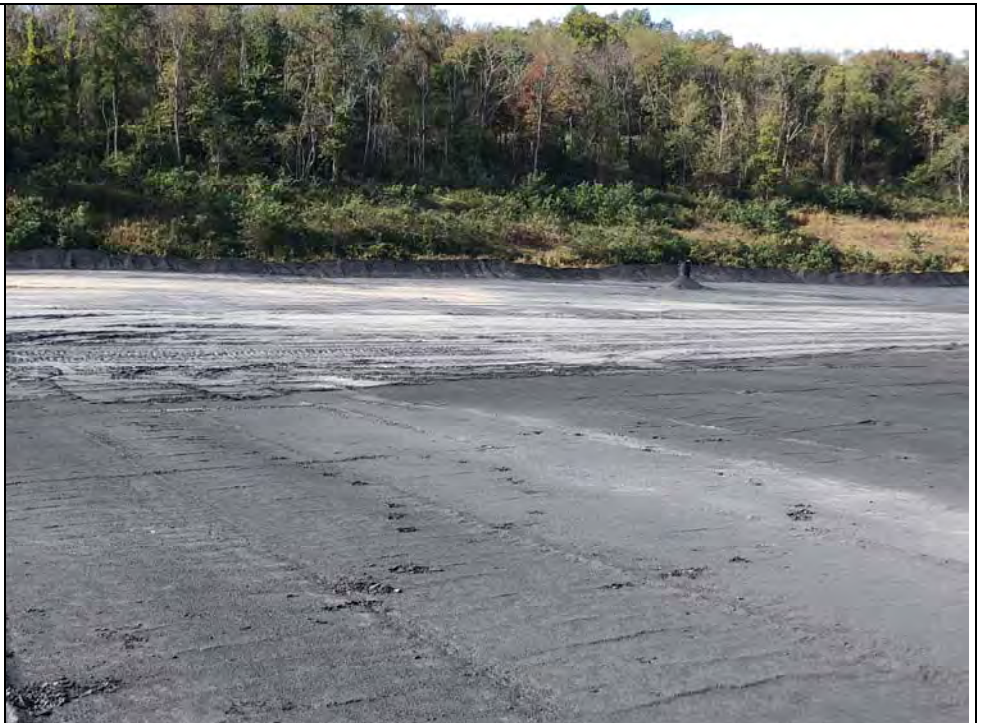
Image: 2404
Date: 10/22/2018
Time: 10:46 AM
Direction: West

Active area. Well maintained, no ponding water. Material is placed in even lifts that are spread and compacted.

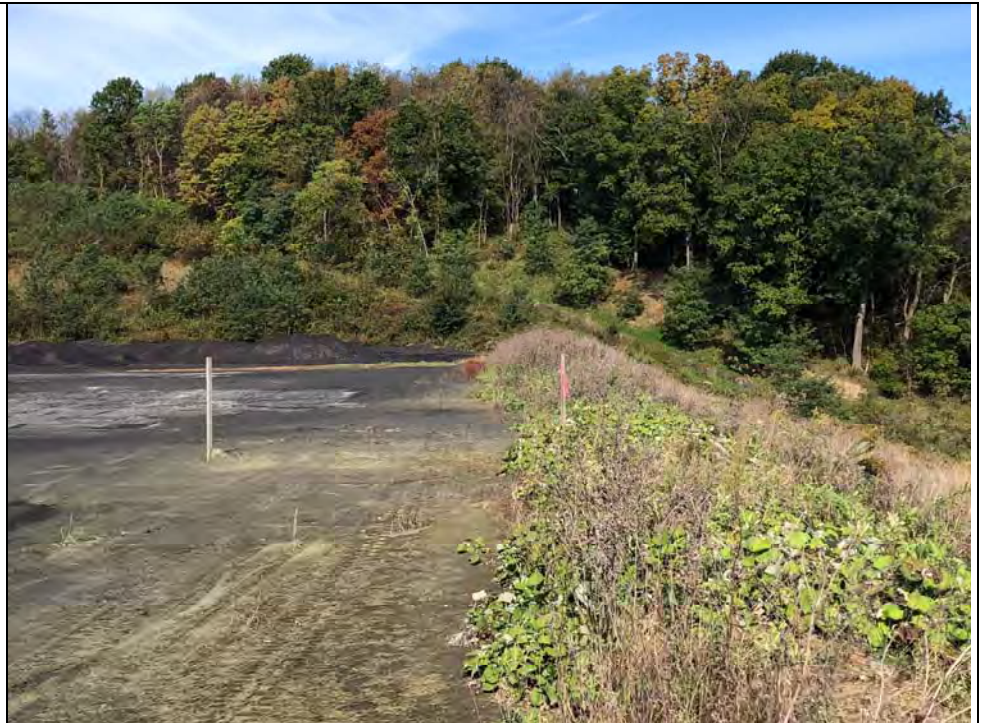
Image: 2406
Date: 10/22/2018
Time: 10:47 AM
Direction: Northwest

Staking has been placed to represent the location and final target CCR elevation for the next terrace bench. Once final CCR material grades are achieved, final cover will be installed.

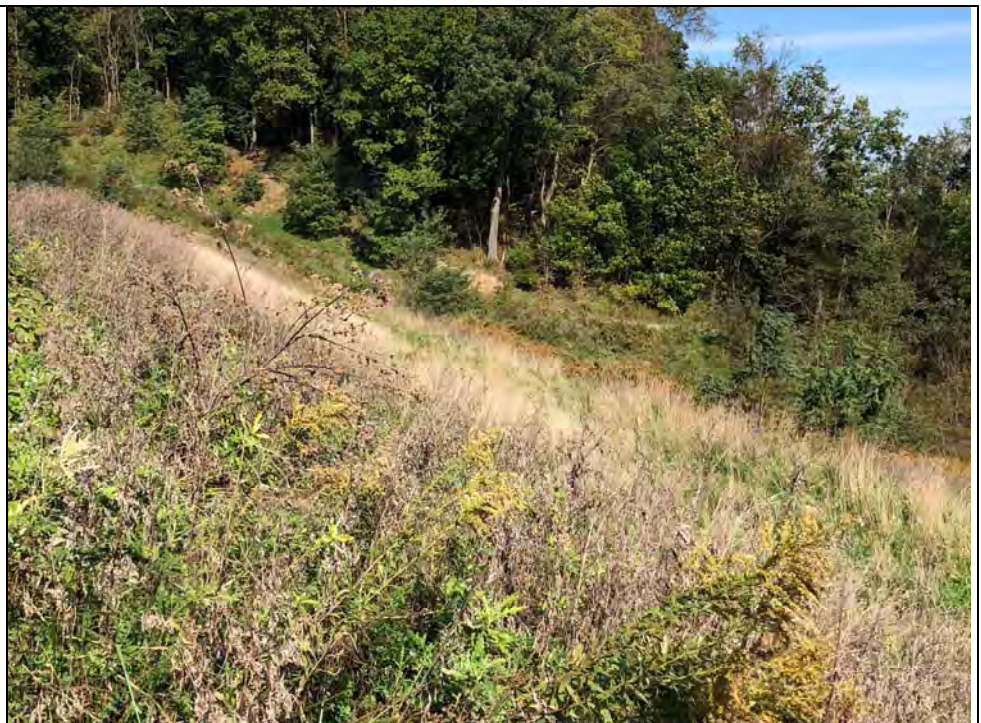
Image: 2408
Date: 10/22/2018
Time: 10:47 AM
Direction: North

Sideslope near active face. Vegetation is healthy and present across the entire sideslope. No evidence of erosion, sloughing, or indications of stability issues.

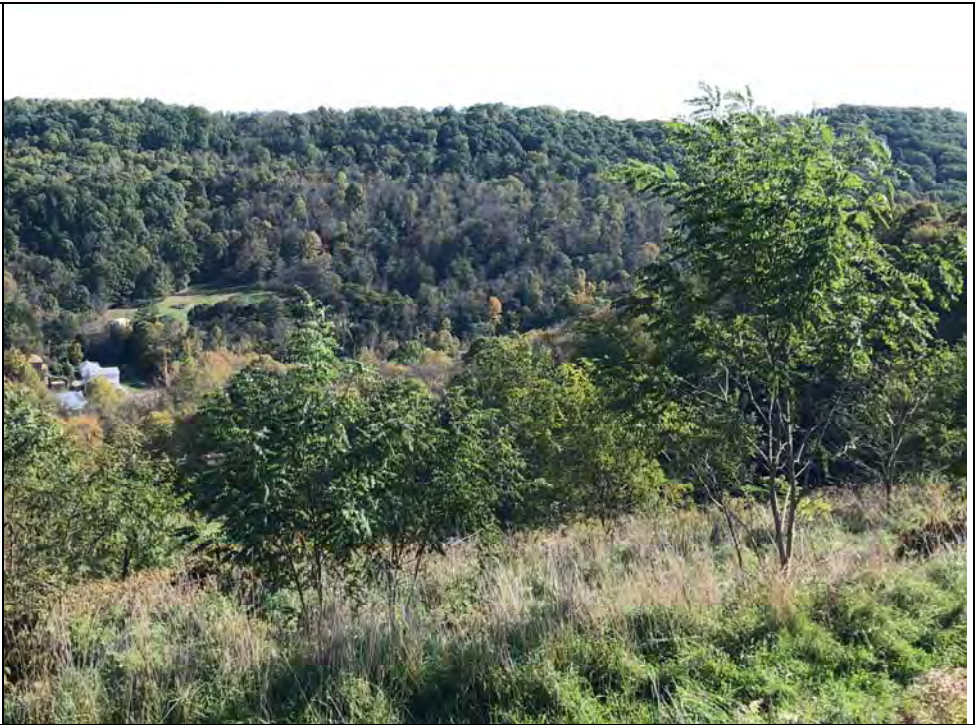
Image: 2410
Date: 10/22/2018
Time: 10:48 AM
Direction: East

Vegetation on sideslope looking downslope. Vegetation is well established. No evidence of erosion or sloughing.

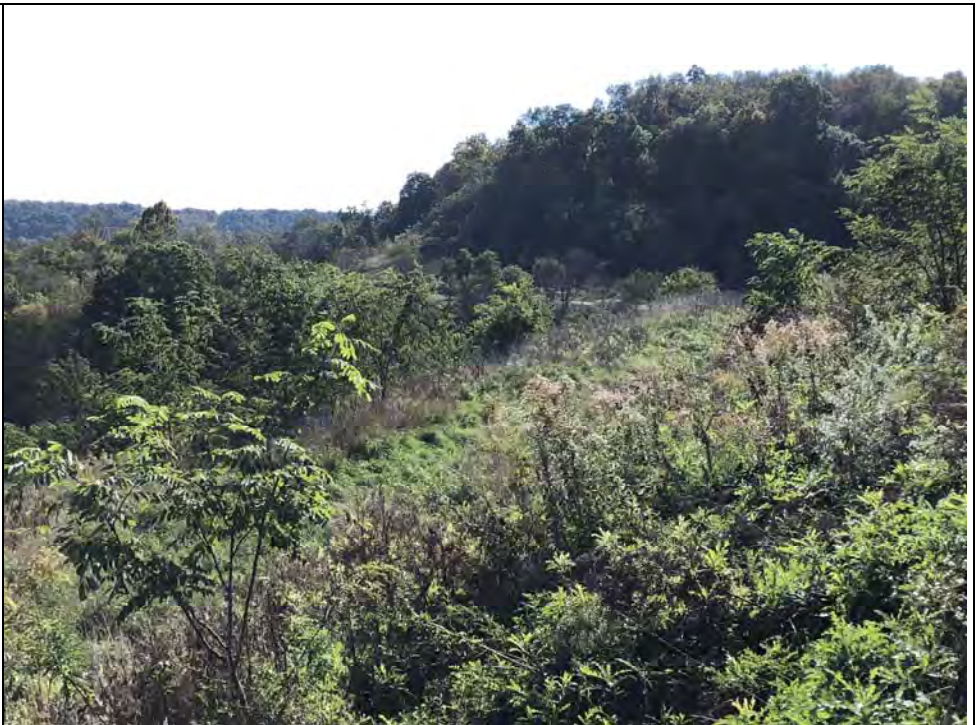
Image: 2412
Date: 10/22/2018
Time: 10:48 AM
Direction: Southeast

Vegetation on sideslope. Vegetation is well established. No evidence of erosion or sloughing.

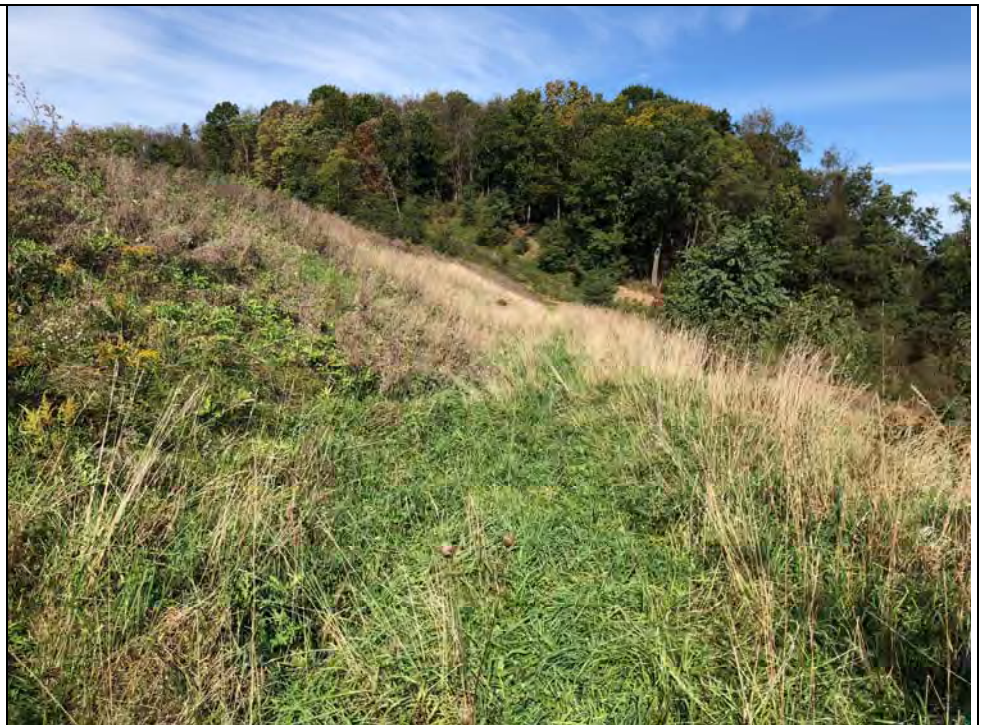
Image: 2416
Date: 10/22/2018
Time: 10:48 AM
Direction: Northwest

Typical slope terrace.
Terraces are well maintained with no evidence of sloughing or erosion. Vegetation is healthy.

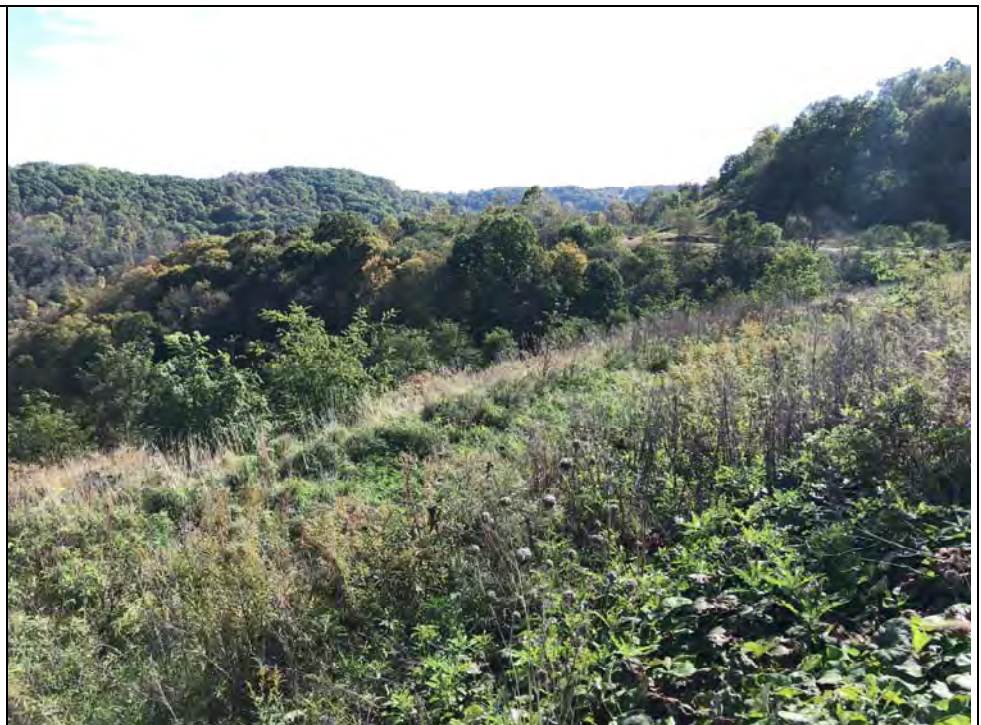
Image: 2418
Date: 10/22/2018
Time: 10:50 AM
Direction: Southeast

Vegetation is healthy and present across the entire sideslope. No evidence of erosion, sloughing, or indications of stability issues.

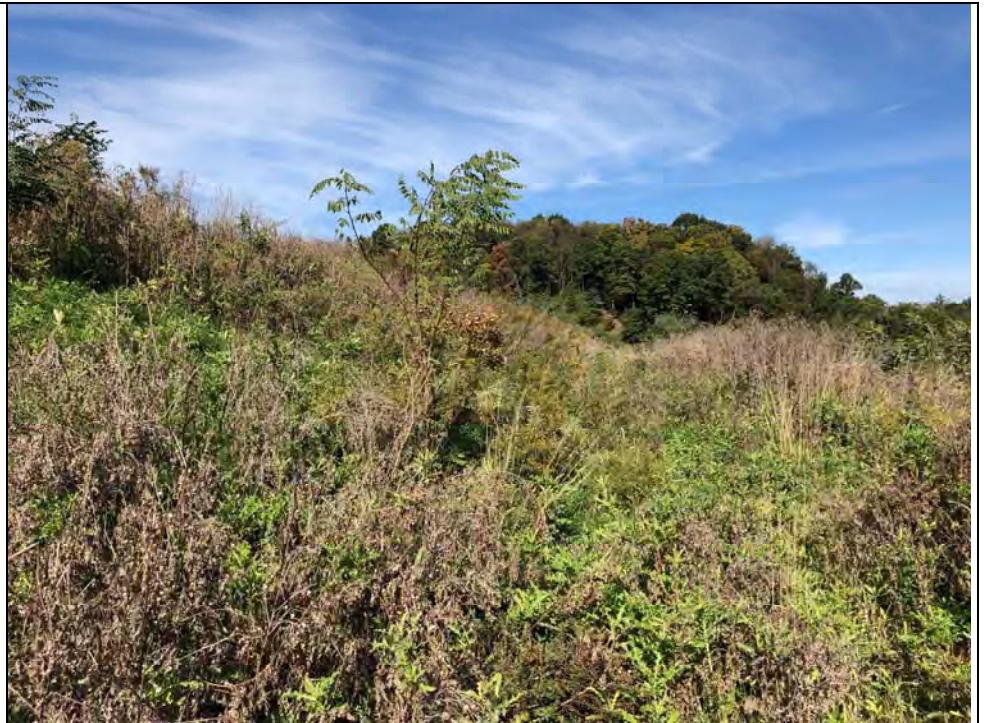
Image: 2420
Date: 10/22/2018
Time: 10:51 AM
Direction: Northwest

Vegetation is healthy and present across the entire sideslope. No evidence of erosion, sloughing, or indications of stability issues.

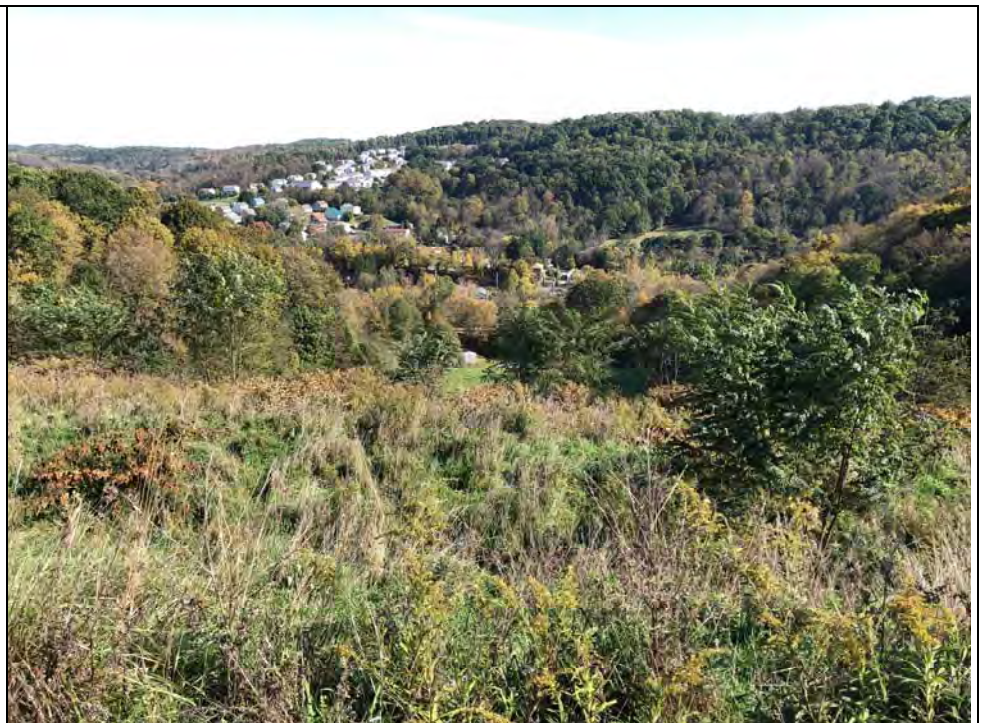
Image: 2422
Date: 10/22/2018
Time: 10:51 AM
Direction: Northeast

Vegetation is healthy and present across the entire sideslope. No evidence of erosion, sloughing, or indications of stability issues.

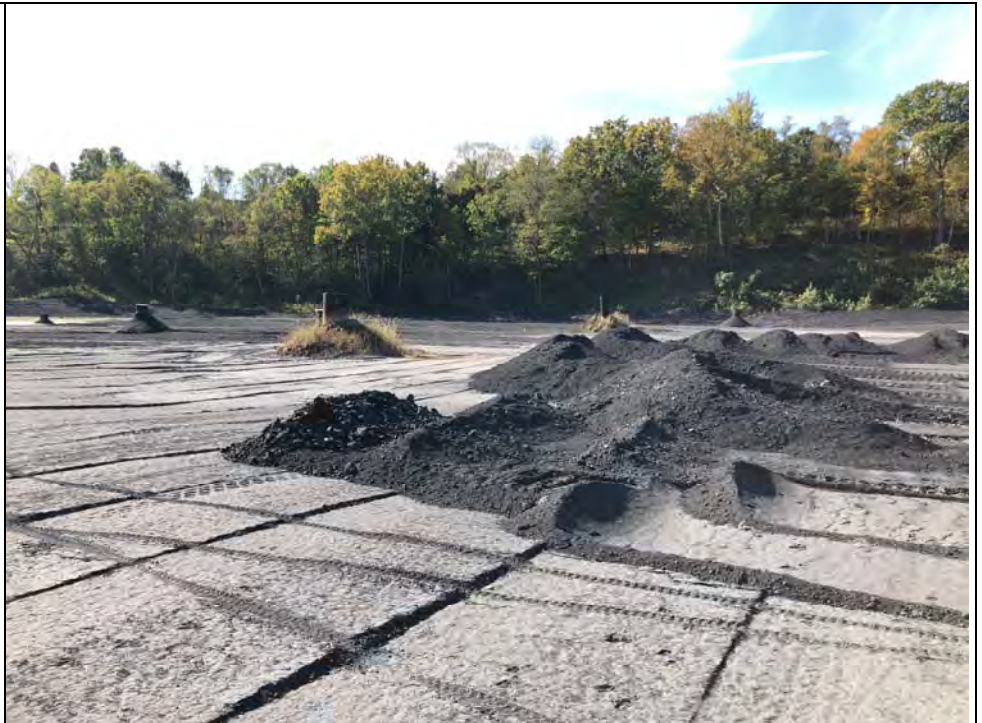
Image: 2424
Date: 10/22/2018
Time: 10:53 AM
Direction: Southwest

Bottom Ash in active disposal area prior to spreading and compacting.

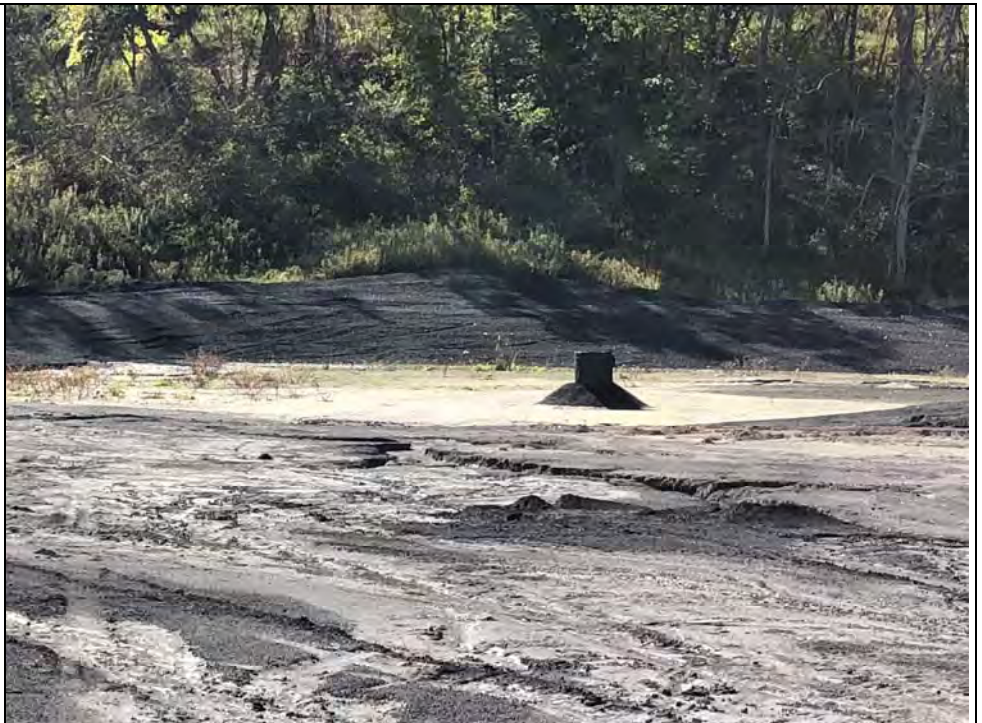
Image: 2426
Date: 10/22/2018
Time: 10:55 AM
Direction: South

Active area with leachate collection riser in background. The active area is sloped to this low point to prevent run-off.

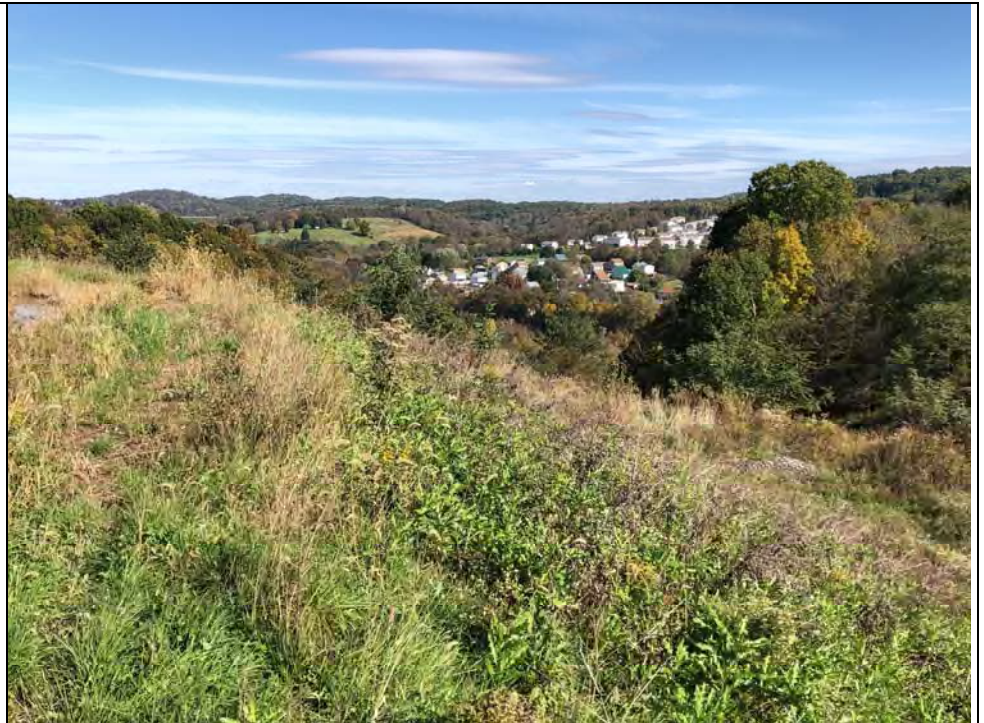
Image: 2428
Date: 10/22/2018
Time: 10:56 AM
Direction: Northeast

Typical healthy
vegetation on sideslopes.
No evidence of erosion or
sloughing.

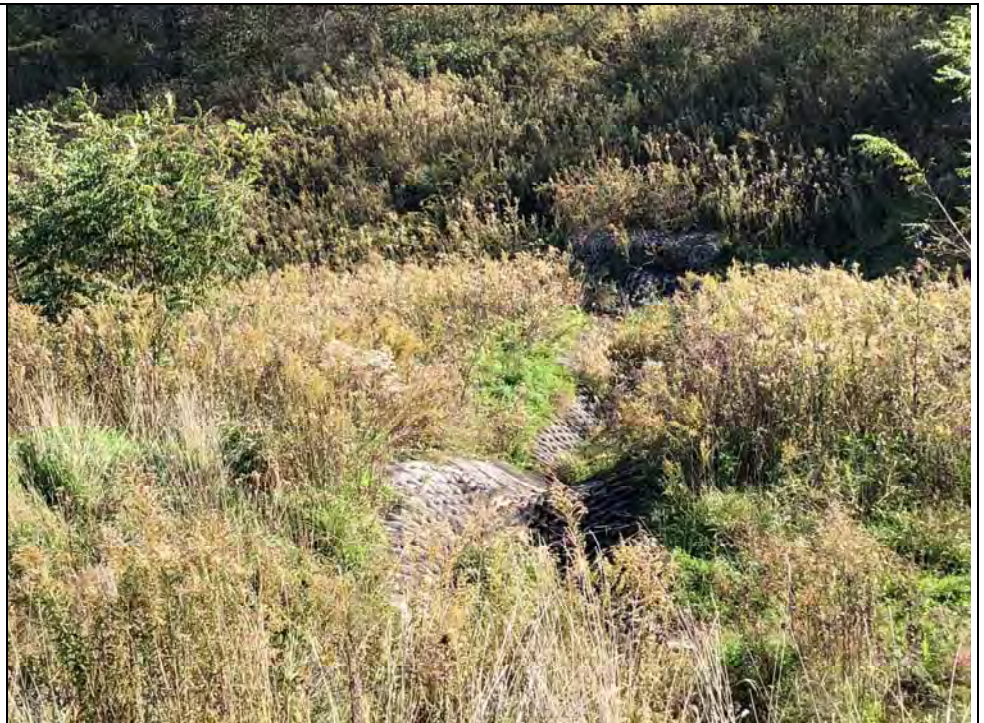
Image: 2430
Date: 10/22/2018
Time: 10:57 AM
Direction: East

South non-contact water
channel. Free of debris
and functioning as
intended.

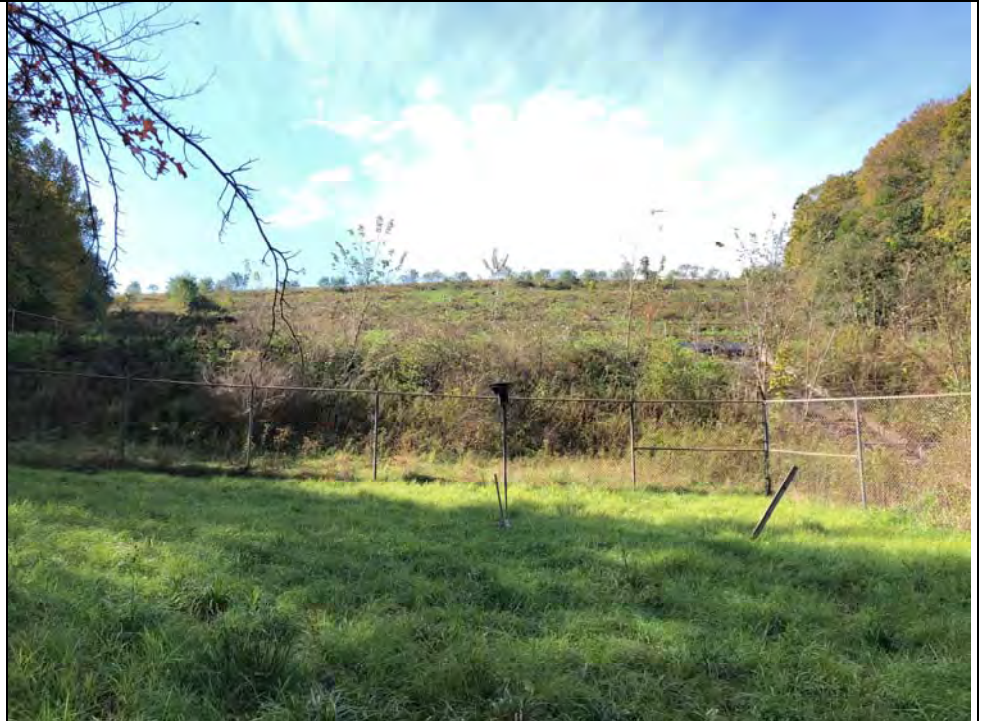
Image: 2434
Date: 10/22/2018
Time: 11:11 AM
Direction: Southwest

Landfill sideslopes and
sedimentation pond area.
Well maintained.

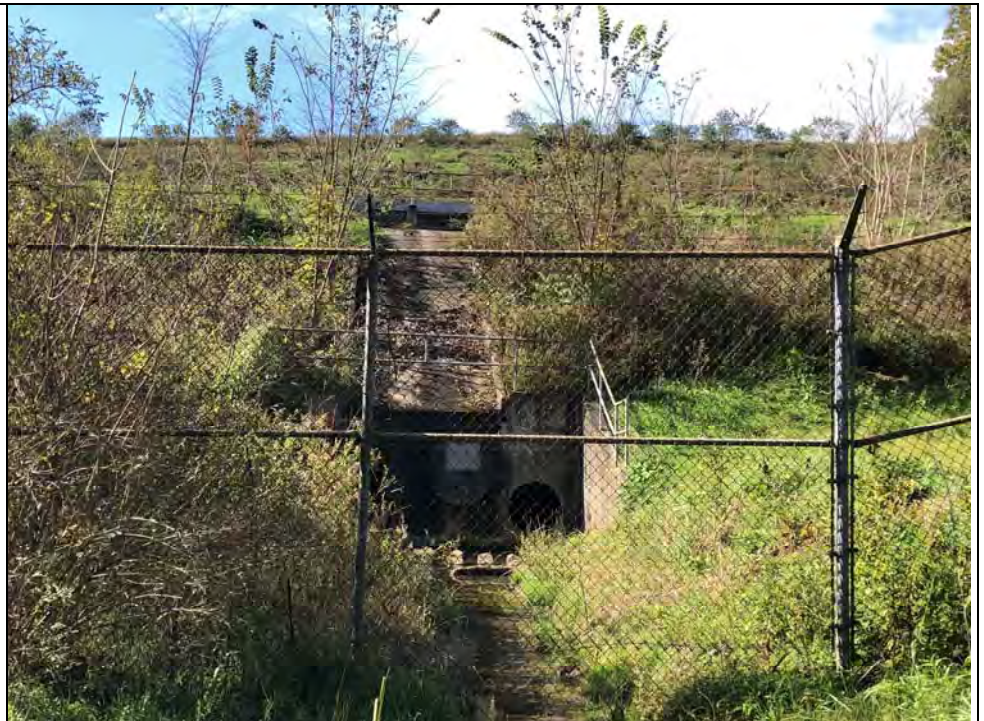
Image: 2436
Date: 10/22/2018
Time: 11:12 AM
Direction: Southwest

Sedimentation Pond
Spillway. Clear of debris.
No cracking or evidence
of structural damage.

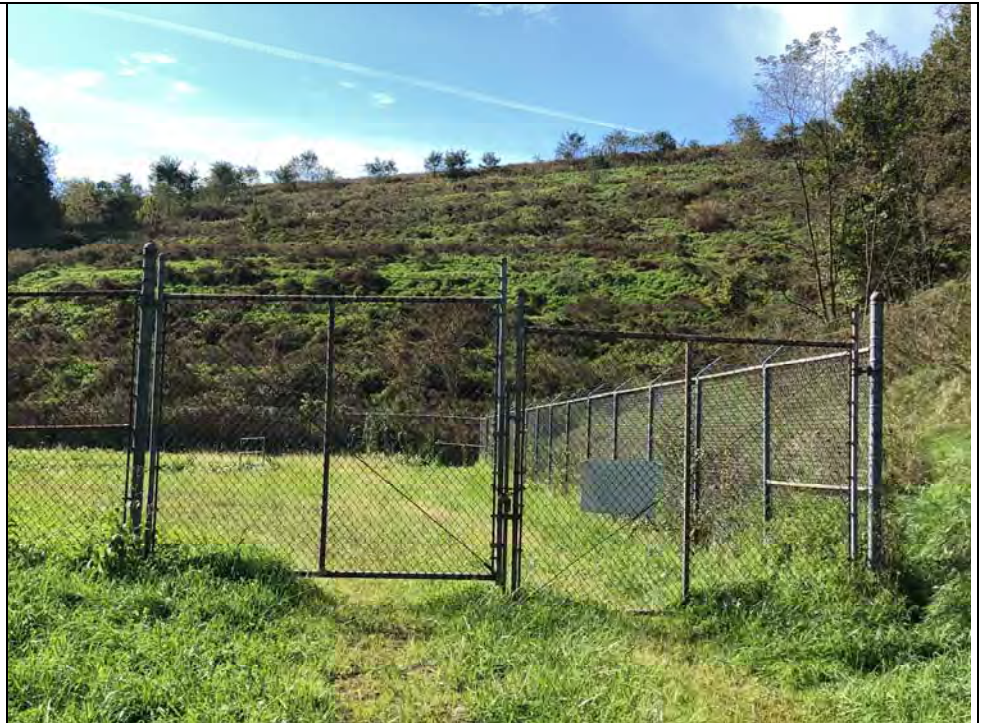
Image: 2438
Date: 10/22/2018
Time: 11:13 AM
Direction: Southwest

Security fence around
Sedimentation Pond.

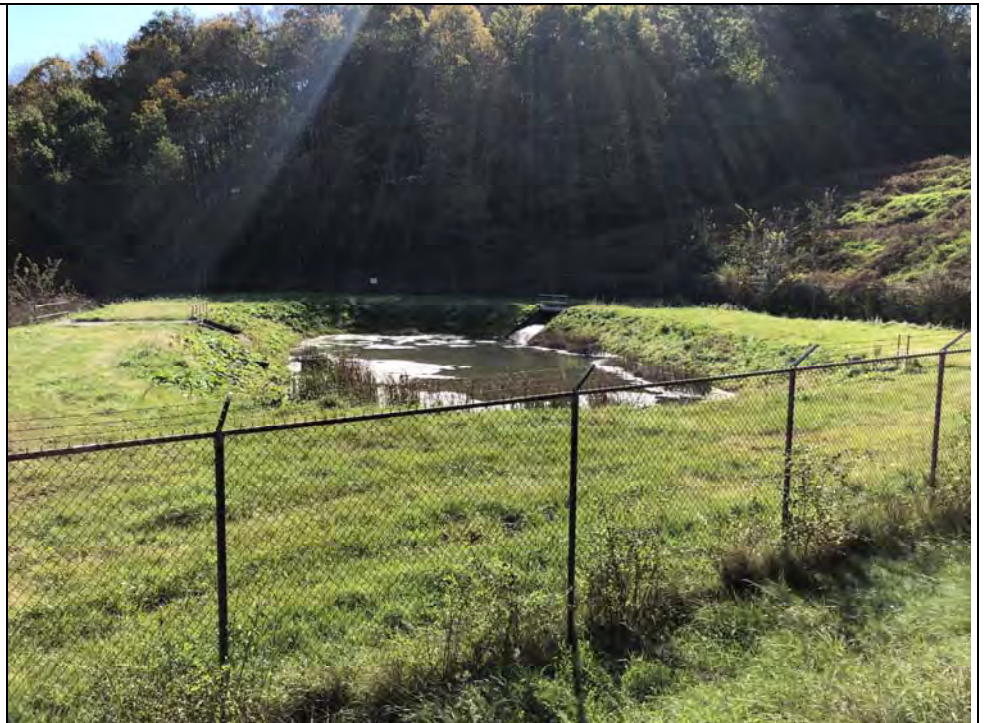
Image: 2440
Date: 10/22/2018
Time: 11:14 AM
Direction: South

Sedimentation Pond.
Healthy vegetation on
pond sideslopes. No
trash or debris noted on
water surface or in
surrounding vegetation.

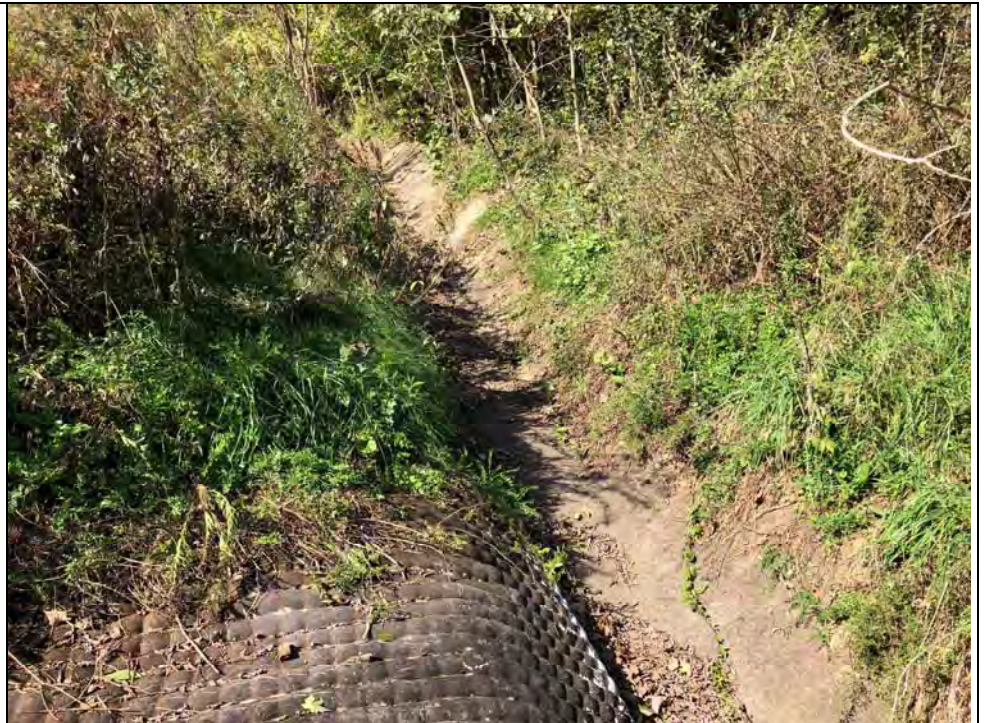
Image: 2442
Date: 10/22/2018
Time: 11:14 AM
Direction: West

North non-contact water channel inlet to Sedimentation Pond looking upslope. Clear of debris. Functioning as intended.

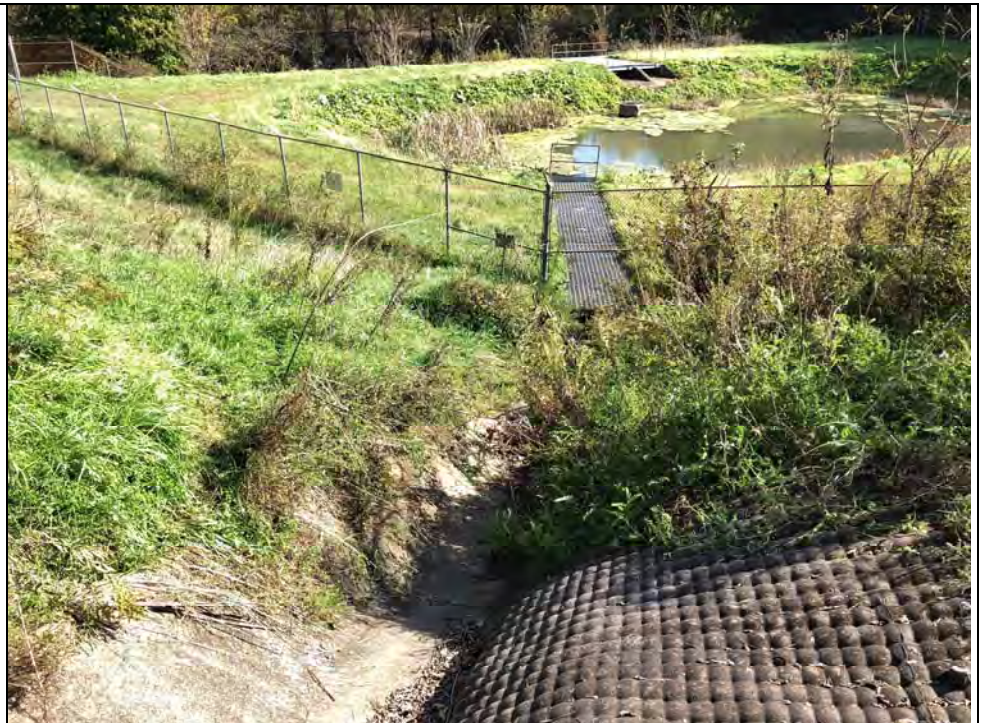
Image: 2444
Date: 10/22/2018
Time: 11:15 AM
Direction: East

North non-contact water channel inlet to Sedimentation Pond looking downslope. Clear of debris. Functioning as intended.

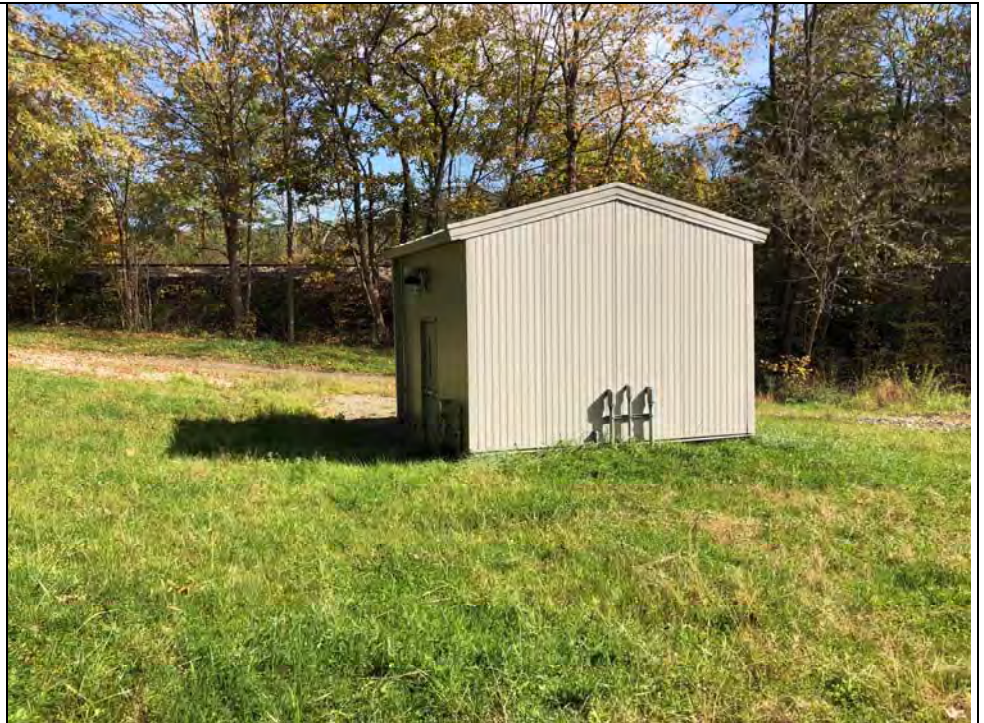
Image: 2448
Date: 10/22/2018
Time: 11:17 AM
Direction: East

Leachate pumphouse
installed in 2017.
Leachate is directed to
the Monarch Mine
Dewatering Plant.
