Inspection Report

Re: New Castle Plant Ash Landfill – Annual CCR Unit Inspection Report No. 2

Inspection Date: November 17, 2016

Report Date: January 16, 2017

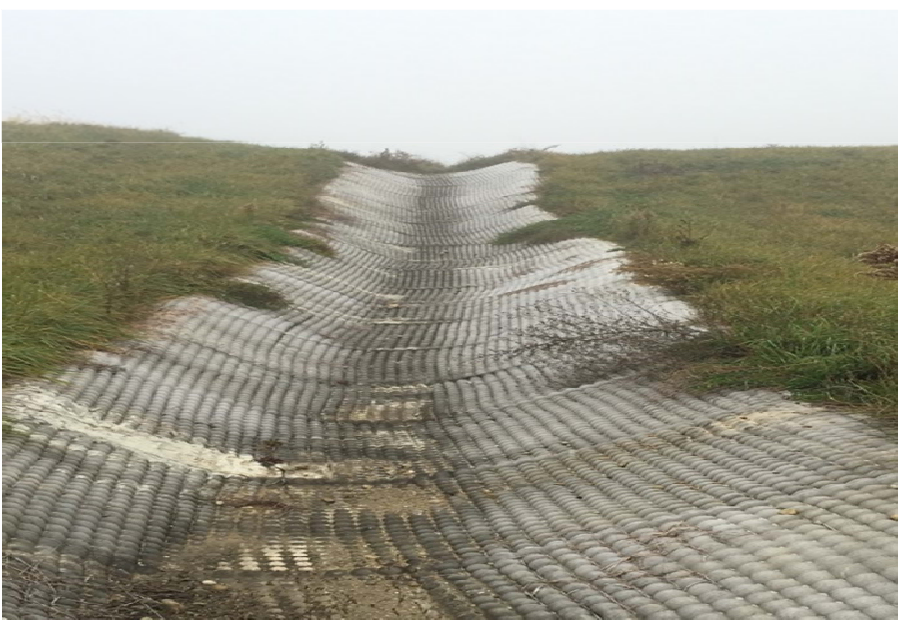
<p>Photograph No. 2</p> <p>Date: November 17, 2016</p> <p>Direction: North</p>

<p>Description: "Non-contact" stormwater downchute. No evidence of erosion or obstruction.</p>

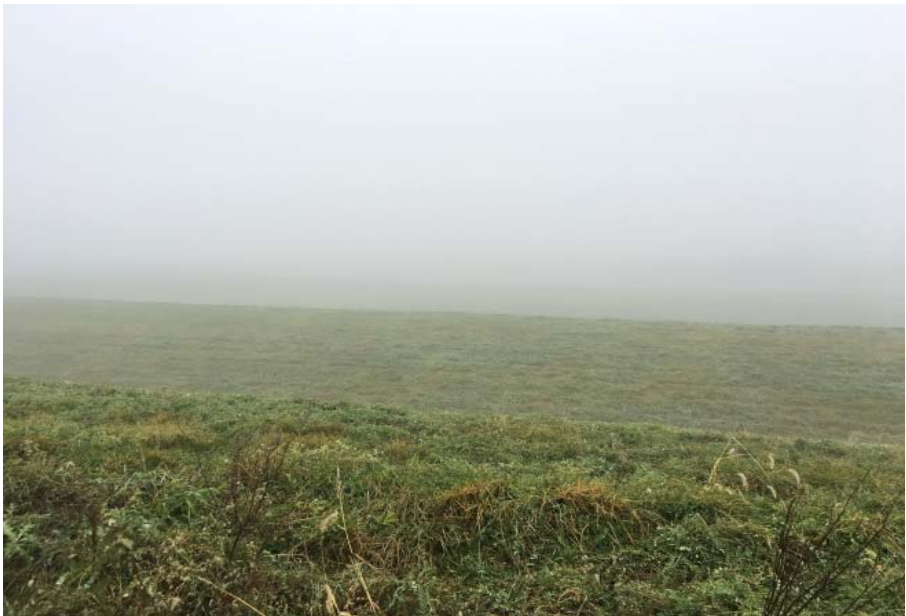
<p>Photograph No. 3</p> <p>Date: November 17, 2016</p> <p>Direction: North</p>

<p>Description: Closed portions of Stage 4 disposal area. Vegetation is well established and maintained. No evidence of erosion or sloughing.</p>

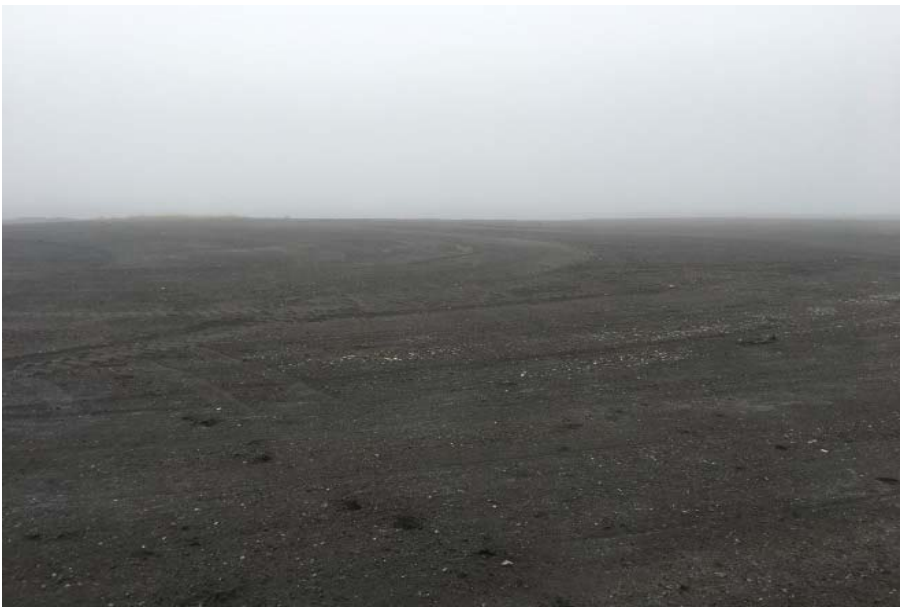
<p>Photograph No. 5</p> <p>Date: November 17, 2016</p> <p>Direction: South</p>

<p>Description: Active filling area in Stage 4 (no disposal since approx. May 2016). No evidence of erosion or airborne dust.</p>

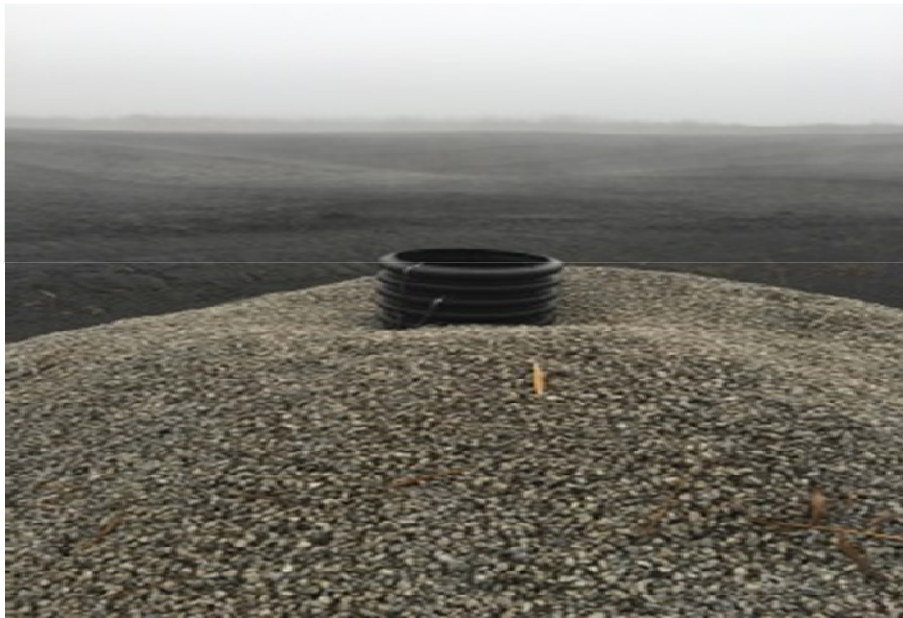
<p>Photograph No. 7</p> <p>Date: November 17, 2016</p> <p>Direction: East</p>

<p>Description: "Contact" stormwater decant structure within the active filling area of Stage 4. No evidence of malfunction.</p>

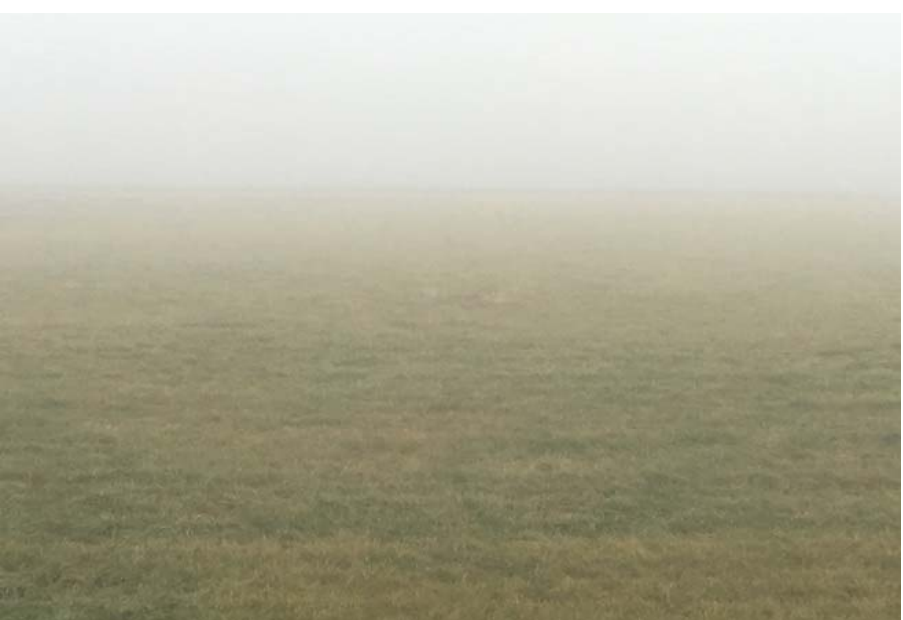
<p>Photograph No. 8</p> <p>Date: November 17, 2016</p> <p>Direction: East</p>

<p>Description: Final cover system on plateau area of Stage 6 (closed). Vegetation is well established and maintained. No evidence of erosion or sloughing.</p>

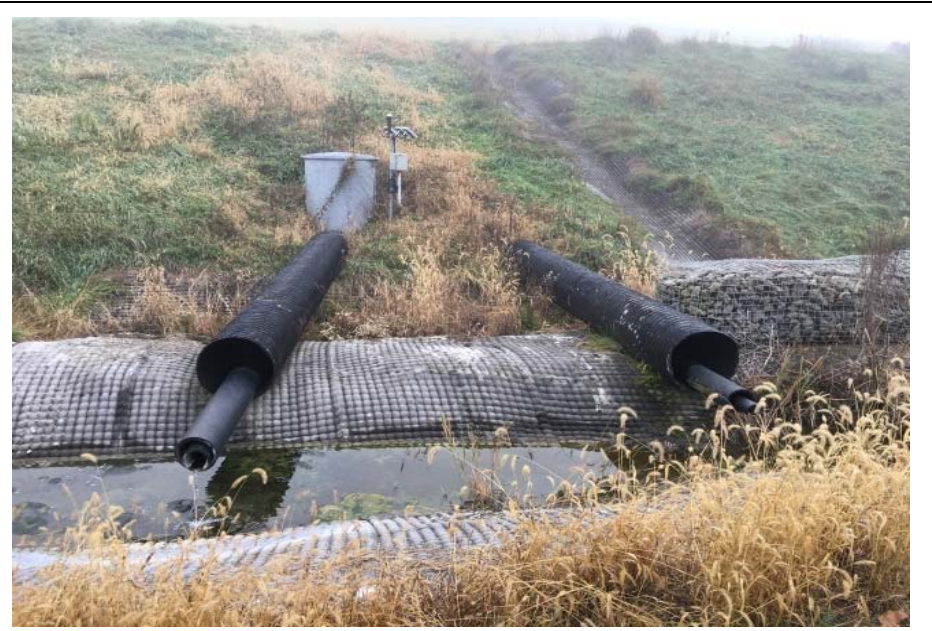
Photograph No. 11

Leachate pipes discharging into "contact" stormwater ditch, which drains to leachate pond. "Non-contact" stormwater downchute (Downchute 4) is also shown (right). "Non-contact" stormwater drains to sedimentation pond.

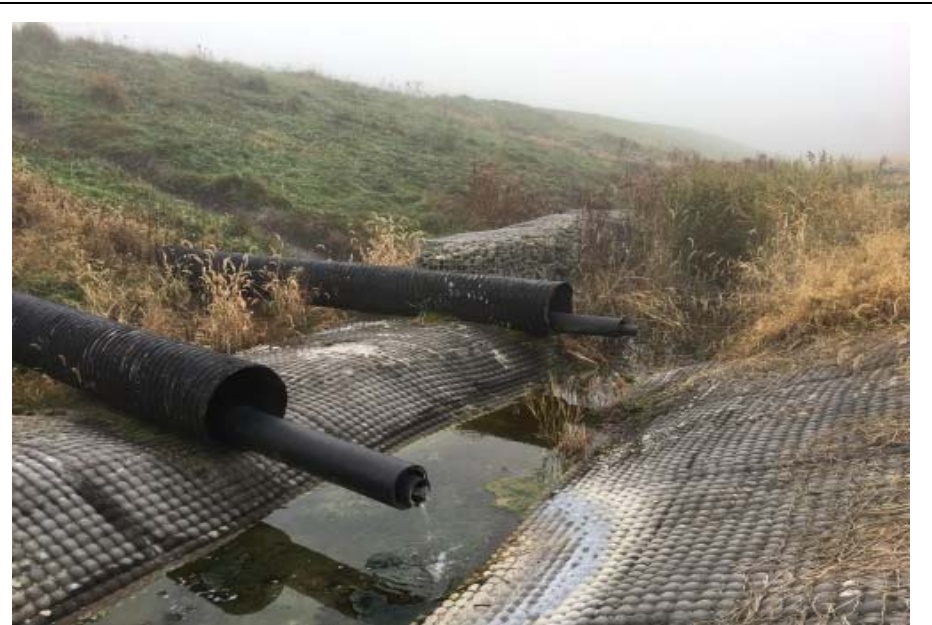
Photograph No. 12

Leachate pipes discharging into "contact" stormwater ditch, which drains to leachate pond.

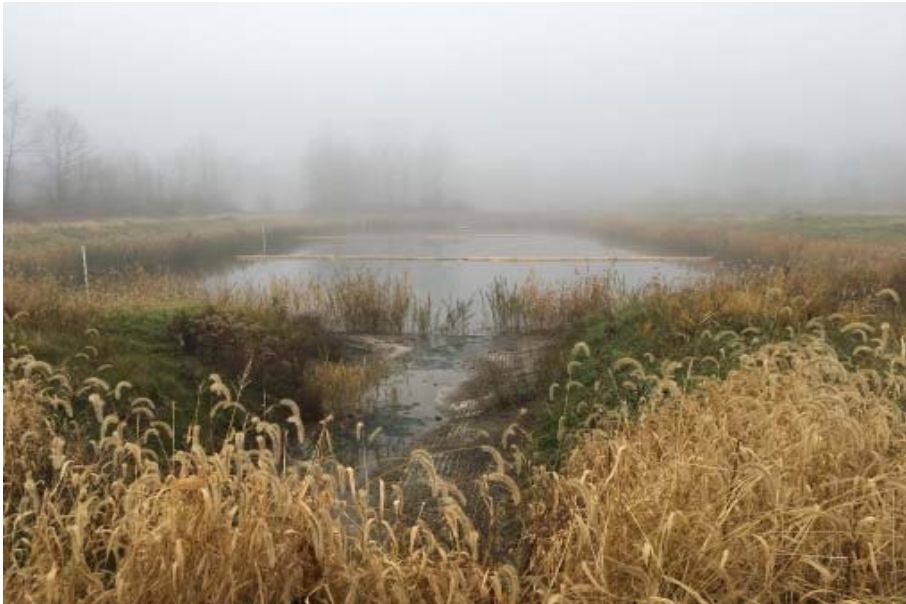
<p>Photograph No. 13</p> <p>Date: November 17, 2016</p> <p>Direction: West</p>

<p>Description: "Contact" stormwater ditch inlet location to the leachate pond. No evidence of erosion or malfunction.</p>

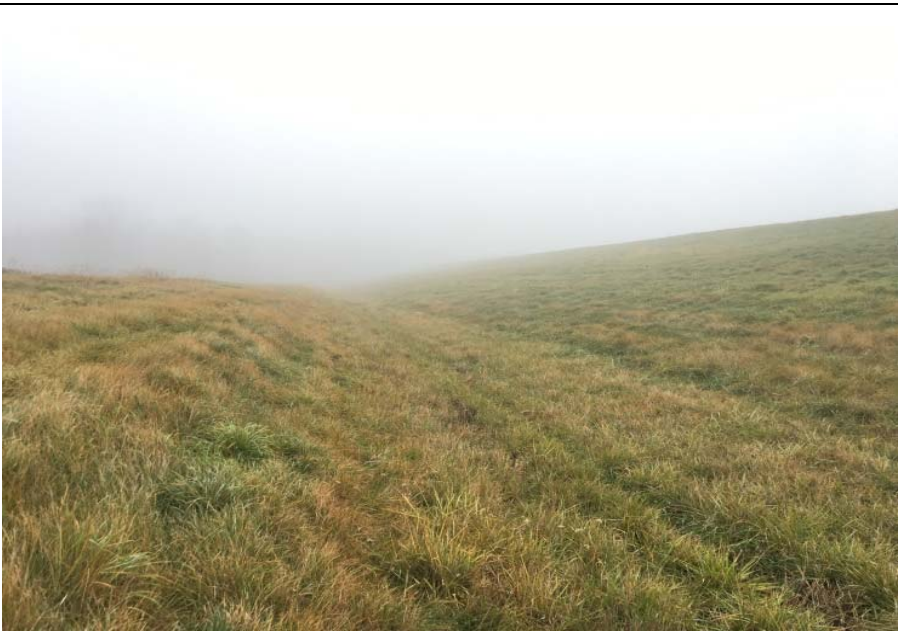
<p>Photograph No. 15</p> <p>Date: November 17, 2016</p> <p>Direction: East</p>

<p>Description: "Non-contact" stormwater perimeter ditch along northern side of Stage 5 disposal area (closed). No evidence of erosion or malfunction.</p>

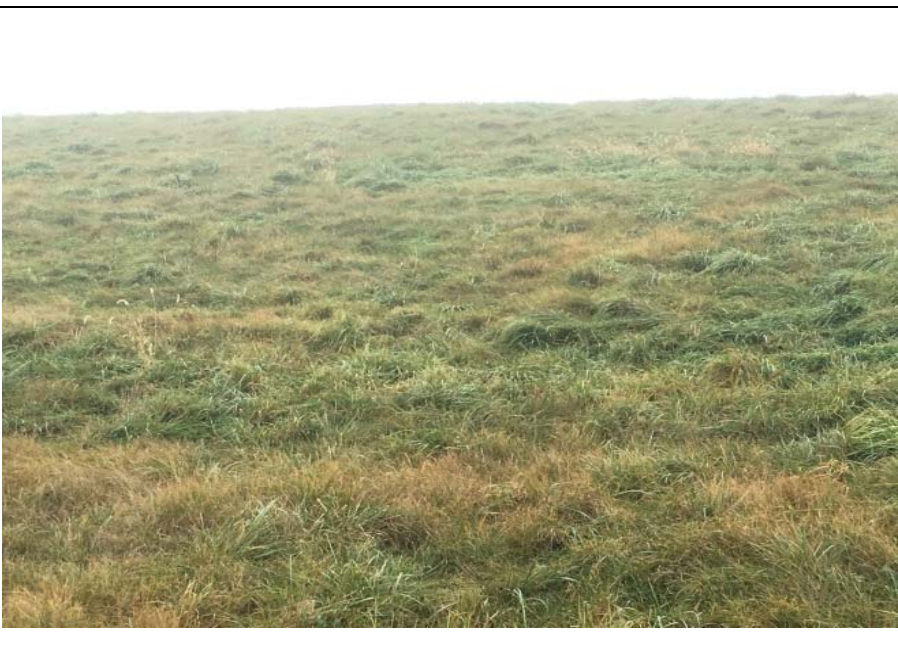
<p>Photograph No. 16</p> <p>Date: November 17, 2016</p> <p>Direction: South</p>

<p>Description: Toe of slope looking up at final cover on closed Stage 5 disposal area. Vegetation is well established and maintained. No evidence of erosion or sloughing.</p>

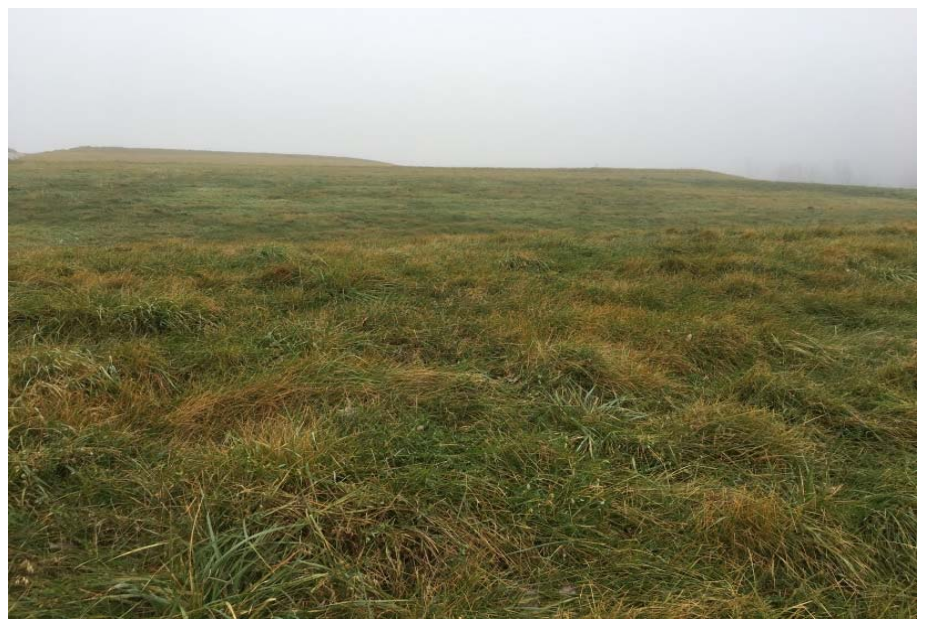
<p>Photograph No. 17</p> <p>Date: November 17, 2016</p> <p>Direction: West</p>

<p>Description: Toe of slope looking up at final cover on closed Stage 5 disposal area. Vegetation is well established and maintained. No evidence of erosion or sloughing.</p>
