Inspection Report

To: Steve Brown (New Castle Generating Station)
From: Richard Southorn, P.E., P.G., CPSWQ
Re: New Castle Plant Ash Landfill–Annual CCR Unit Inspection Report
Inspection Date: October 17, 2017
Report Date: January 16, 2018

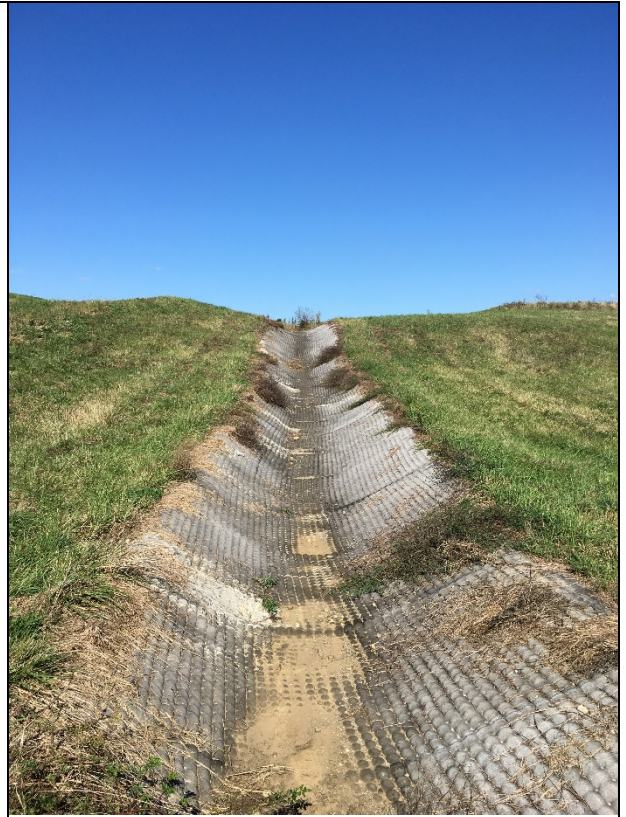
Photograph No. 1

Non-contact stormwater downchute. Clear of obstructions. Revetment is in good condition. Functioning as intended.

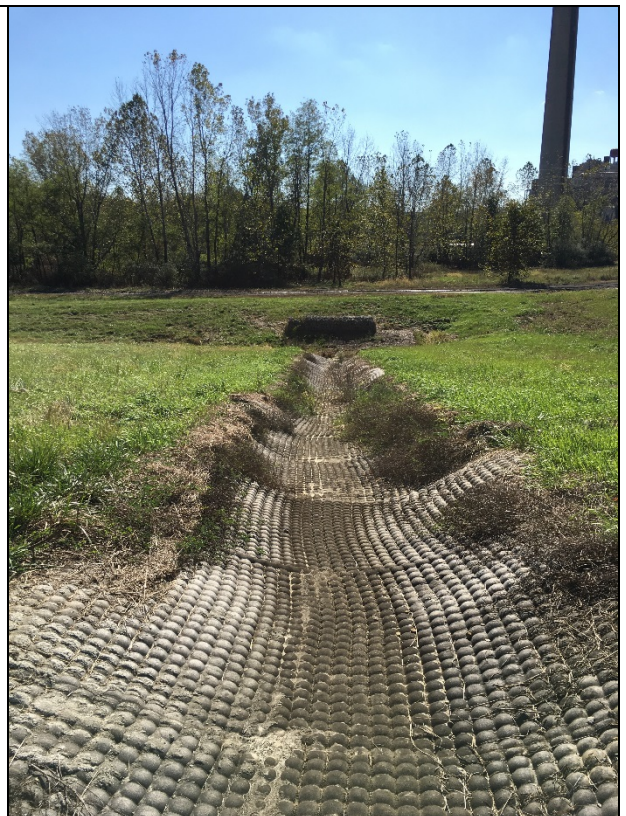
Photograph No. 2

Non-contact stormwater downchute is clear of obstructions. Gabion energy dissipator is installed at the junction with the stormwater perimeter ditch.

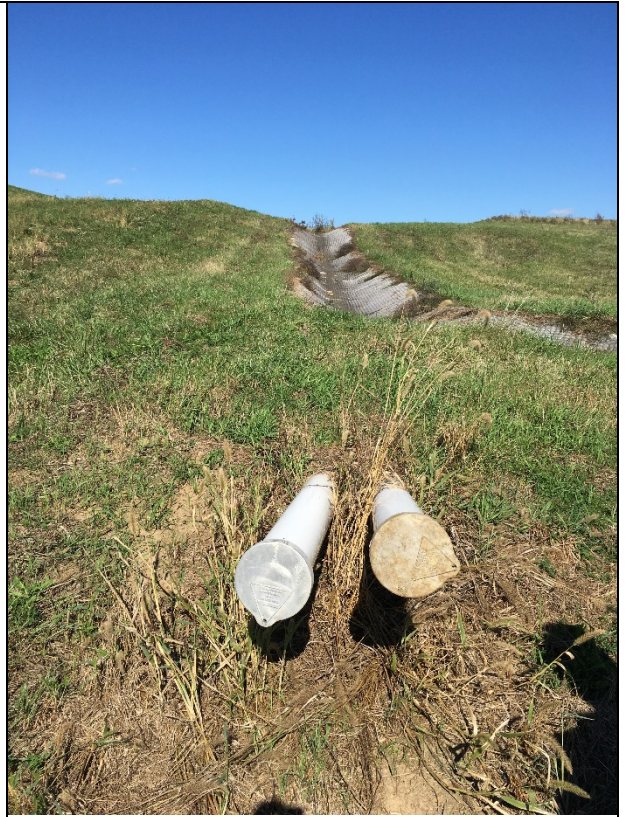
Photograph No. 3

Leachate cleanout pipe with non-contact stormwater downchute in background.

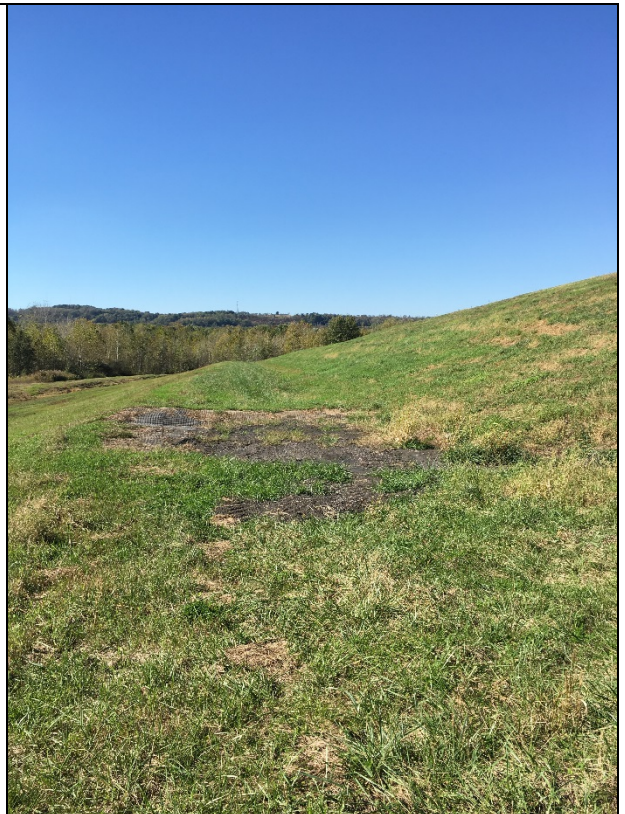
Photograph No. 4

Looking along a terrace berm to the low point where a downchute starts.

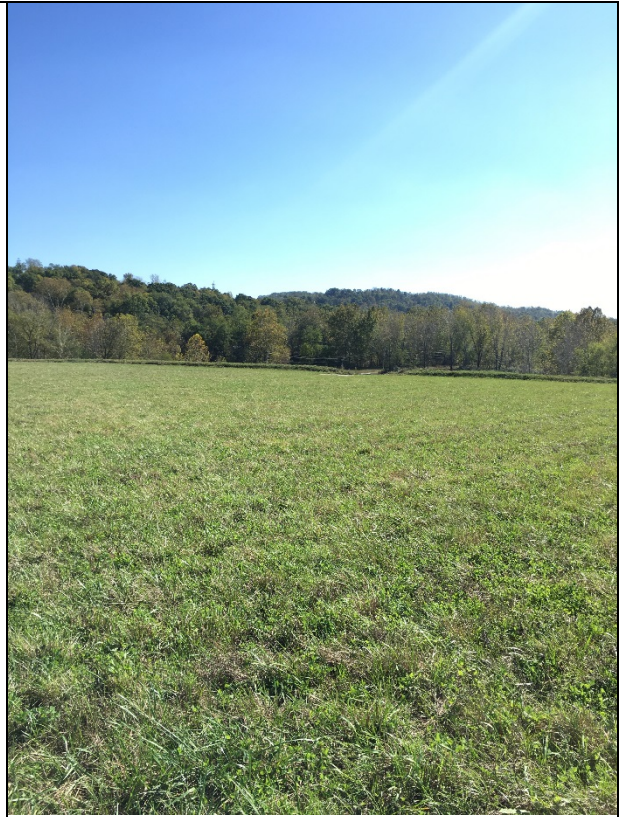
Photograph No. 5

Stage 6 final cover. Vegetation is healthy and well maintained. No evidence of animal burrows, erosion, or stability.

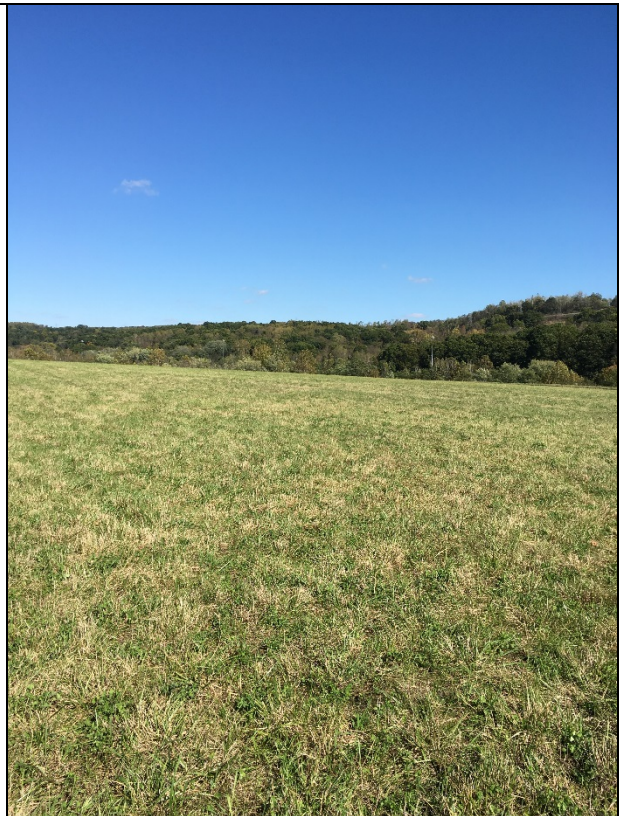
Photograph No. 6

Stage 6 final cover. Vegetation is healthy and well maintained. No evidence of animal burrows, erosion, or stability.

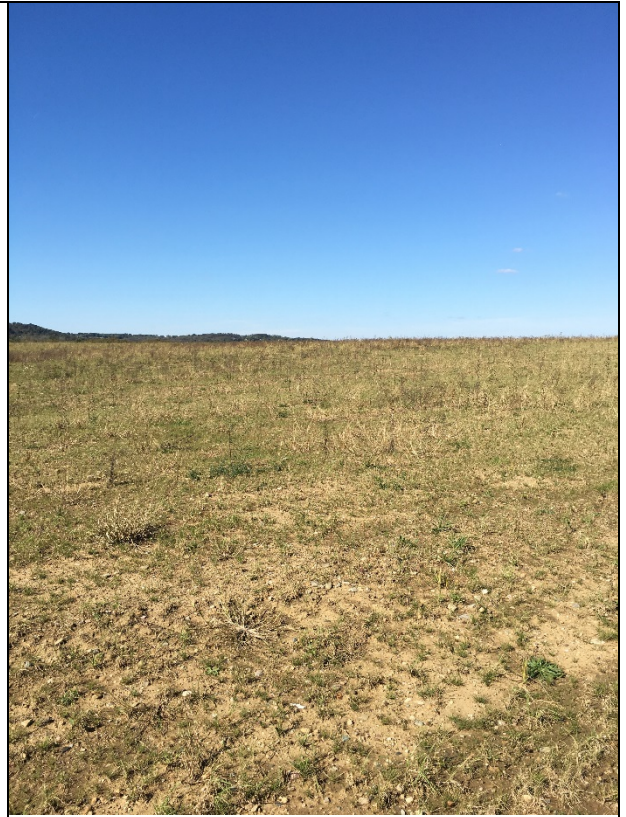
Photograph No. 7

The vegetation on intermediate cover of Stage 4 appears healthy, but has not yet achieved full coverage. It is understood that this is due to the relatively short growing time since seeding. The coverage is not identified as a concern as part of this report.

Stage 4 intermediate cover. Vegetation is partially established. No stability concerns evident.

1. Continue to fill any animal burrows or holes observed during weekly inspections to prevent instability.
2. Monitor the vegetation on the Stage 4 intermediate cover for improved coverage.
3. Ensure adequate access to the closed portions of the landfill to maintain the ability to perform weekly visual site structural inspections.
4. Continue operations and maintenance of stormwater drainage features and leachate collection systems.

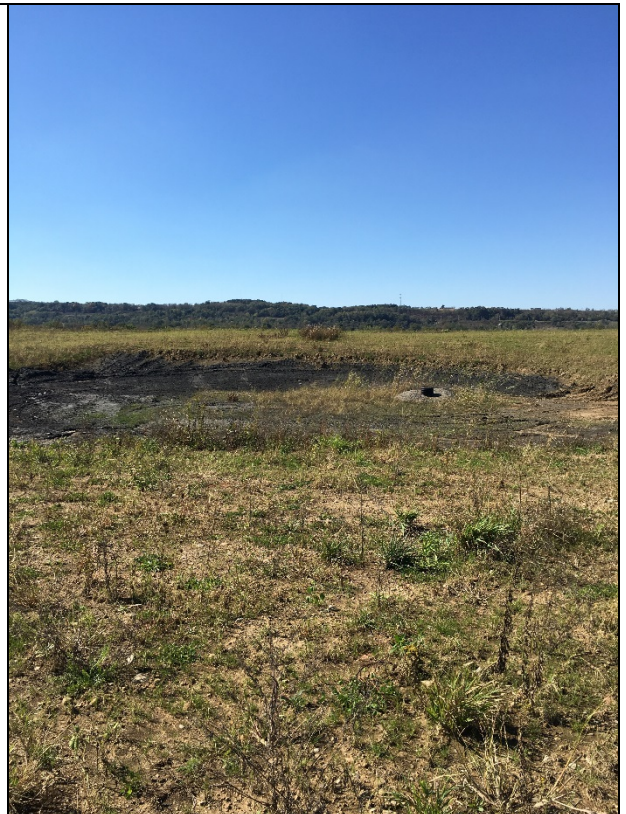
Photograph No. 8

Stage 4 active area surrounded with intermediate cover.

A vertical leachate riser is shown within the active area. No stability concerns evident.

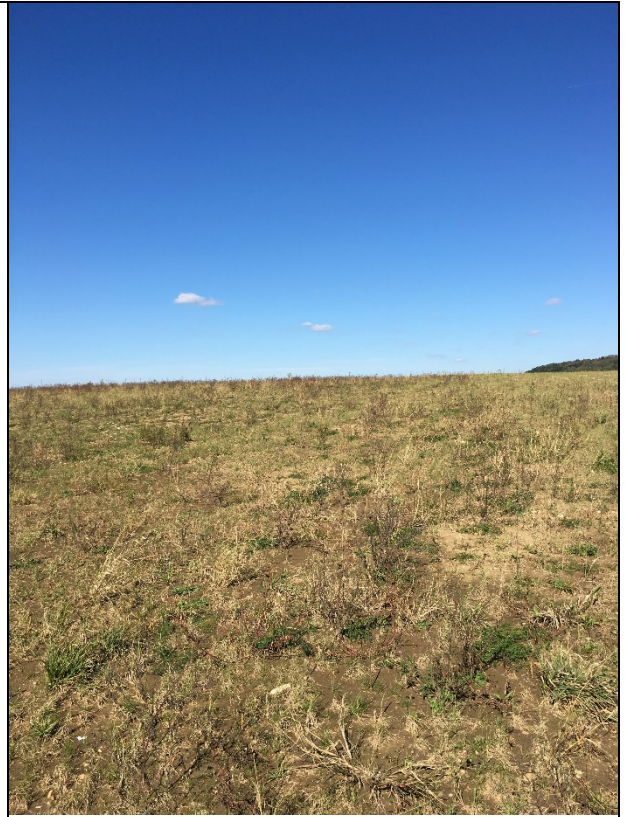
Photograph No. 9

Stage 4 intermediate cover. Vegetation is partially established. No stability concerns evident.

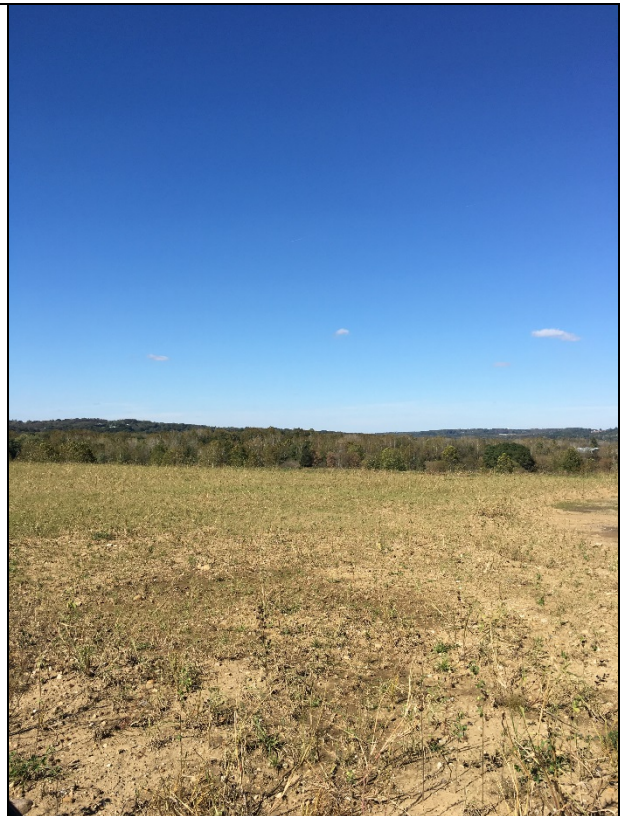
Photograph No. 10

Stage 4 intermediate cover. Vegetation is partially established. No stability concerns evident.

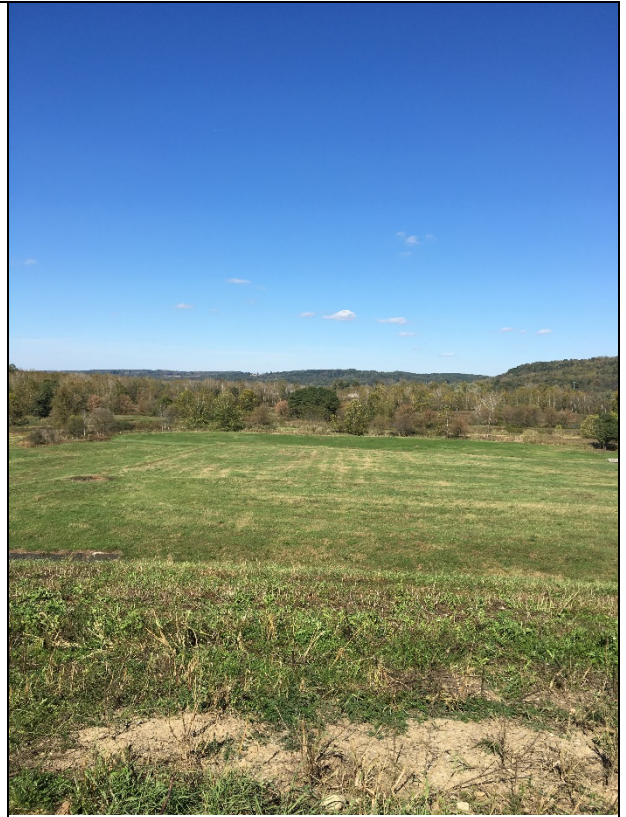
Photograph No. 11

Standing on Stage 4 intermediate cover looking north toward Stage 5 final cover. Stage 5 final cover vegetation is healthy and well established.

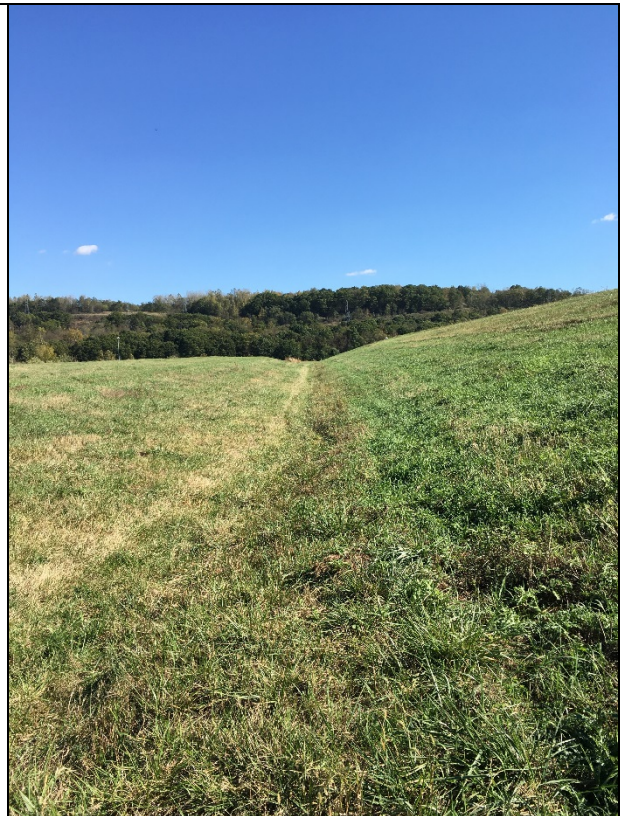
Photograph No. 12

Drainage swale at toe of Stage 4. Drainage swale is free of obstructions and well vegetated.

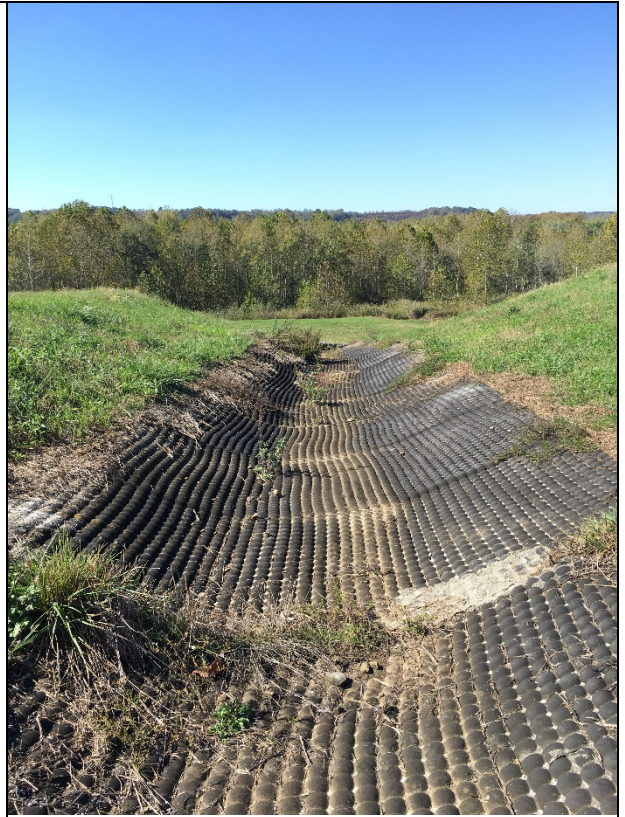
Photograph No. 13

Non-contact stormwater downchute is free of obstructions and in good condition.

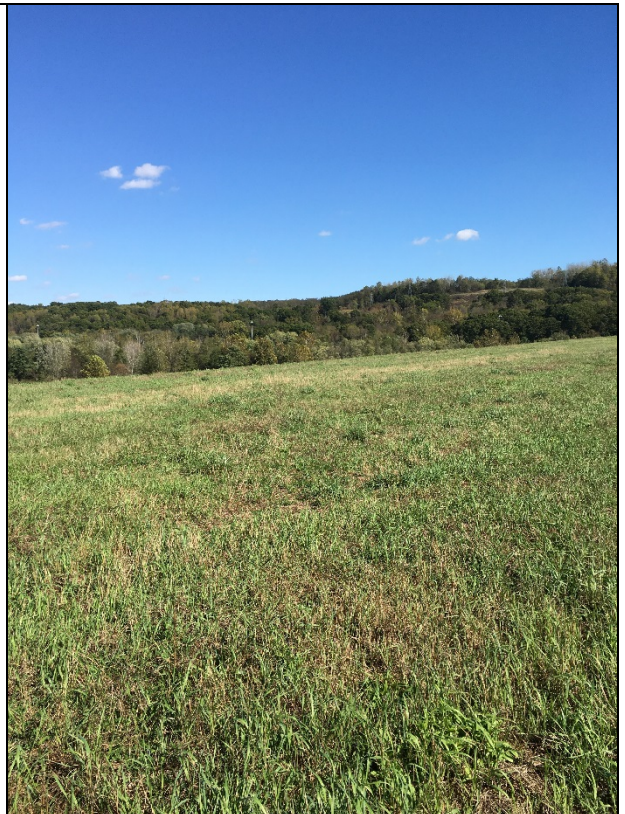
Photograph No. 14

Stage 5 final cover is in good condition.

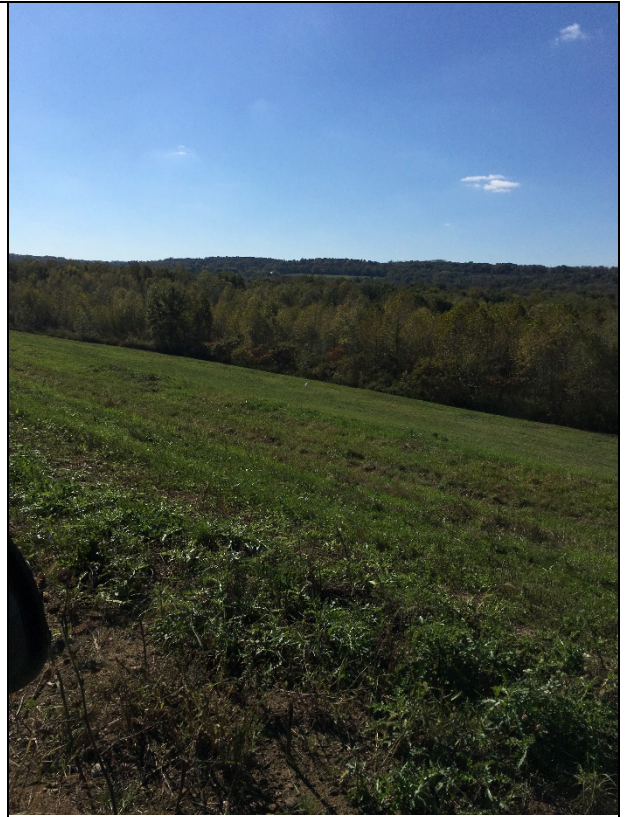
Photograph No. 15

Stage 4 final cover on sideslopes is in good condition with no evidence of erosion, sloughing, seeps, or stability issues. No animal burrows noted.

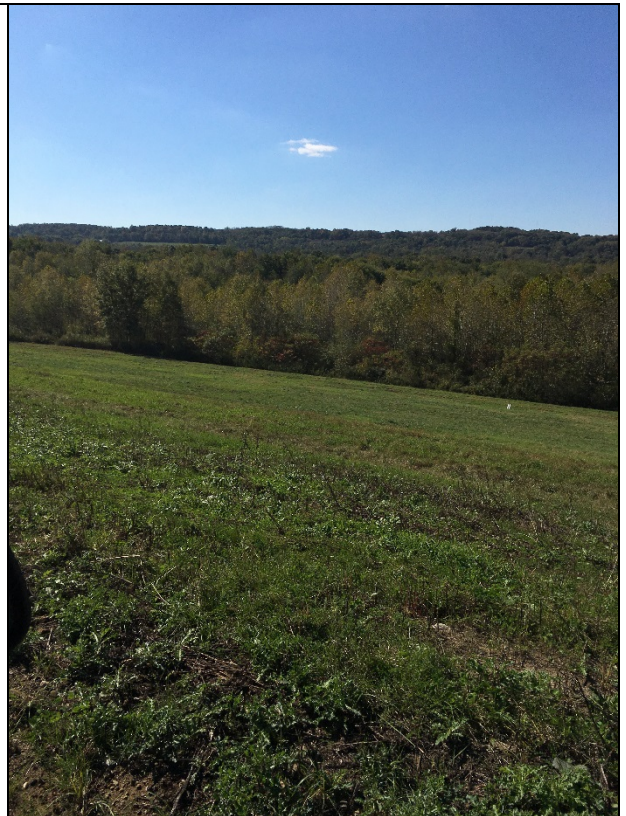
Photograph No. 16

Stage 4 final cover in good condition with no evidence of erosion, sloughing, seeps, or stability issues. No animal burrows noted.

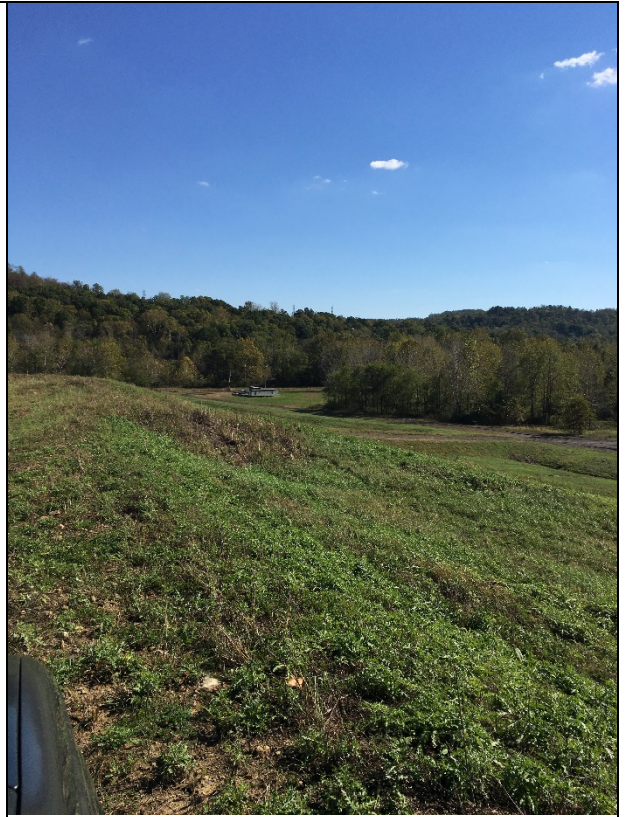
Photograph No. 17

Stage 4 final cover on sideslopes is in good condition with no evidence of erosion, sloughing, seeps, or stability issues. No animal burrows noted.

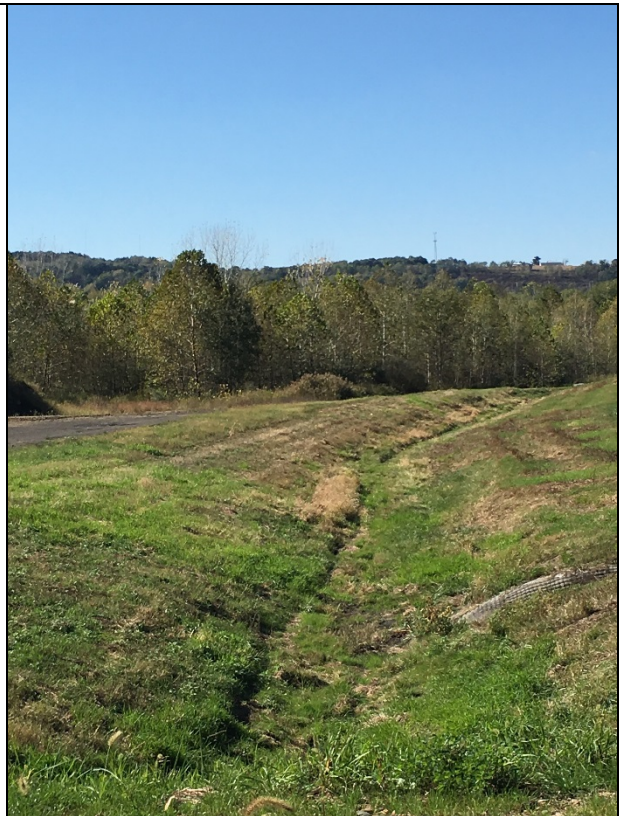
Photograph No. 18

Stormwater ditch at confluence with downchute. Ditch is in good condition, well lined, and does not have any noted obstructions.

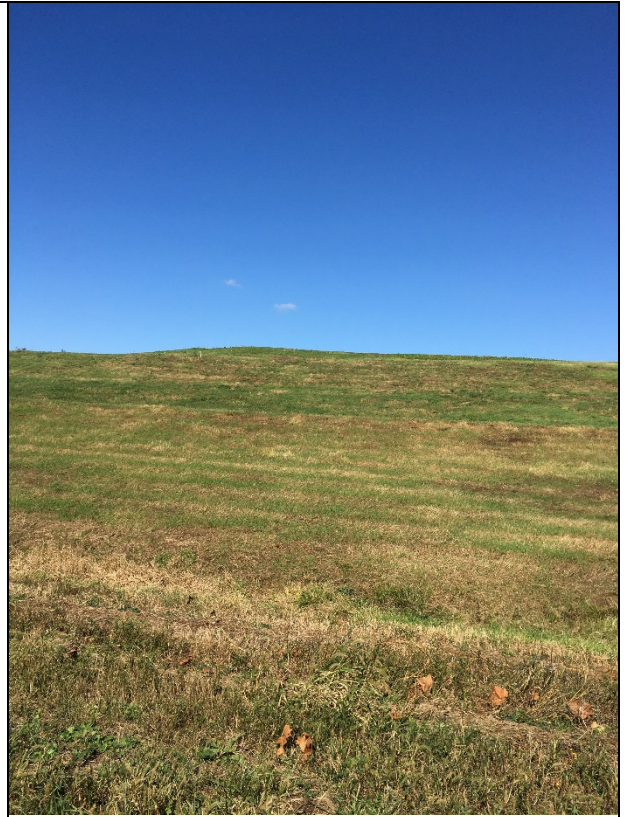
Photograph No. 19

Final cover on Stage 4 sideslopes is in good condition with no evidence of damage from erosion, animals, or sloughing or stability issues.

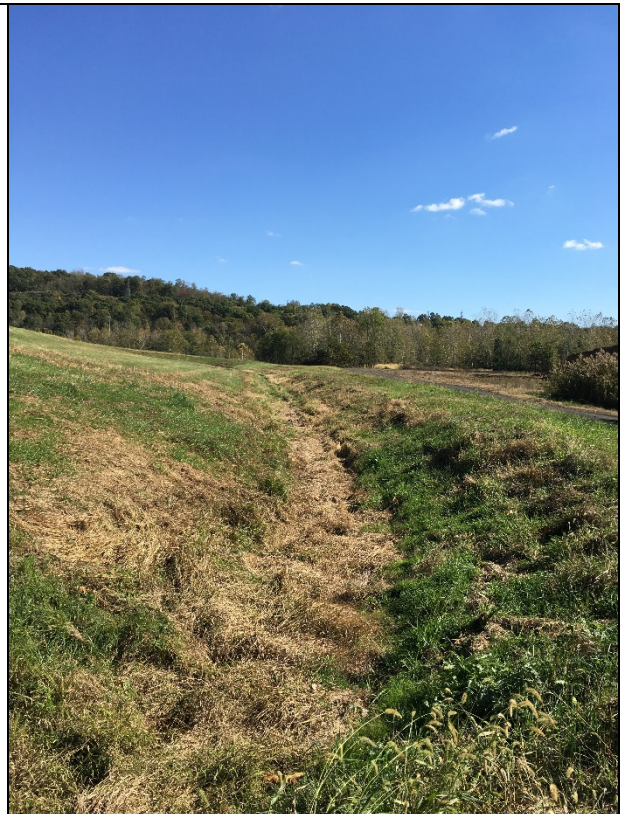
Photograph No. 20

Stormwater ditch at corner of landfill. Ditch is in good condition, well lined with vegetation, and does not have any noted obstructions.

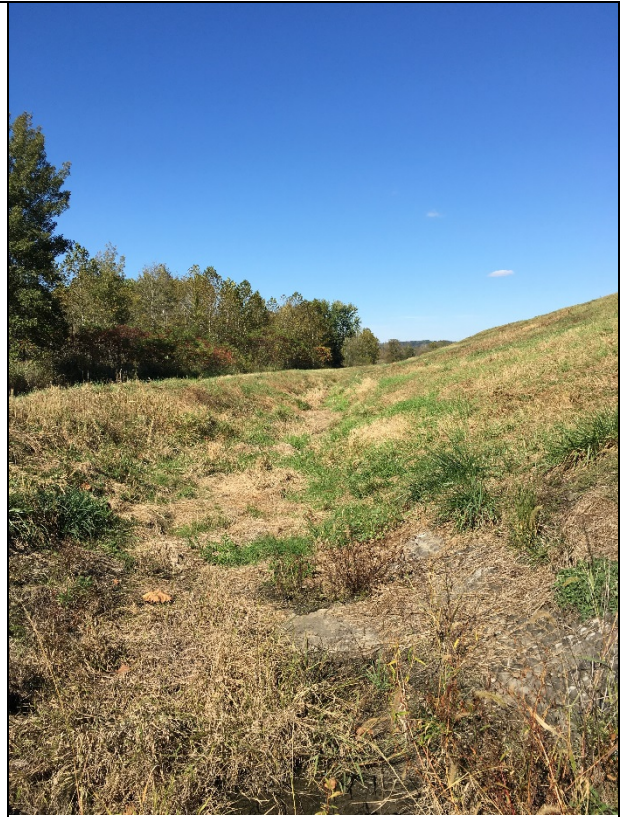
Photograph No. 21

Storm water ditch at corner of landfill. Ditch is in good condition, well lined with vegetation, and does not have any noted obstructions.

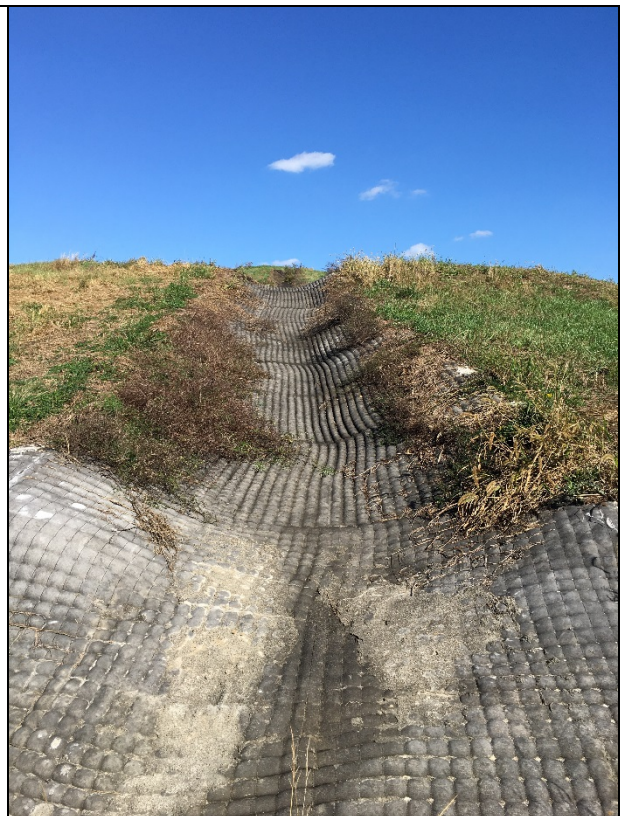
Photograph No. 22

Non-contact stormwater downchute. Clear of obstructions. Revetment is in good condition. Functioning as intended.

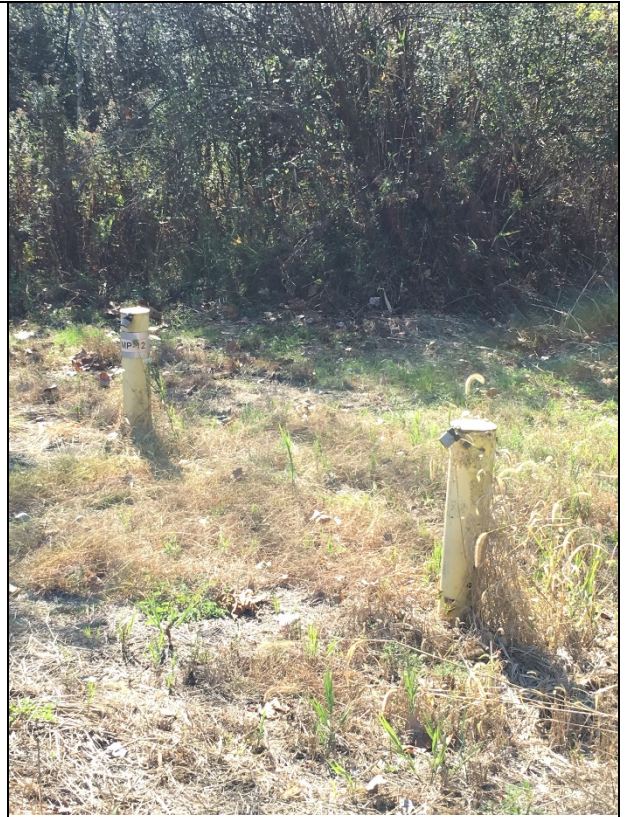
Photograph No. 23

Groundwater monitoring wells. Concrete pads are intact. Wells are locked.

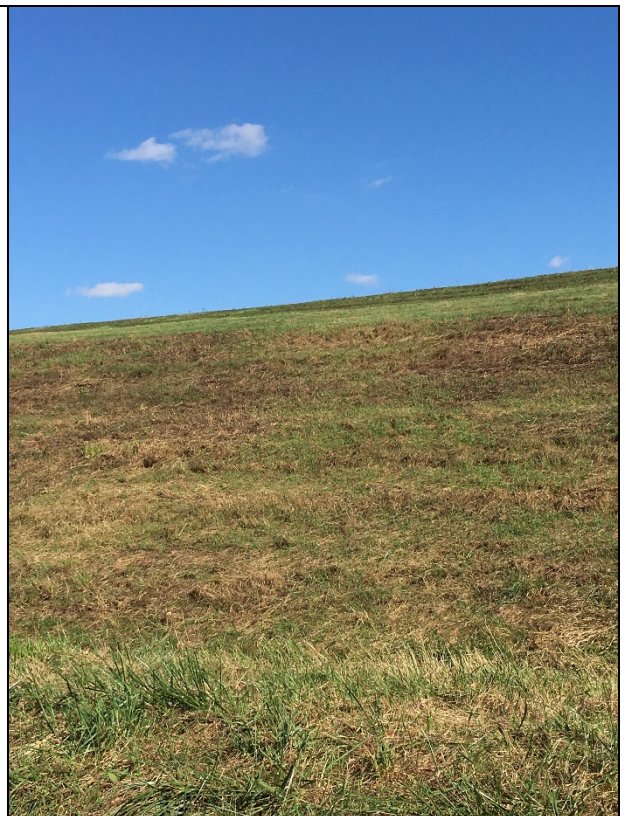
Photograph No. 24

Final Cover on Stage 4 sideslopes is in good condition with no evidence of damage from erosion, animals, or sloughing or stability issues.

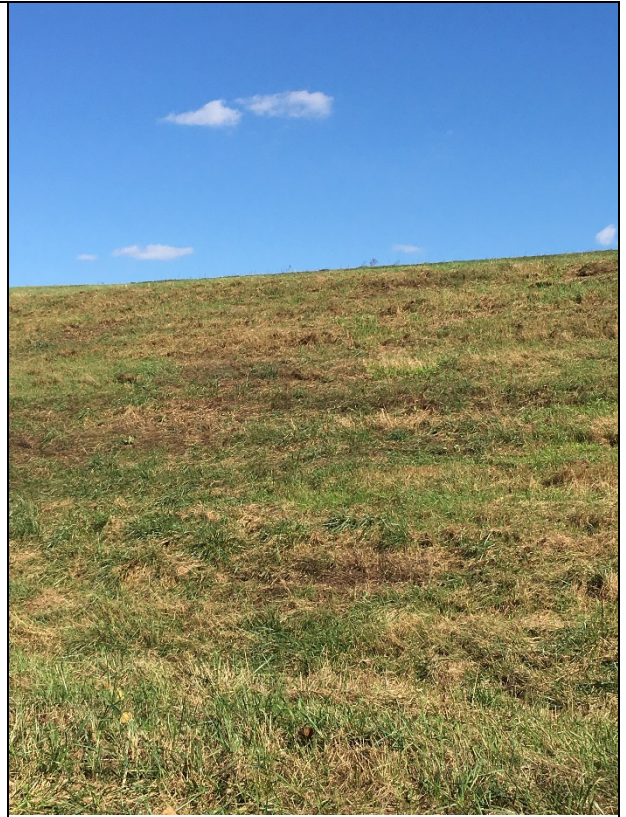
Photograph No. 25

Final Cover on Stage 4 sideslopes is in good condition with no evidence of damage from erosion, animals, or sloughing or stability issues.

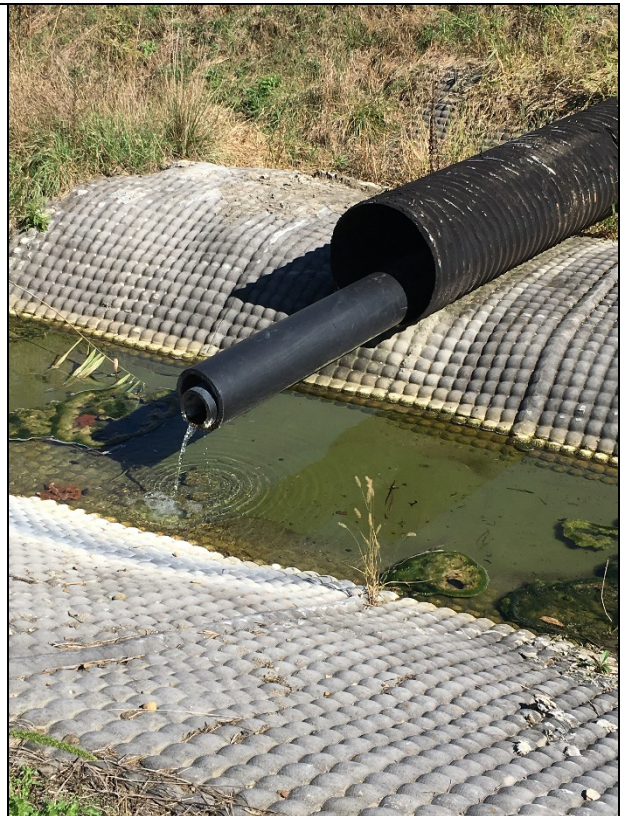
Photograph No. 26

Leachate pipe discharging into contact stormwater ditch which ultimately flows to Leachate Pond. Pipe is free draining. No staining evidence of overtopping of ditch. Ditch is clear of obstructions.

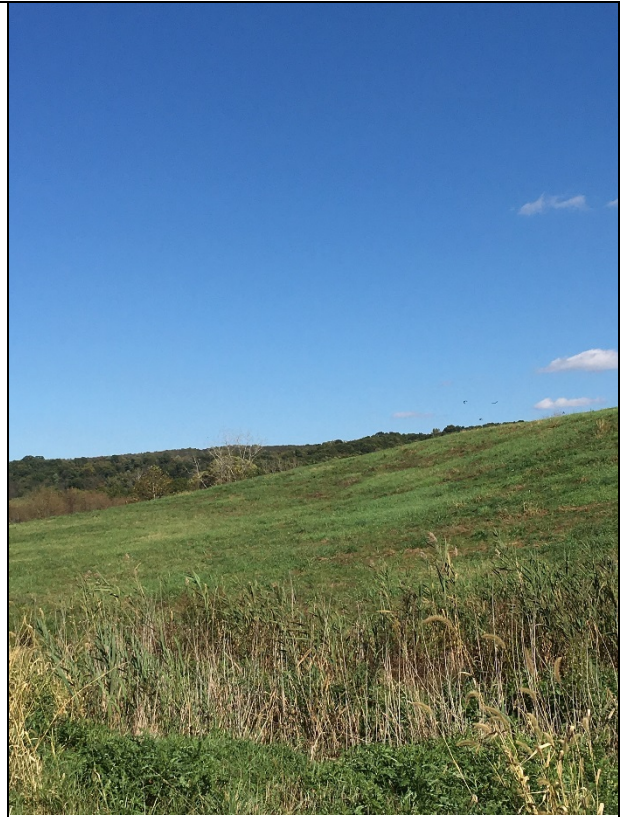
Photograph No. 27

Final Cover on Stage 5 sideslopes is in good condition with no evidence of damage from erosion, animals, or sloughing or stability issues.

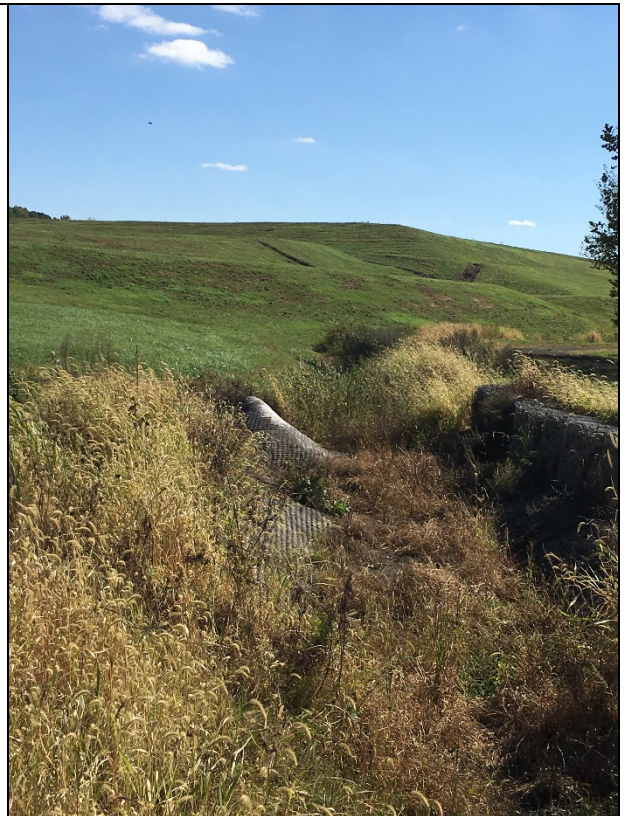
Photograph No. 28

Stormwater ditch.

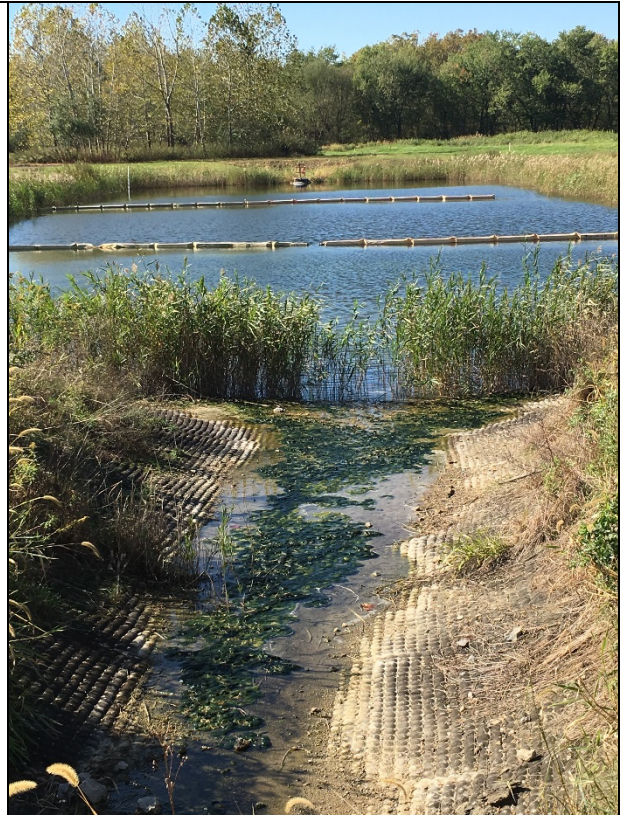
Photograph No. 29

Inlet to Leachate Pond.

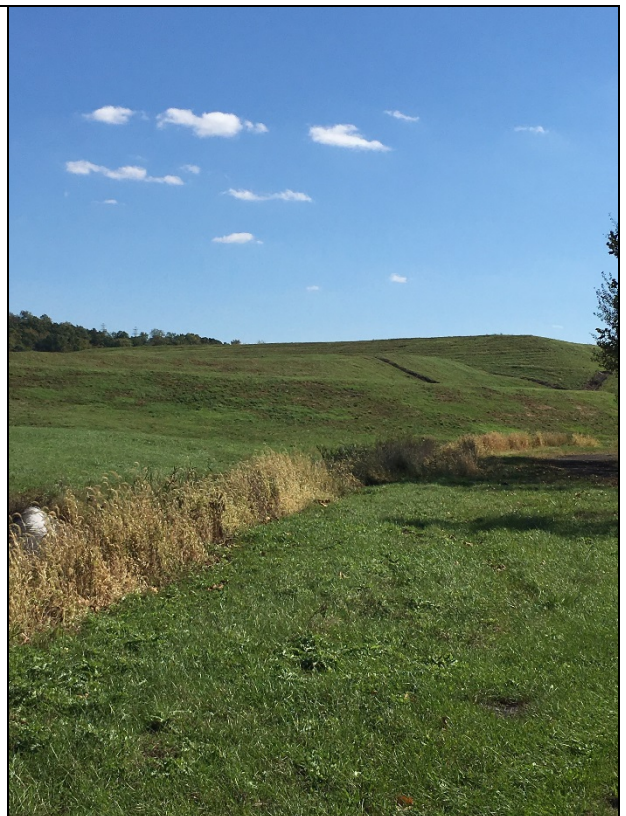
Photograph No. 30

Landfill Overview. Landfill is well maintained with no visible issues requiring modification.

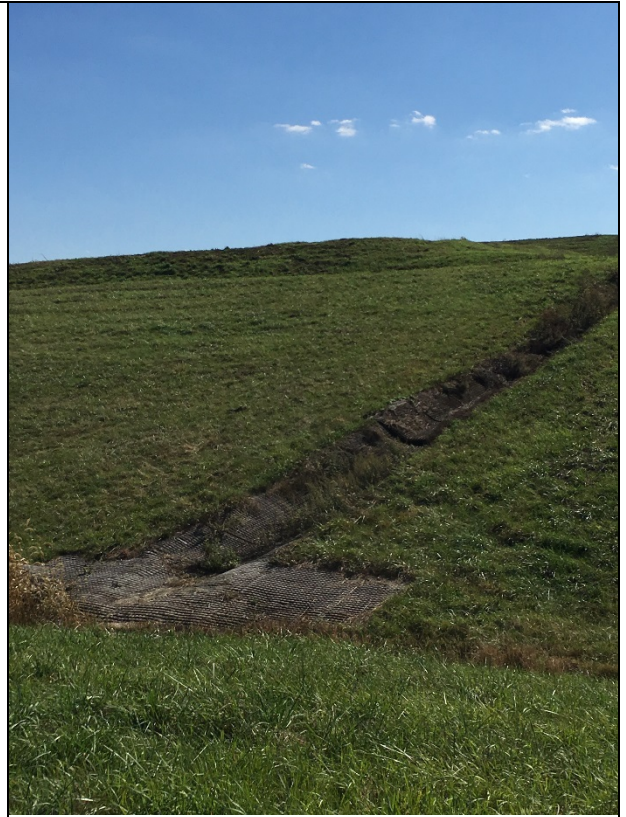
Photograph No. 31

Non-contact stormwater downchute. Clear of obstructions. Revetment is in good condition. Functioning as intended.

Stage 5 final cover is in good condition with no signs of stability. No animal burrows noted. Vegetation is healthy.

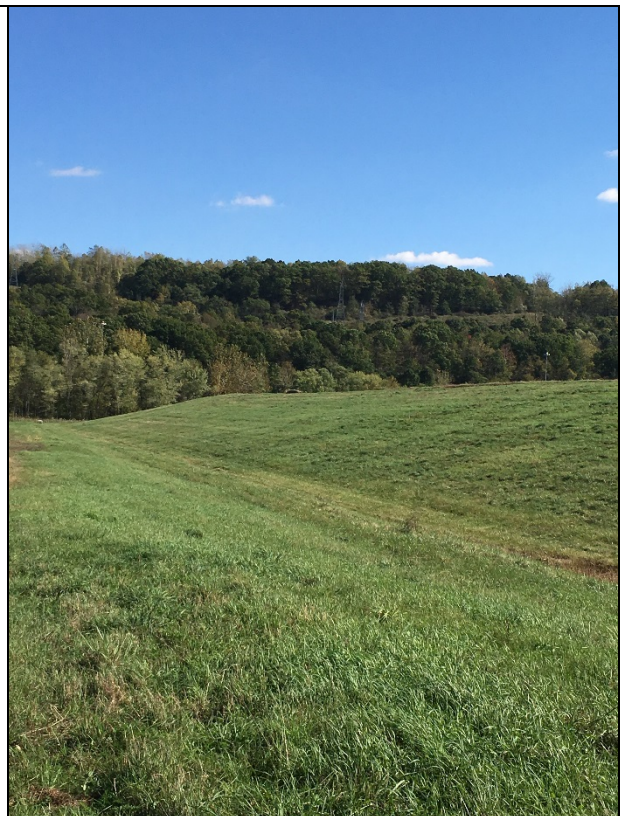
Photograph No. 32

Stormwater swale is in good condition. Well maintained with healthy vegetation. No debris or obstructions.

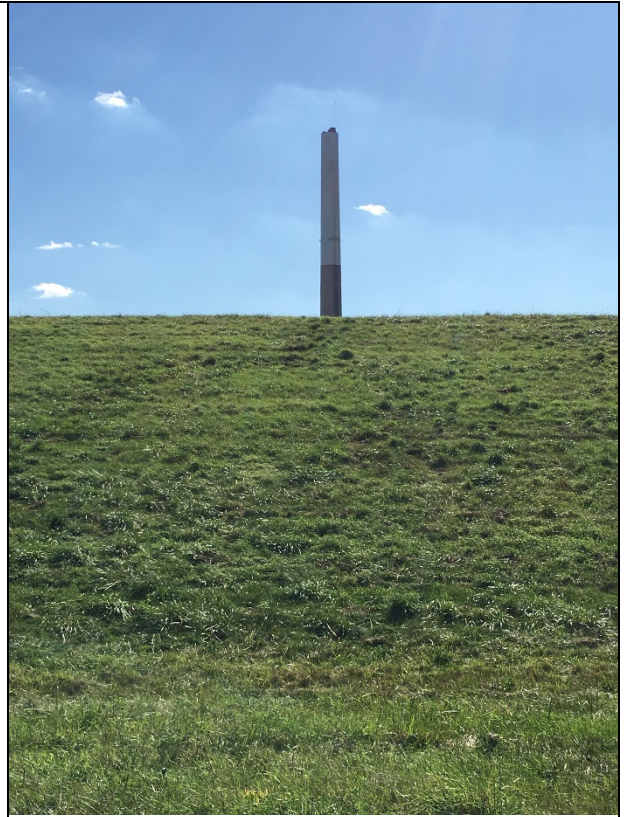
Photograph No. 33

Stage 5 final cover is in good condition with no signs of stability. No animal burrows noted. Vegetation is healthy.

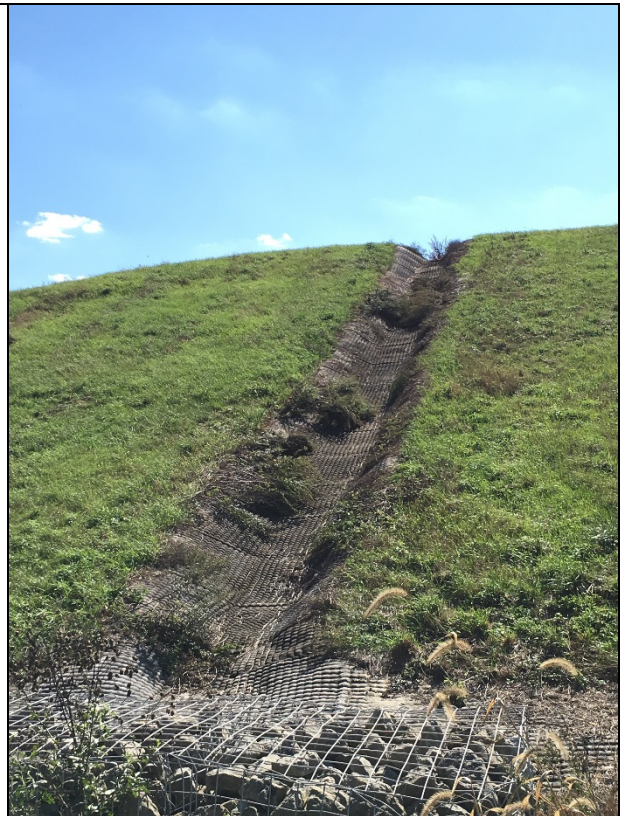
Photograph No. 34

Non-contact stormwater downchute. Clear of obstructions. Revetment is in good condition. Functioning as intended.

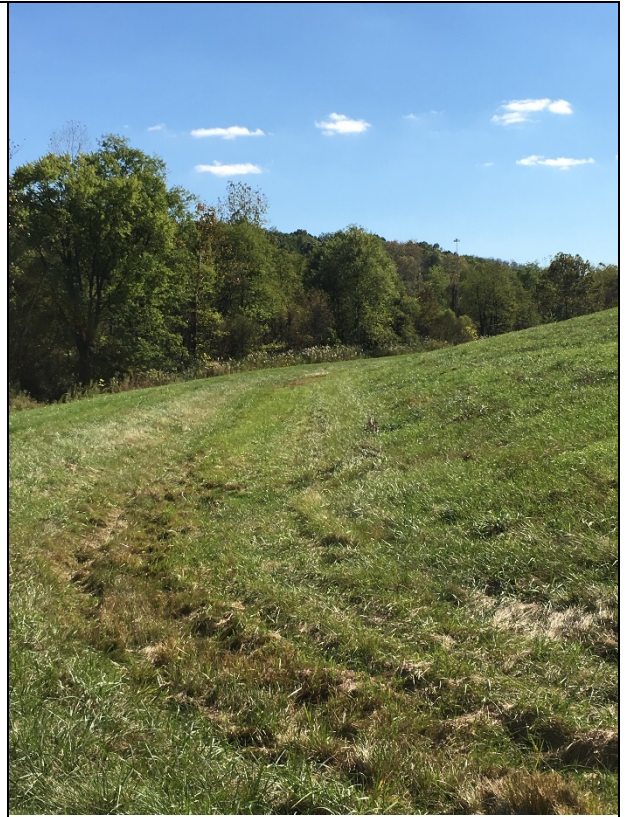
Photograph No. 35

Stormwater swale is in good condition. Well maintained with healthy vegetation. No debris or obstructions.

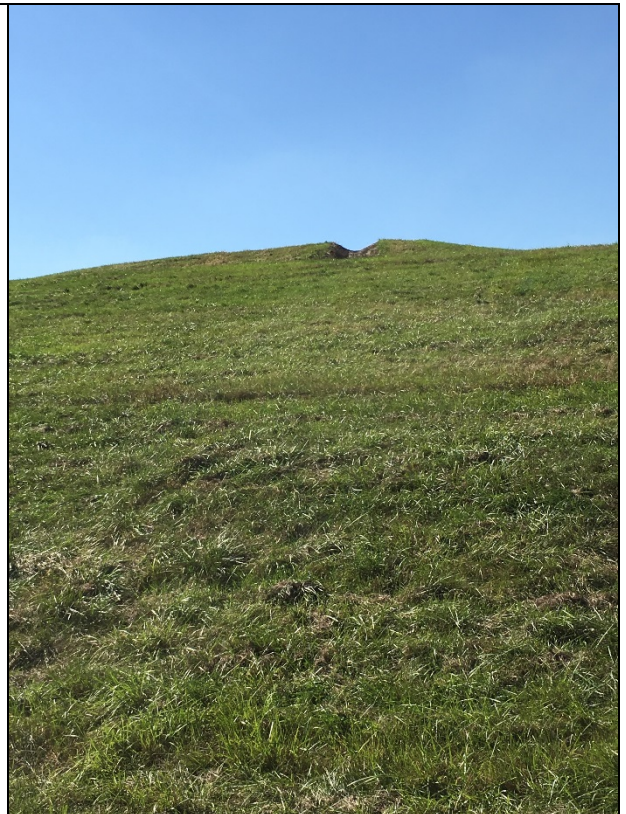
Photograph No. 36

Stage 5 final cover is in good condition with no signs of stability. No animal burrows noted. Vegetation is healthy.

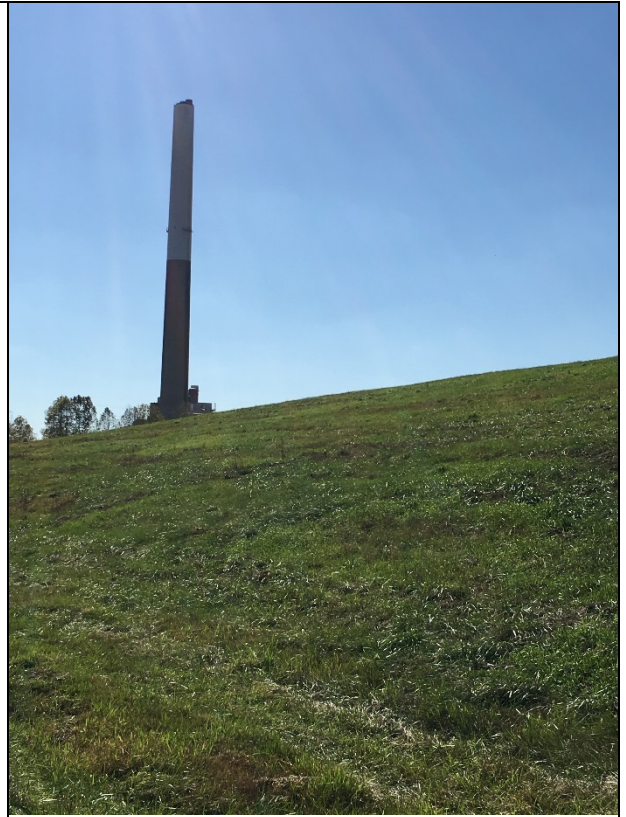
Photograph No. 37

Stage 6 final cover is in good condition with no signs of stability. No animal burrows noted. Vegetation is healthy.

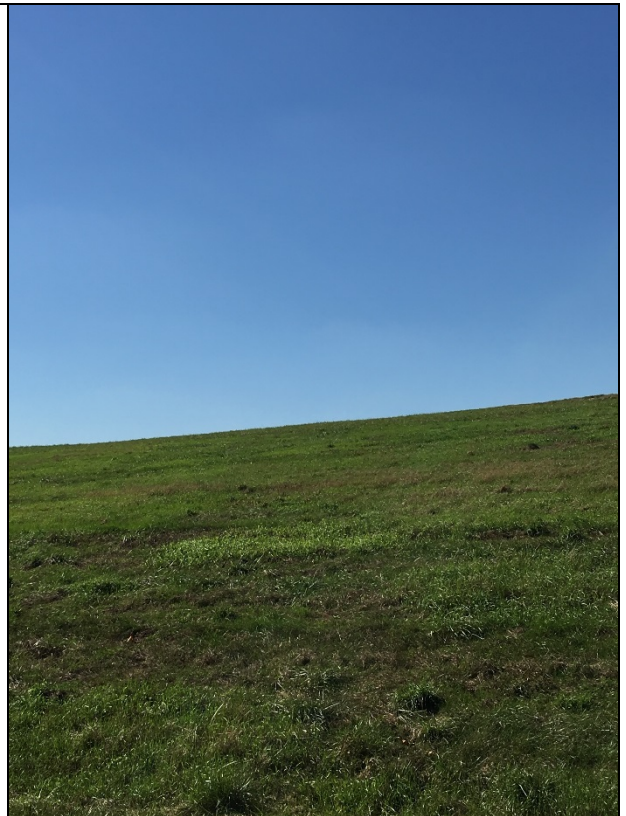
Photograph No. 38

Stage 6 final cover is in good condition with no signs of stability. No animal burrows noted. Vegetation is healthy.

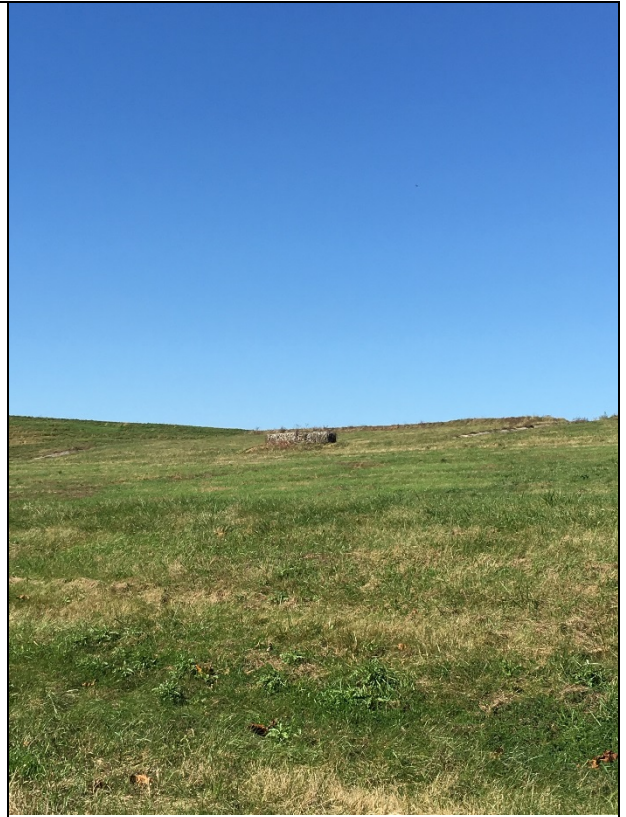
Photograph No. 39

Stage 6 final cover is in good condition with no signs of stability. No animal burrows noted. Vegetation is healthy.
