Inspection Report

To: Steve Brown (New Castle Generating Station)
From: Richard Southorn, P.E., P.G.
Re: New Castle Plant Ash Landfill—Annual CCR Unit Inspection Report
Inspection Date: October 23, 2018
Report Date: January 16, 2019

Project: New Castle 2018 Annual Inspection

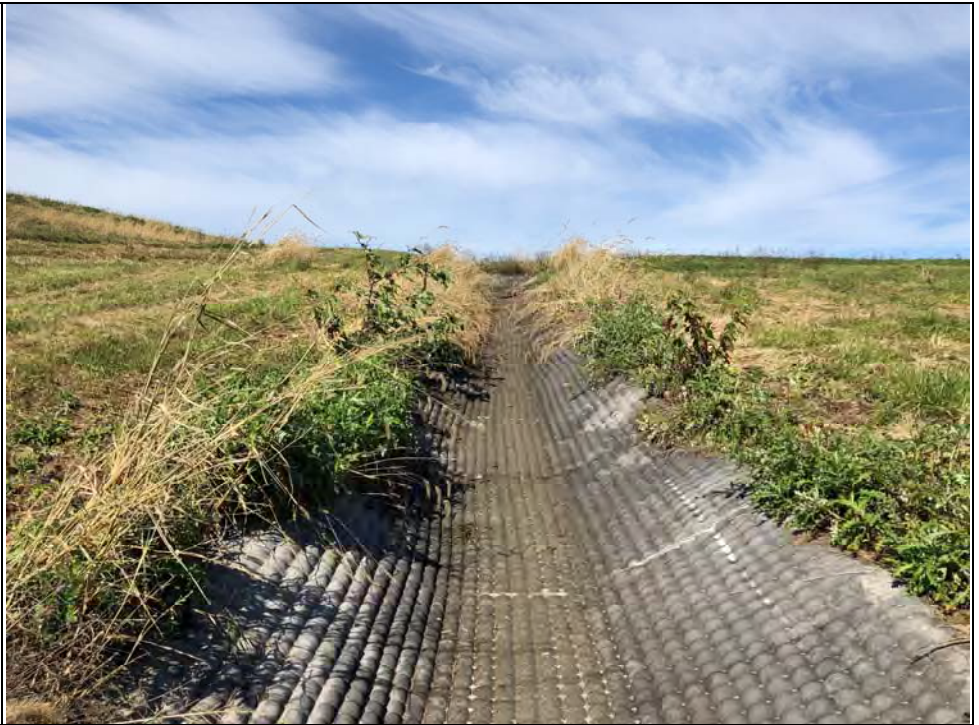
Image: 2491
Date: 10/23/2018
Time: 1:08 PM
Direction: North

Non-contact stormwater downchute. Clear of obstructions. Revetment is in good condition. Functioning as intended.

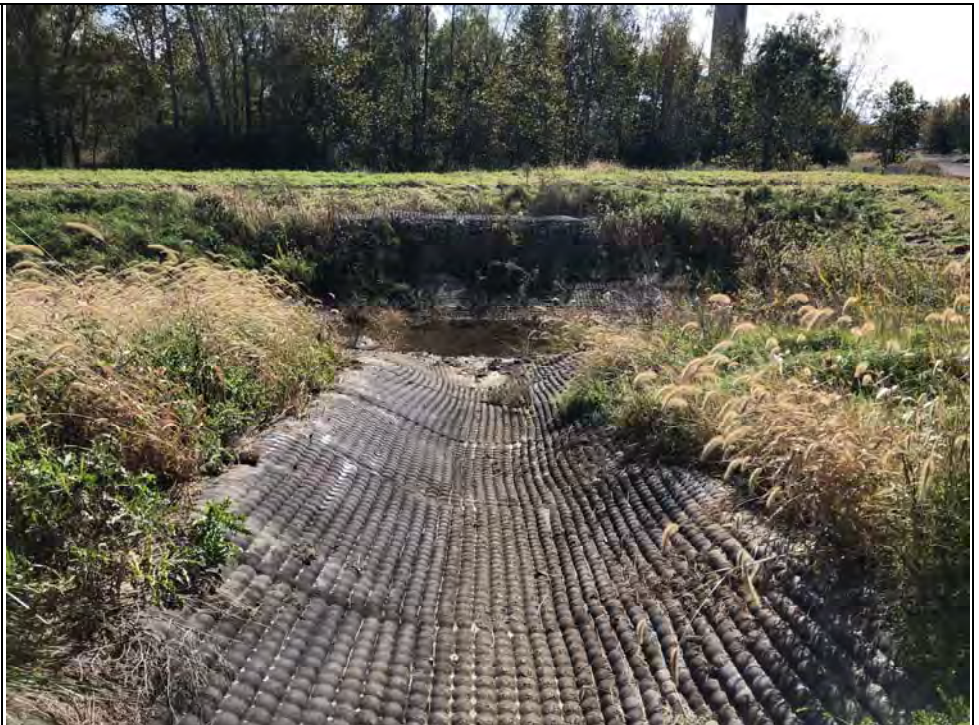
Image: 2493
Date: 10/23/2018
Time: 1:08 PM
Direction: South

Non-contact stormwater downchute is clear of obstructions. Gabion energy dissipator is installed at the junction with the stormwater (non-contact water) perimeter ditch.

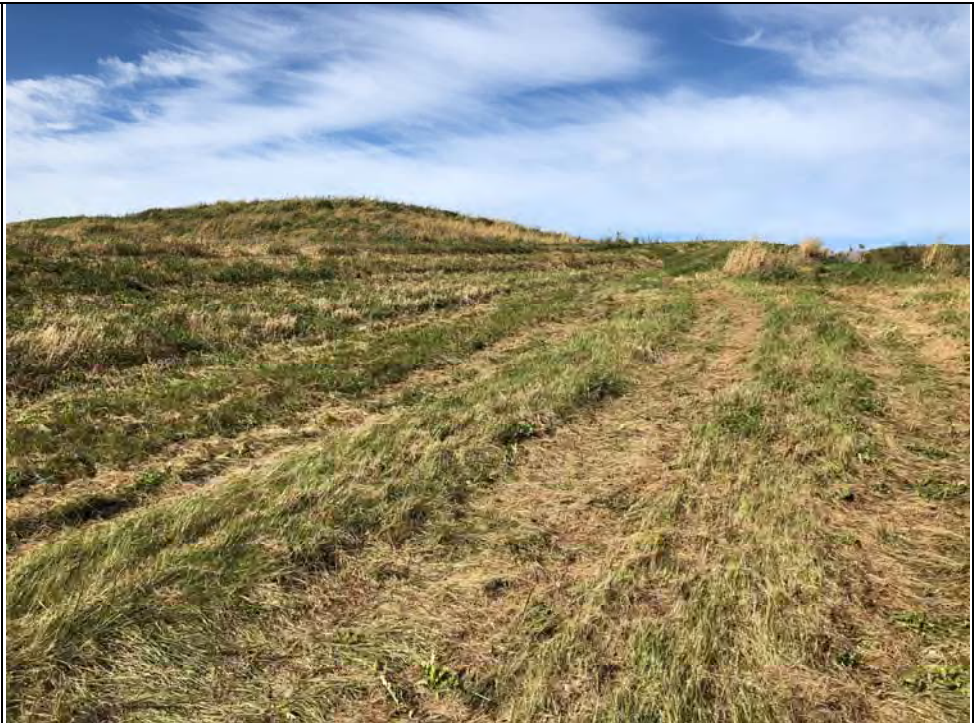
Image: 2495
Date: 10/23/2018
Time: 1:08 PM
Direction: North

Final cover sideslopes, recently mowed. Good condition, no evidence of animal burrows, erosion, or sloughing.

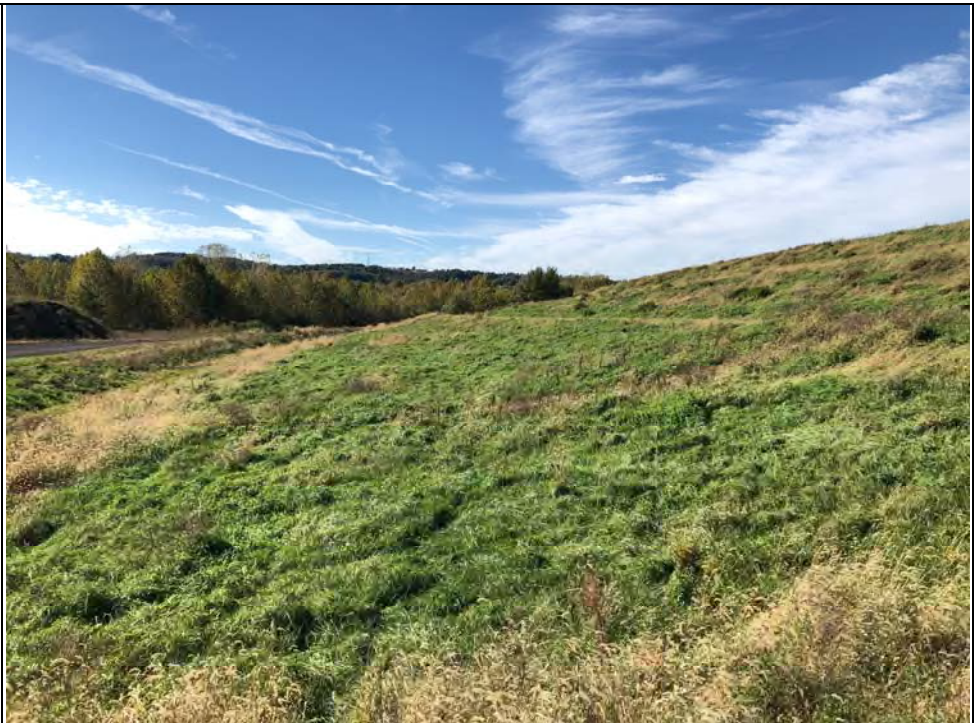
Image: 2497
Date: 10/23/2018
Time: 1:09 PM
Direction: West

Final cover sideslopes. Good condition, no evidence of animal burrows, erosion, or sloughing.

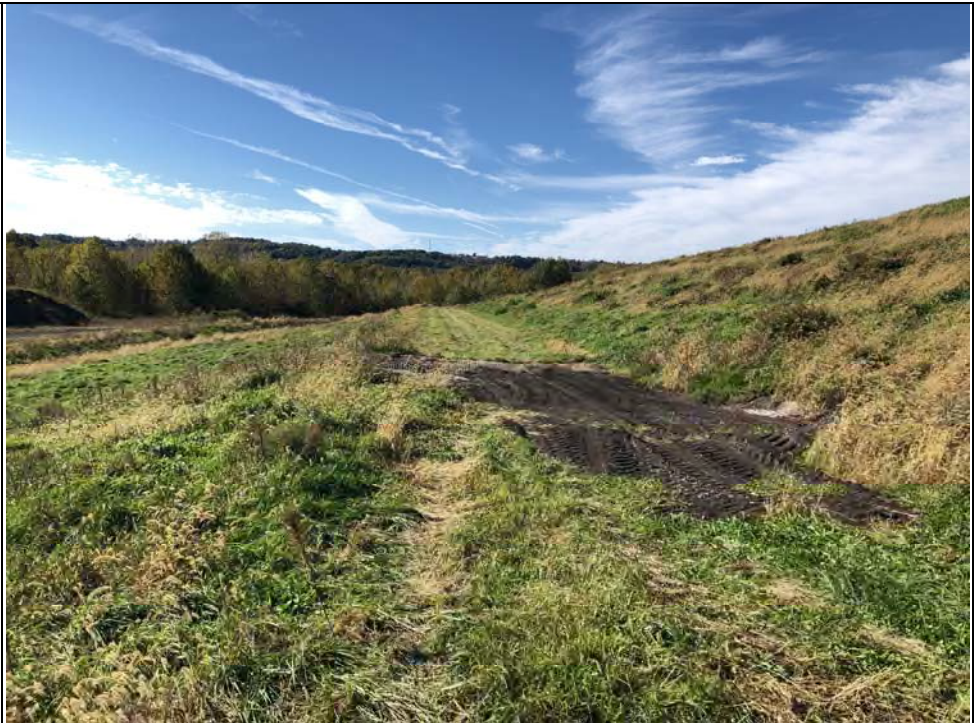
Image: 2499
Date: 10/23/2018
Time: 1:09 PM
Direction: West

Looking along a terrace berm where an area that experienced erosion was recently repaired.

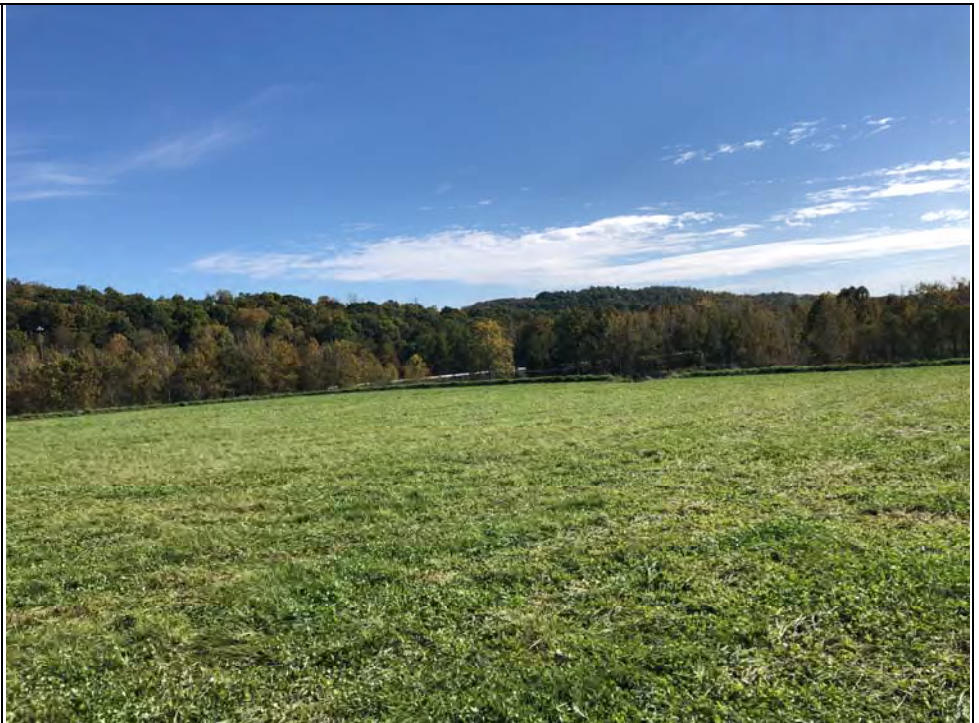
Image: 2501
Date: 10/23/2018
Time: 1:10 PM
Direction: East

Stage 6 final cover. Vegetation is healthy and well maintained. No evidence of animal burrows, erosion, or stability.

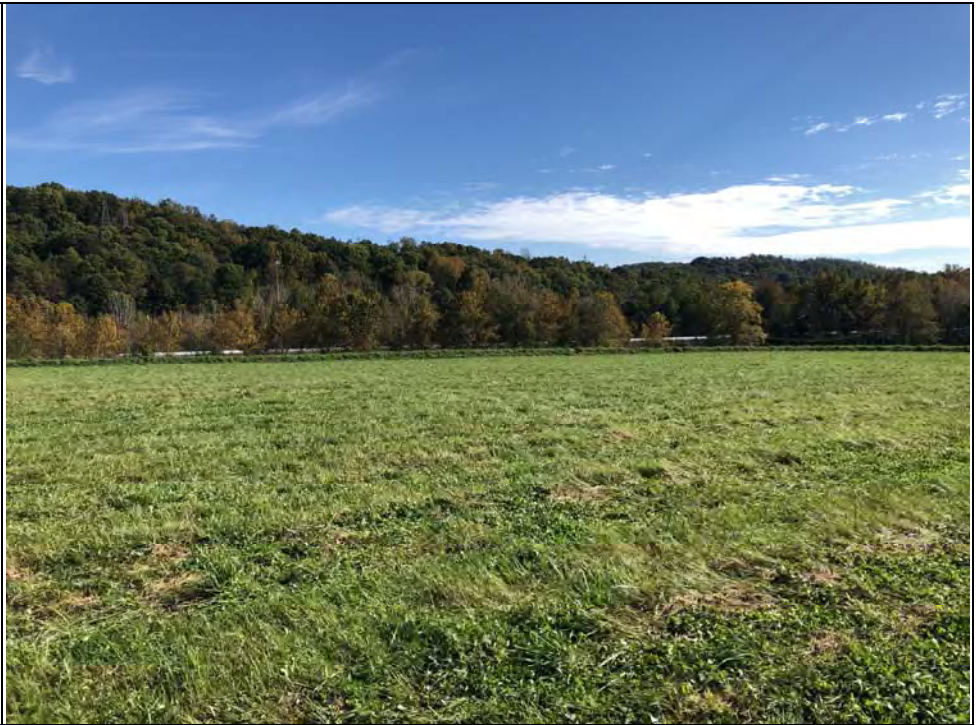
Image: 2503
Date: 10/23/2018
Time: 1:11 PM
Direction: East

Stage 6 final cover. Vegetation is healthy and well maintained. No evidence of animal burrows, erosion, or stability.

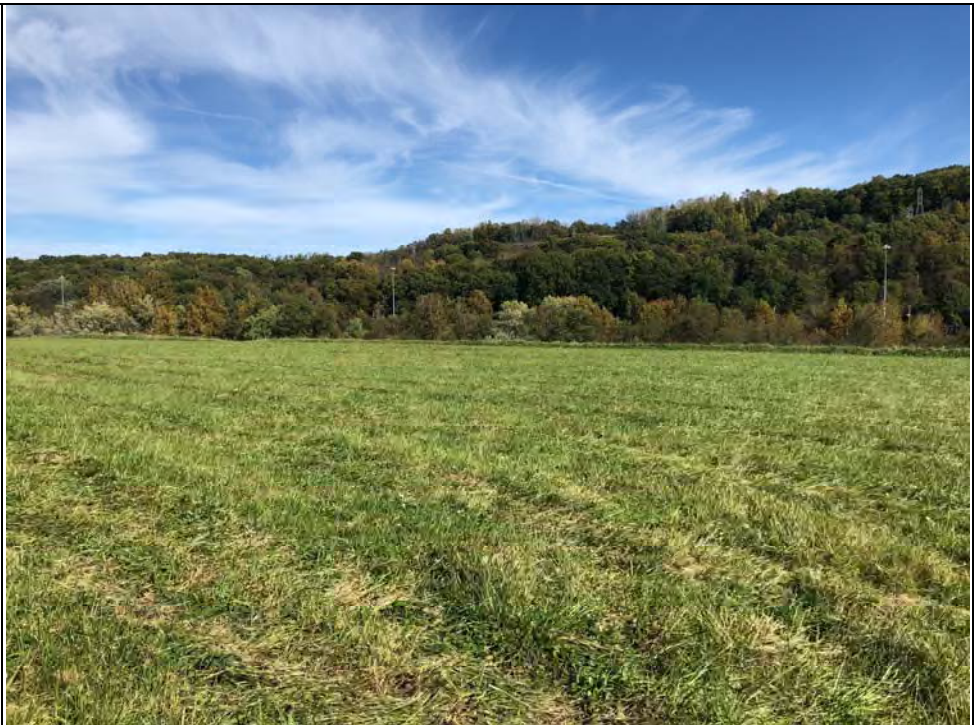
Image: 2505
Date: 10/23/2018
Time: 1:11 PM
Direction: Northeast

Stage 6 final cover. Vegetation is healthy and well maintained. No evidence of animal burrows, erosion, or stability.

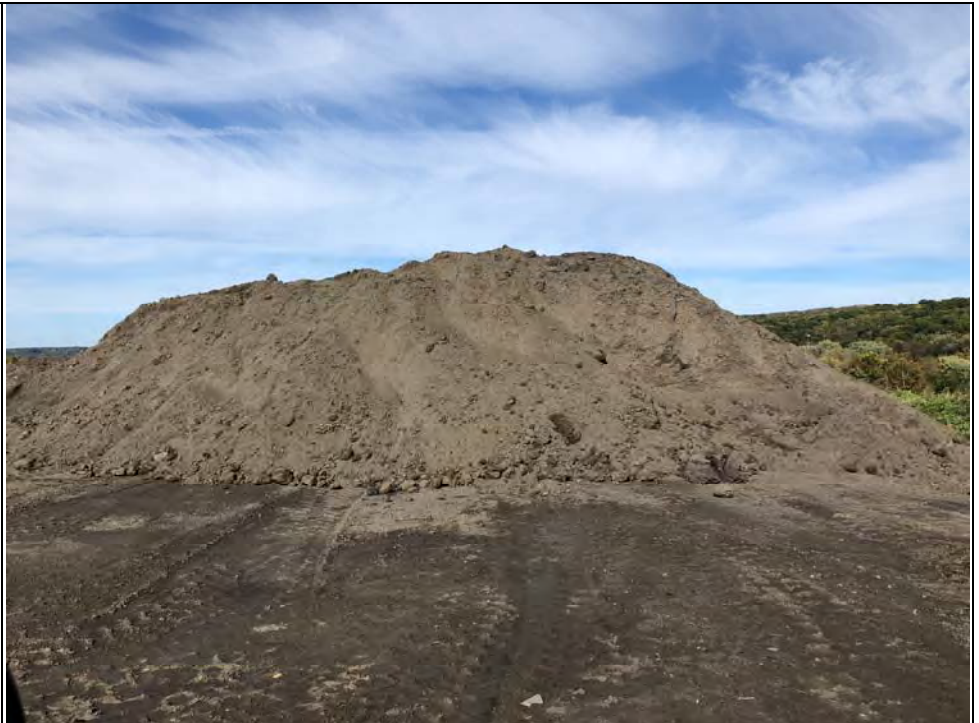
Image: 2507
Date: 10/23/2018
Time: 1:13 PM
Direction: North

CCR Material recently dredged from the North Ash Pond.

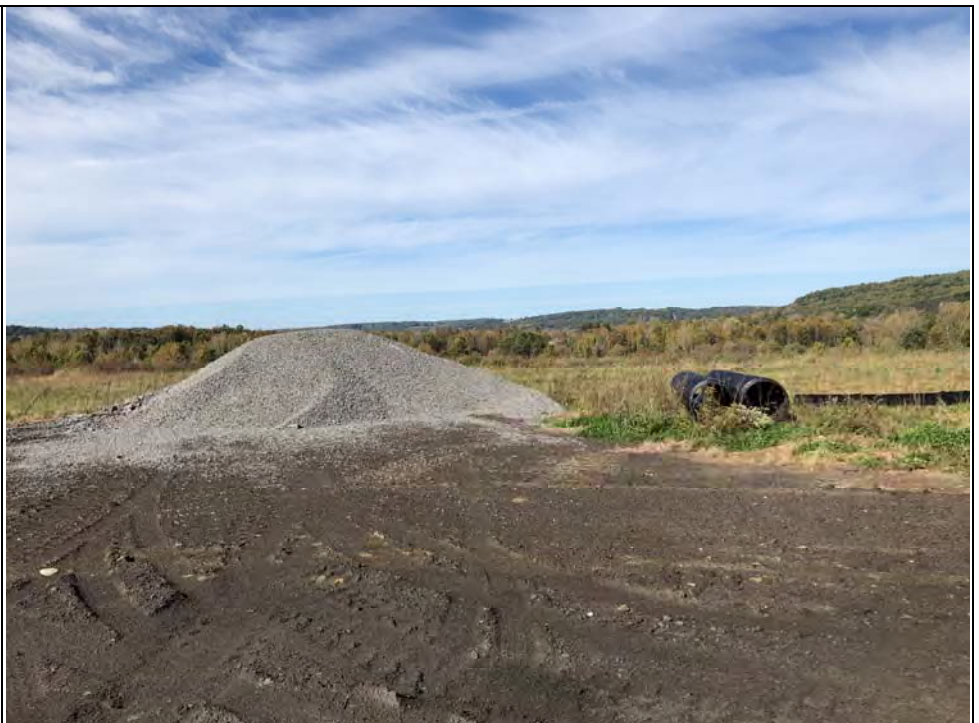
Image: 2509
Date: 10/23/2018
Time: 1:14 PM
Direction: North

Aggregate stockpile for vertical leachate riser.

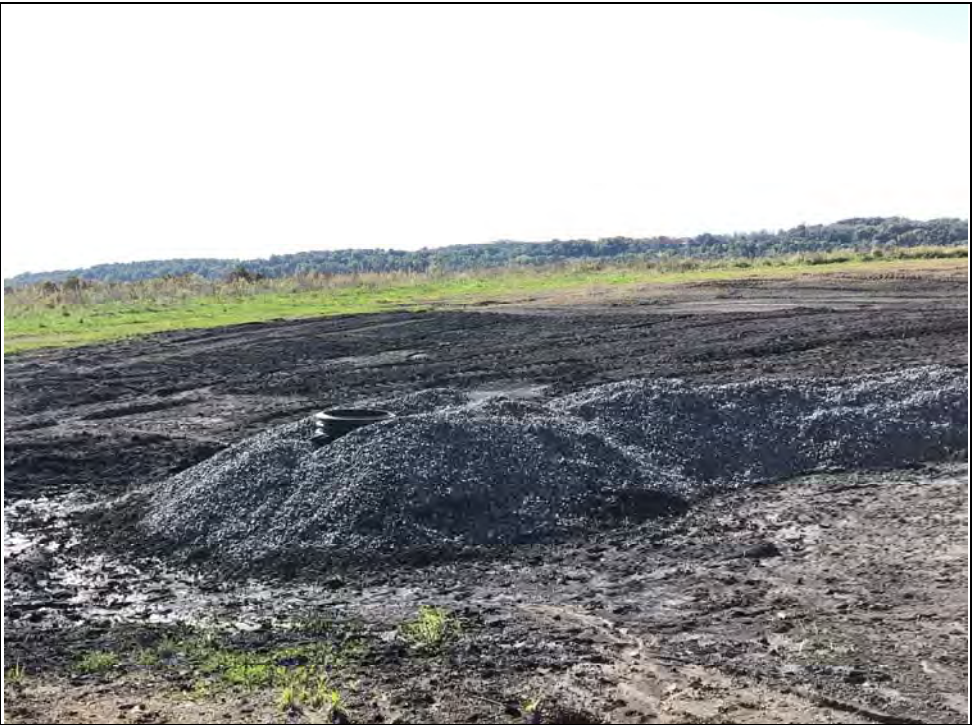
Image: 2511
Date: 10/23/2018
Time: 1:15 PM
Direction: Southwest

Vertical leachate riser within active area. The ground is sloped to drain into this riser, with contact water treated as leachate.

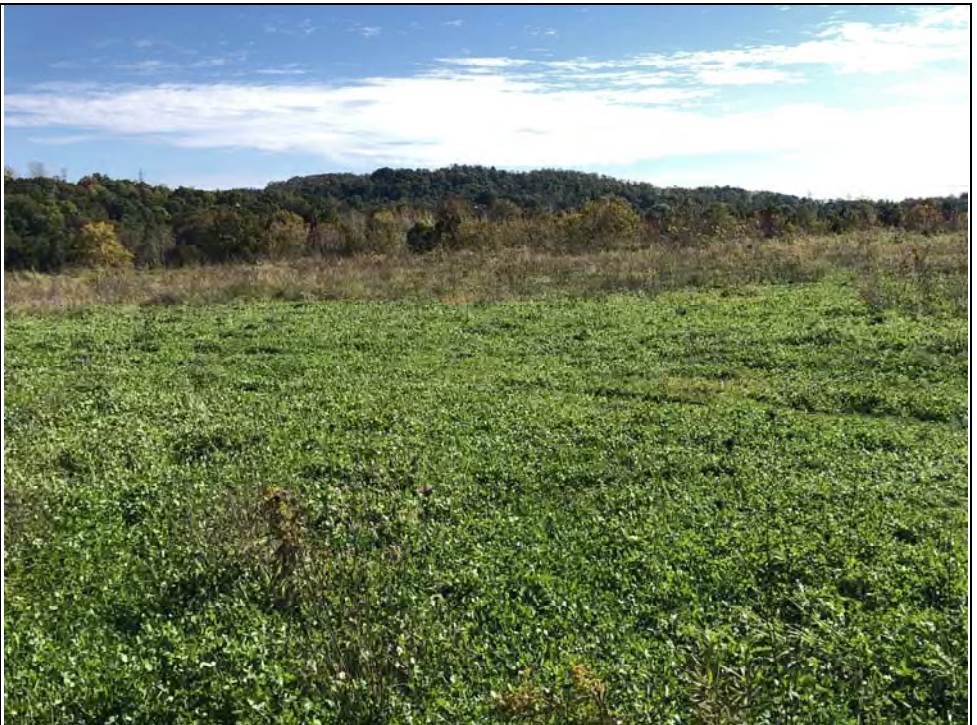
Image: 2513
Date: 10/23/2018
Time: 1:15 PM
Direction: South

2018 Finding: The vegetation has achieved full coverage.

Stage 4 intermediate cover. Vegetation had only partially seeded during the 2017 inspection, but now has full coverage.

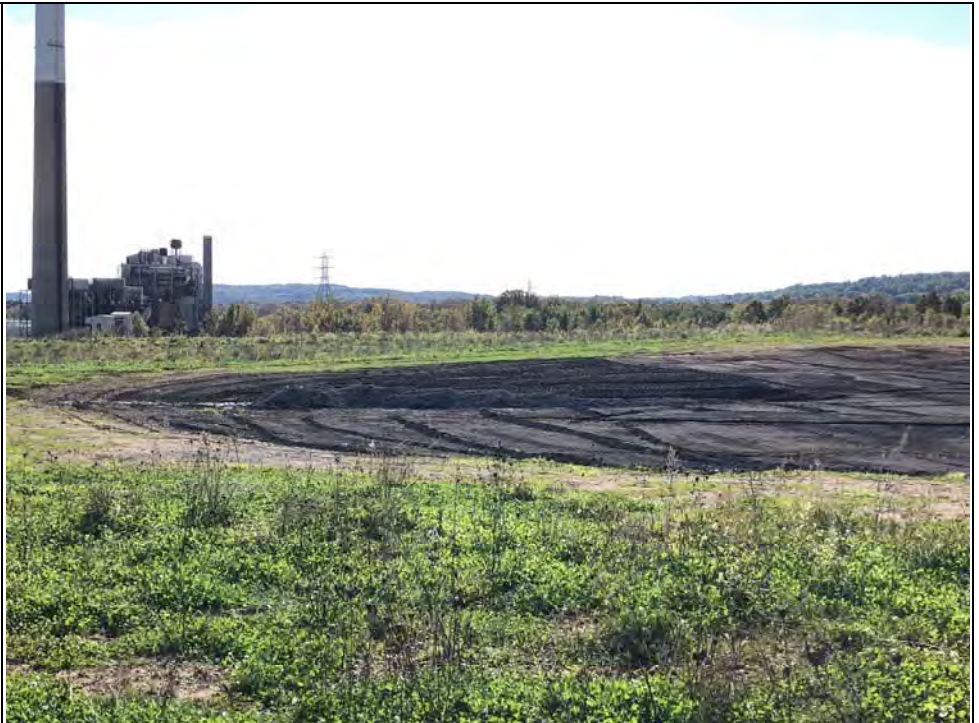
Image: 2515
Date: 10/23/2018
Time: 1:16 PM
Direction: South

Stage 4 active area. Well graded and compacted. No ponding water.

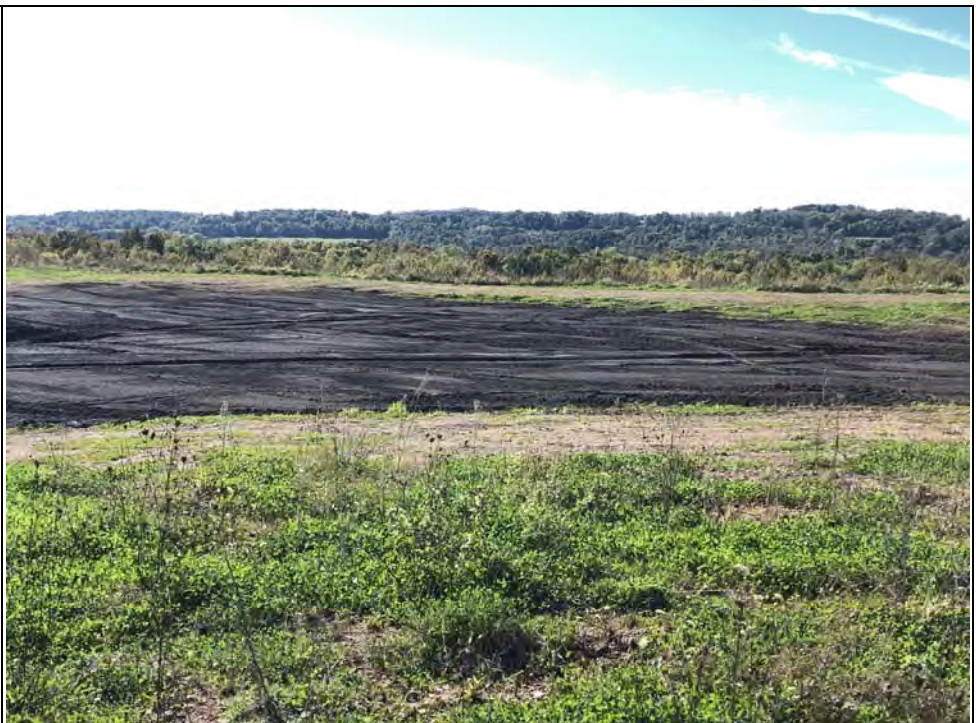
Image: 2517
Date: 10/23/2018
Time: 1:16 PM
Direction: Southwest

Stage 4 active area. Well graded and compacted. No ponding water.

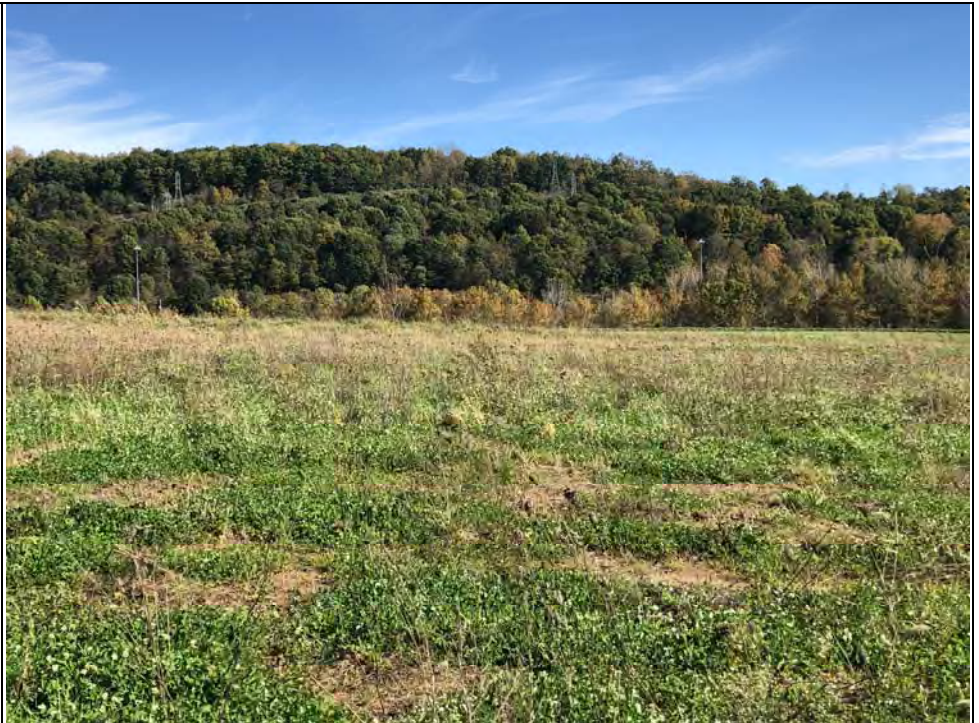
Image: 2519
Date: 10/23/2018
Time: 1:16 PM
Direction: East

Stage 4 intermediate cover. Vegetation is fully established. No stability concerns evident.

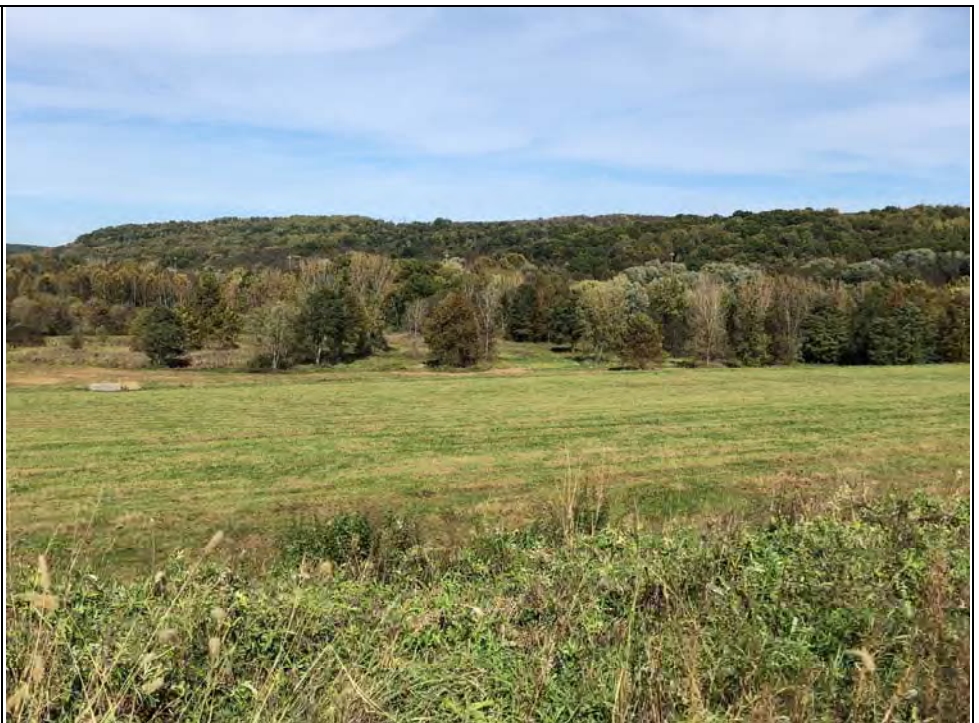
Image: 2523
Date: 10/23/2018
Time: 1:20 PM
Direction: Northeast

Standing on Stage 4 intermediate cover looking north toward Stage 5 final cover. Stage 5 final cover vegetation is healthy and well established.

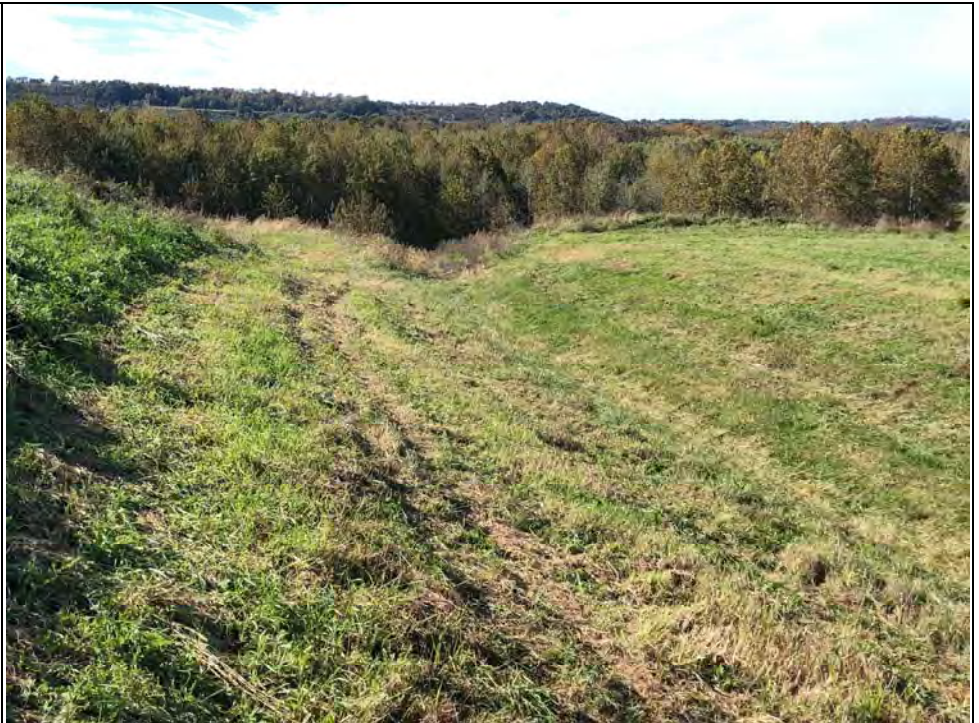
Image: 2525
Date: 10/23/2018
Time: 1:21 PM
Direction: West

Drainage swale at toe of Stage 4. Drainage swale is free of obstructions and well vegetated.

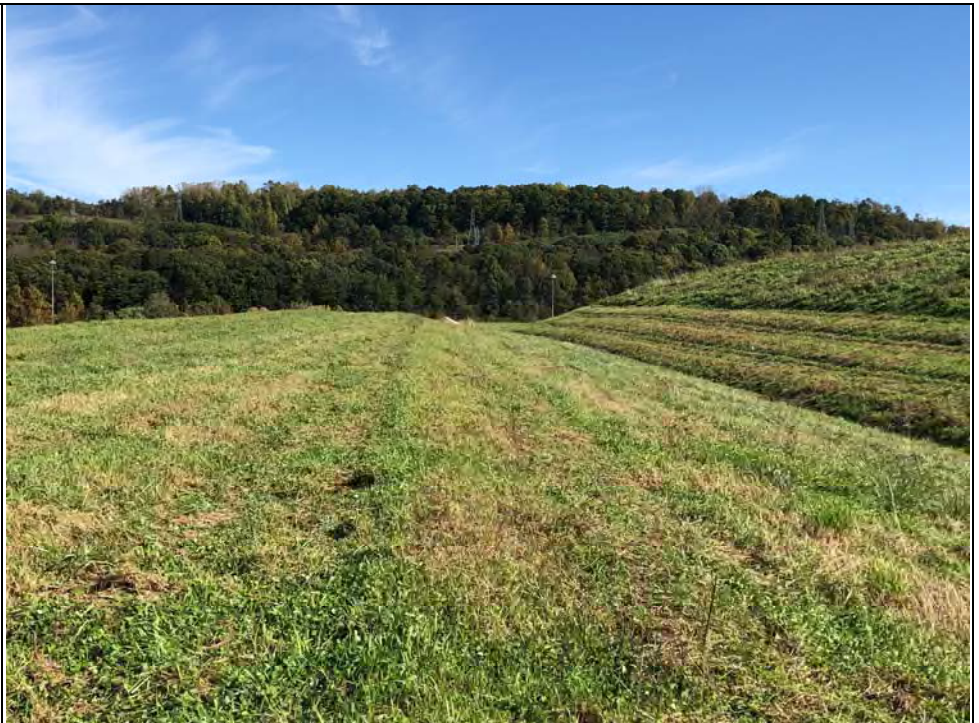
Image: 2527
Date: 10/23/2018
Time: 1:21 PM
Direction: East

Drainage swale at toe of Stage 4. Drainage swale is free of obstructions and well vegetated.

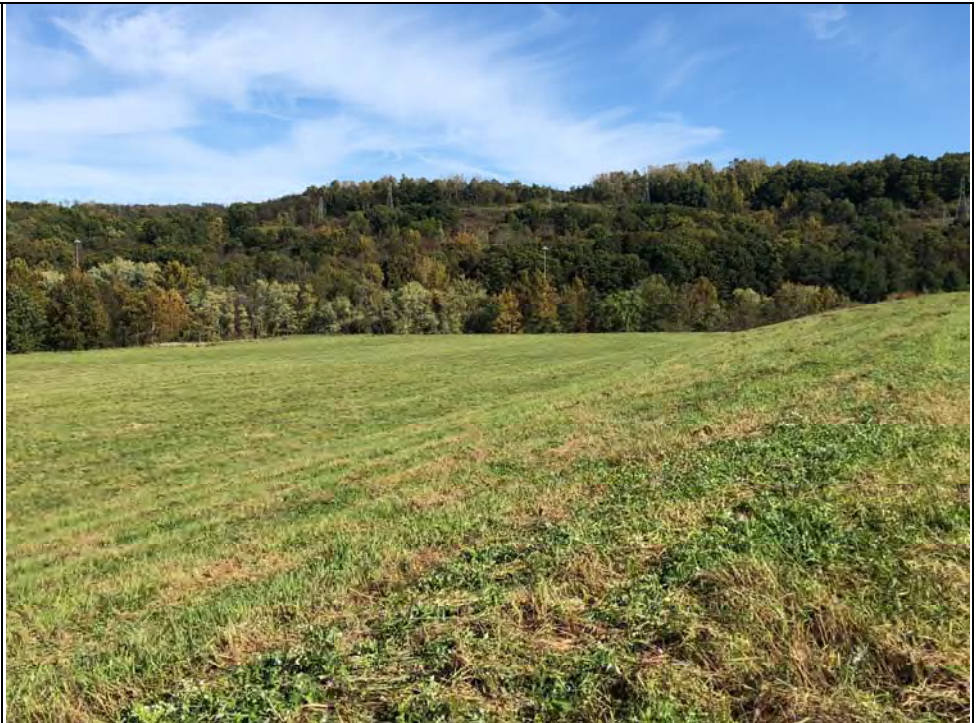
Image: 2529
Date: 10/23/2018
Time: 1:22 PM
Direction: East

Stage 5 final cover is in good condition.

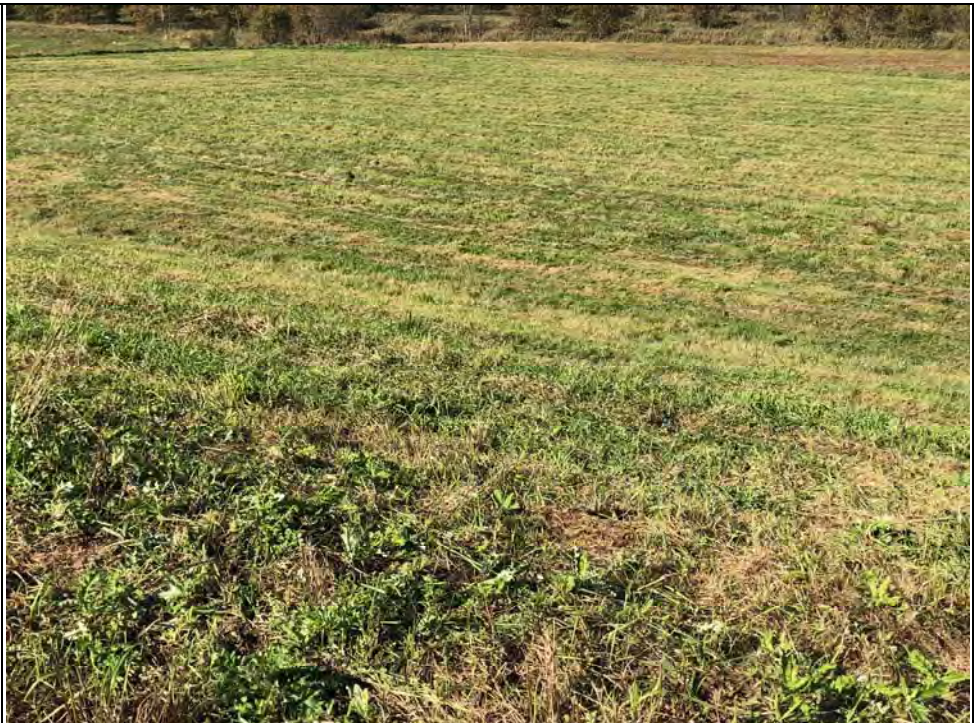
Image: 2531
Date: 10/23/2018
Time: 1:22 PM
Direction: Northwest

Stage 5 final cover is in good condition.

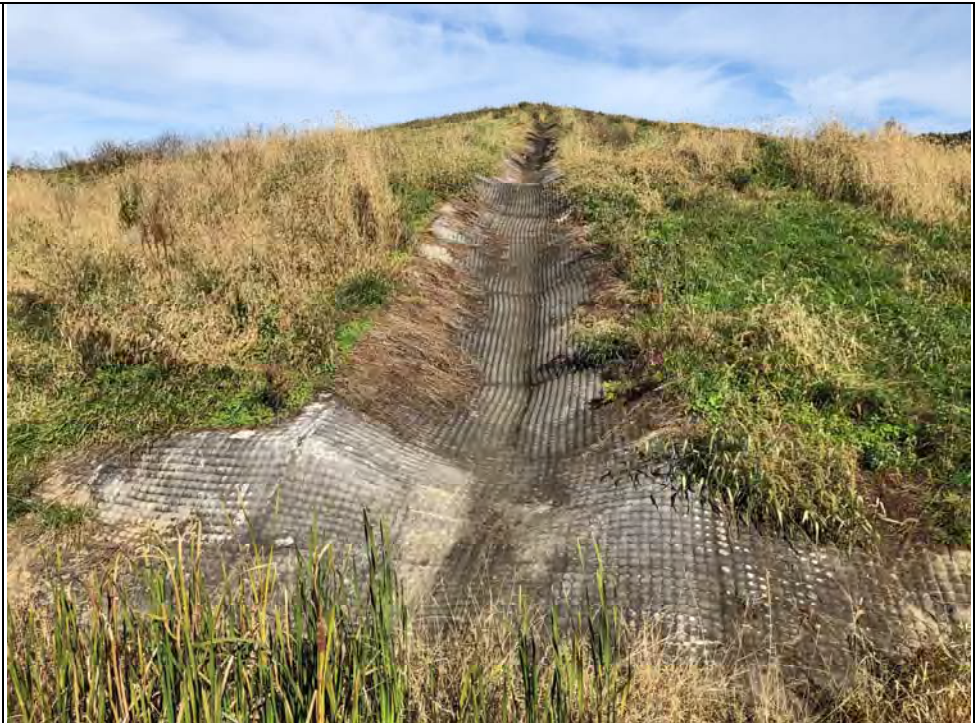
Image: 2533
Date: 10/23/2018
Time: 1:26 PM
Direction: Northeast

Non-contact stormwater downchute is free of obstructions and in good condition.

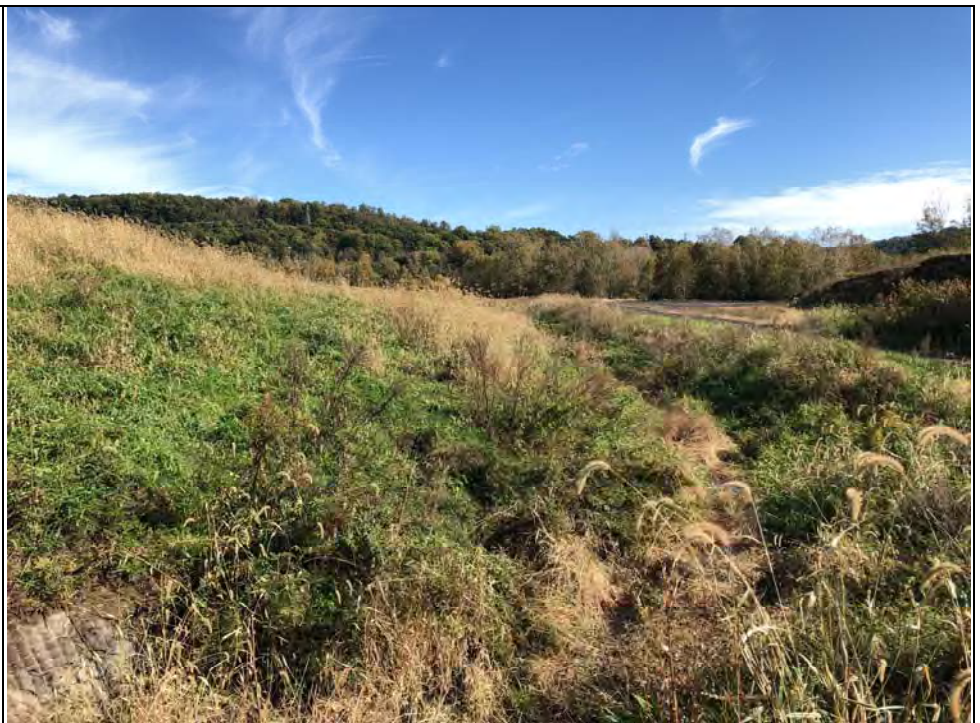
Image: 2535
Date: 10/23/2018
Time: 1:26 PM
Direction: East

Non-contact stormwater ditch at corner of landfill. Ditch is in good condition, well lined with vegetation, and does not have any noted obstructions.

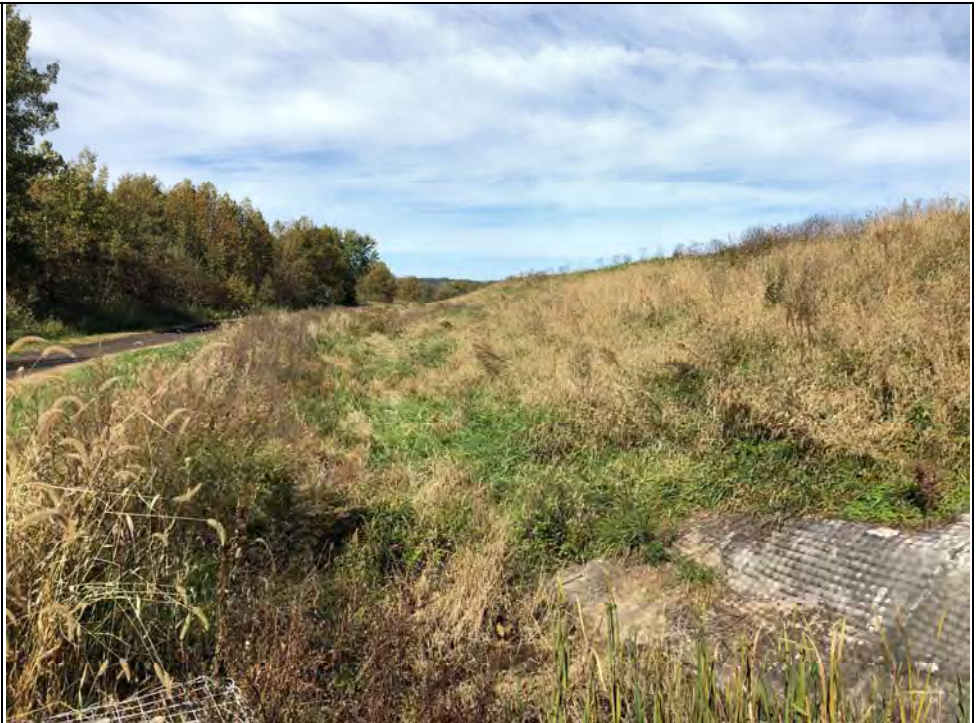
Image: 2537
Date: 10/23/2018
Time: 1:26 PM
Direction: North

Non-contact stormwater ditch at corner of landfill. Ditch is in good condition, well lined with vegetation, and does not have any noted obstructions.

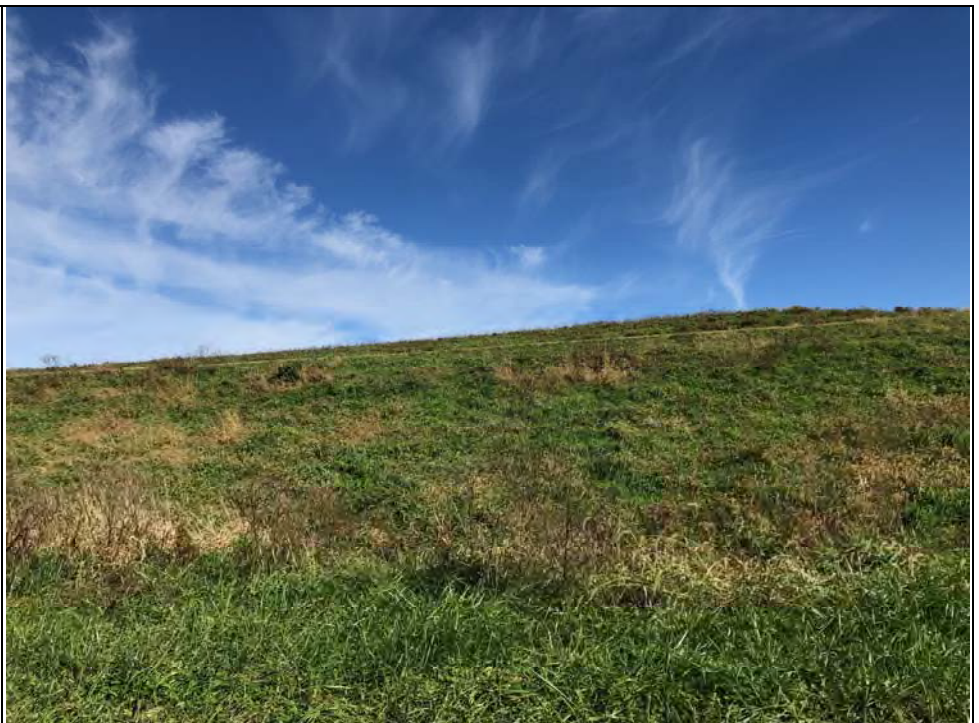
Image: 2539
Date: 10/23/2018
Time: 1:27 PM
Direction: Northeast

Final Cover on Stage 4 sideslopes is in good condition with no evidence of damage from erosion, animals, or sloughing or stability issues.

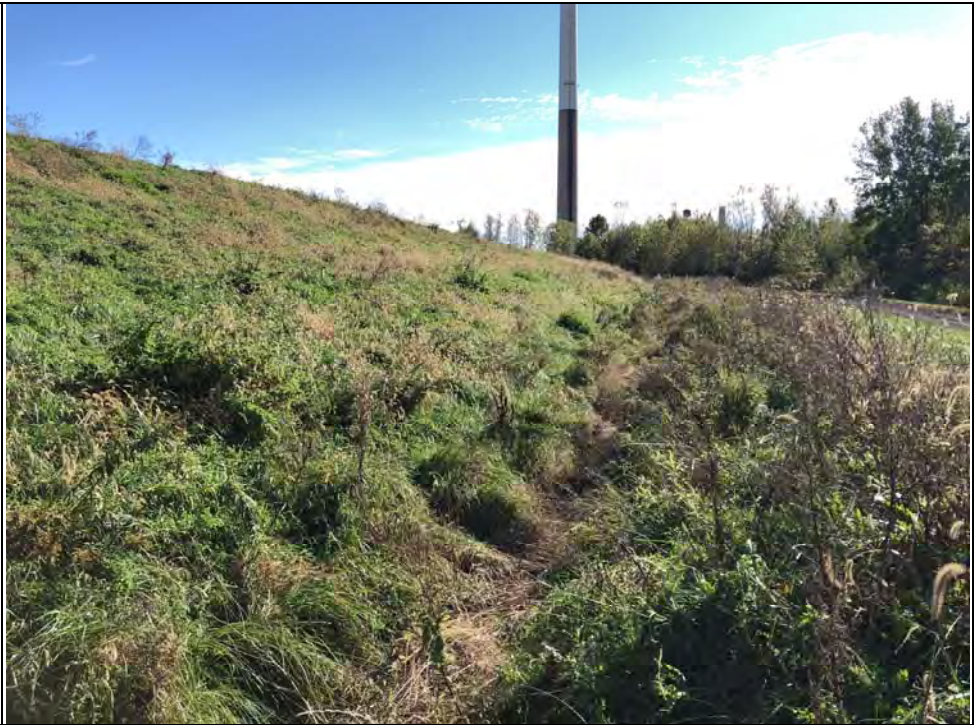
Image: 2541
Date: 10/23/2018
Time: 1:28 PM
Direction: South

Non-contact stormwater ditch along Phase 4 is free of obstructions and does not exhibit scour or erosion issues.

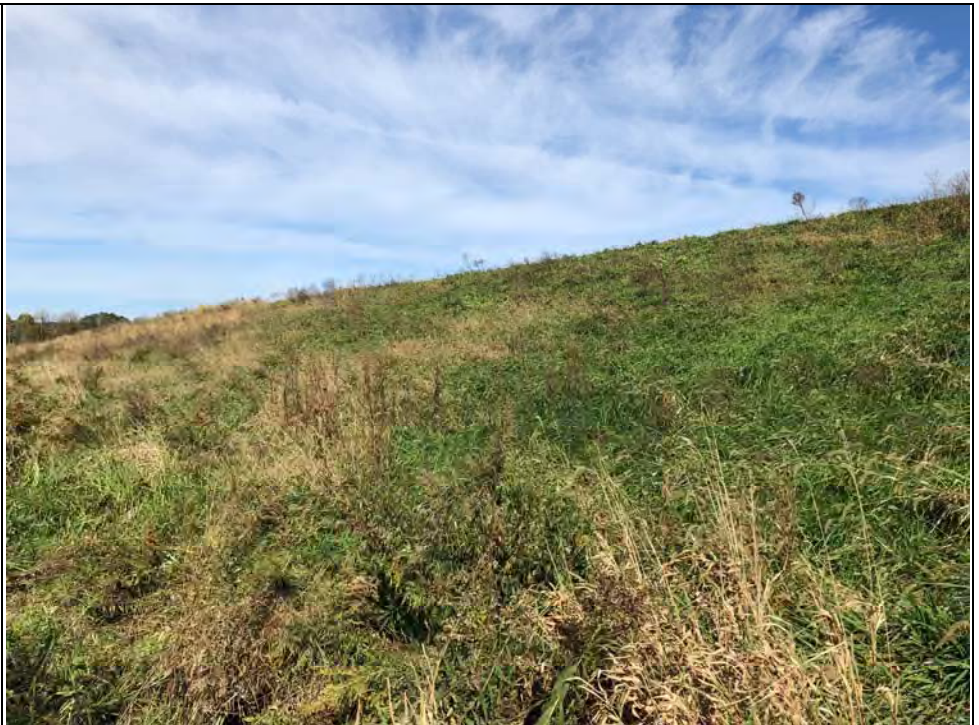
Image: 2543
Date: 10/23/2018
Time: 1:28 PM
Direction: Northeast

Final Cover on Stage 4 sideslopes is in good condition with no evidence of damage from erosion, animals, or sloughing or stability issues.

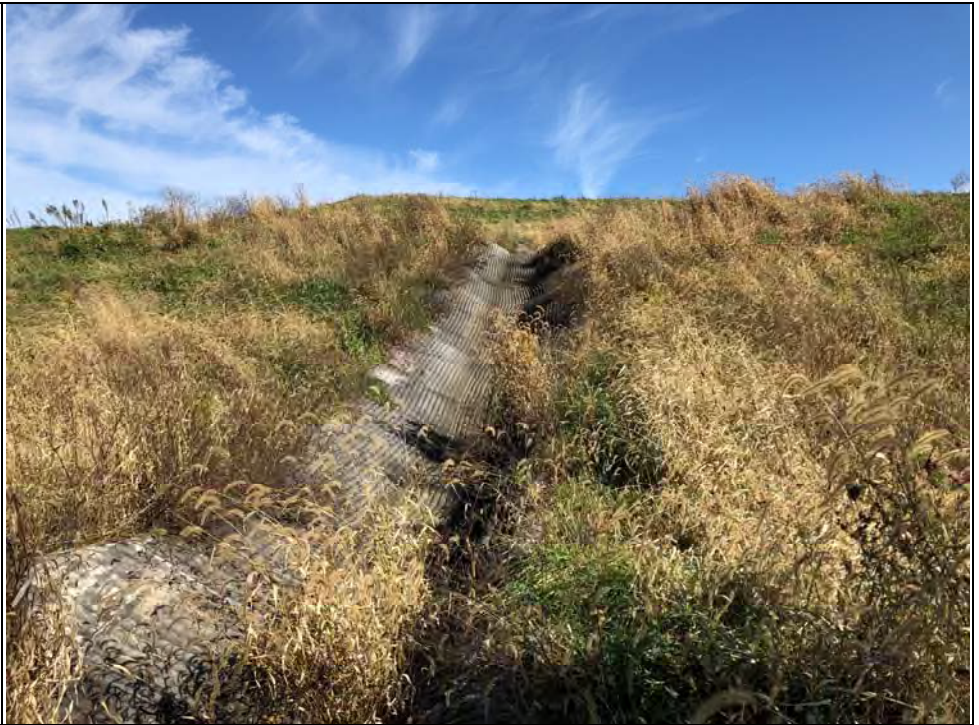
Image: 2545
Date: 10/23/2018
Time: 1:29 PM
Direction: East

Non-contact stormwater downchute. Clear of obstructions. Revetment is in good condition. Functioning as intended.

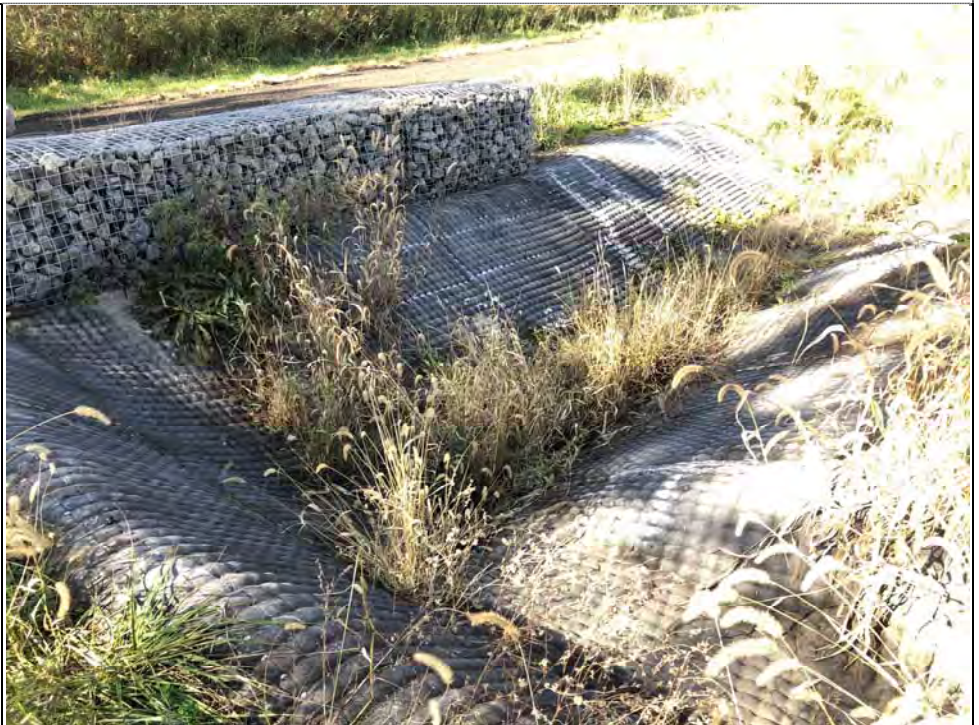
Image: 2547
Date: 10/23/2018
Time: 1:30 PM
Direction: Northwest

Stormwater energy dissipator at toe of slope is functioning as intended.

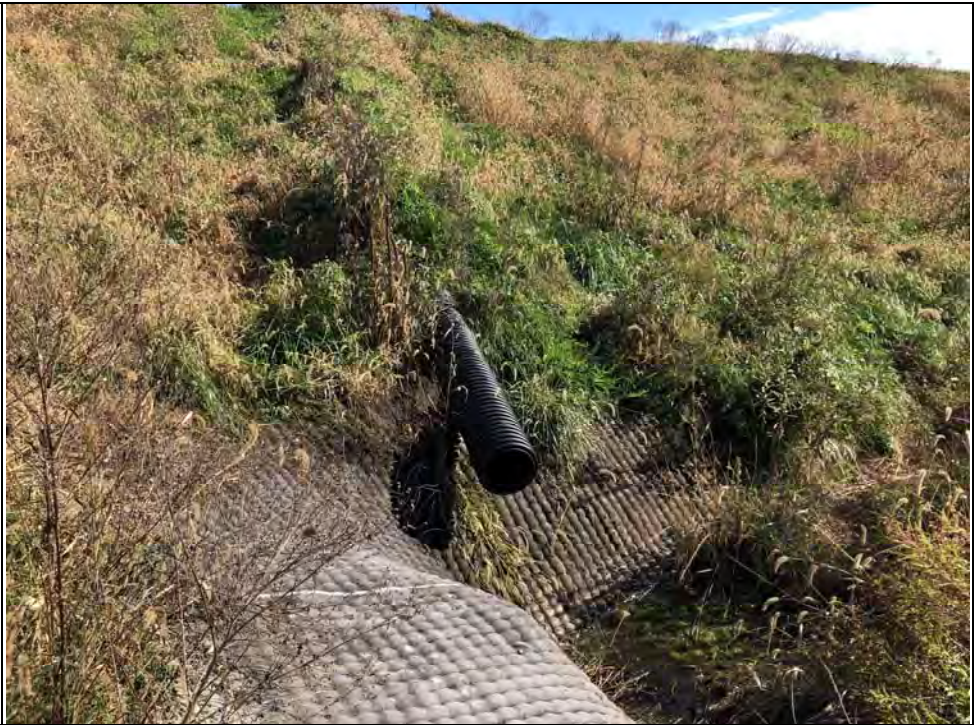
Image: 2549
Date: 10/23/2018
Time: 1:30 PM
Direction: Southeast

Non-contact stormwater discharge pipe from upper bench into non-contact water ditch.

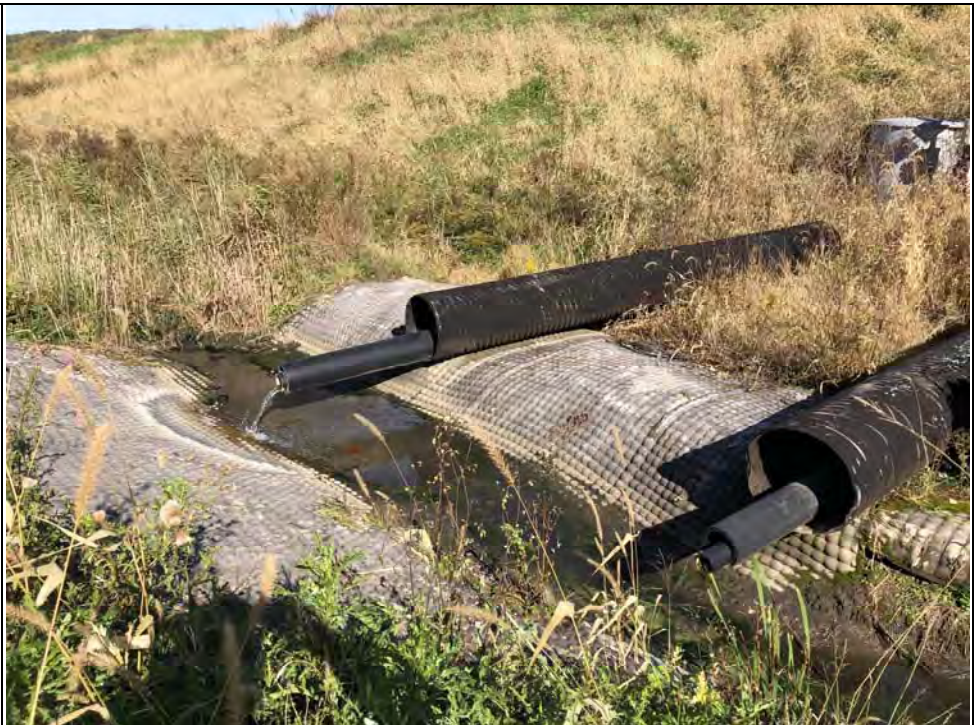
Image: 2551
Date: 10/23/2018
Time: 1:31 PM
Direction: Northeast

With no evidence to the contrary, the bottom liner system at the active Stage 4 disposal area is believed to be in good operating condition and functioning as intended. At the time of the inspection, leachate and stormwater conveyance systems were operating as designed. A leachate leak detection pipe was reviewed during the inspection and was not flowing, indicating that the bottom liner system is not leaking.

Leachate pipe (on left) discharging into contact water ditch, which ultimately flows to Leachate Pond. Leak detection pipe (on right) which was not flowing, demonstrating that the liner is not leaking. Ditch is clear of obstructions.
