Inspection Report

To: Steve Brown (New Castle Generating Station)
From: Richard Southorn, P.E., P.G.
Re: New Castle Plant Ash Landfill—Annual CCR Unit Inspection Report
Inspection Date: October 23, 2018
Report Date: January 16, 2019

Project: New Castle 2018 Annual Inspection

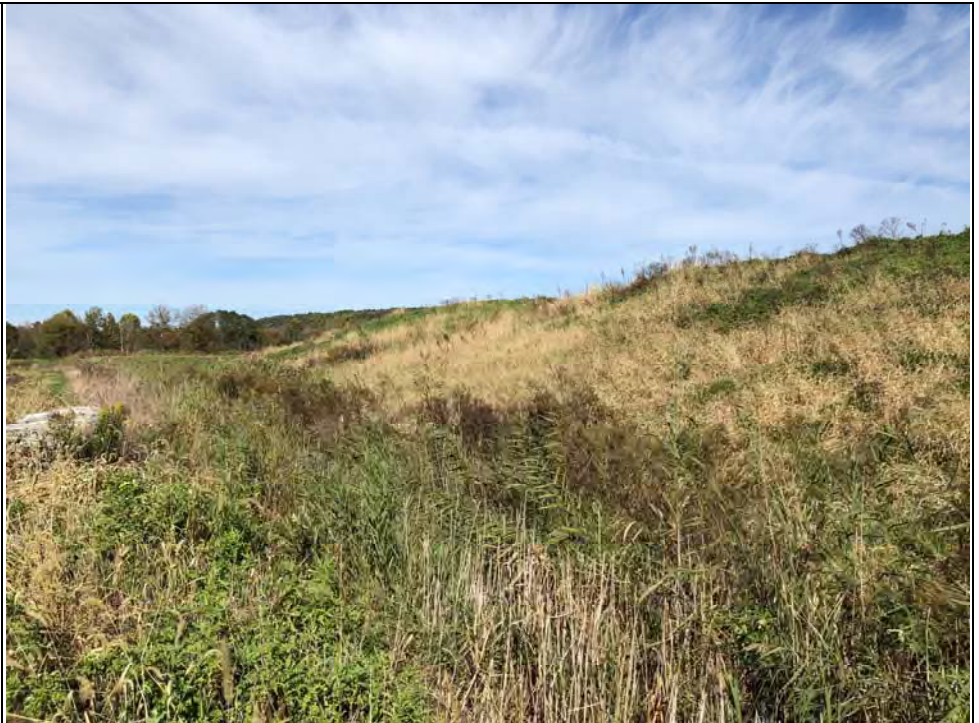
Image: 2555
Date: 10/23/2018
Time: 1:32 PM
Direction: Northeast

Non-contact water ditch exhibits no scour or erosion.

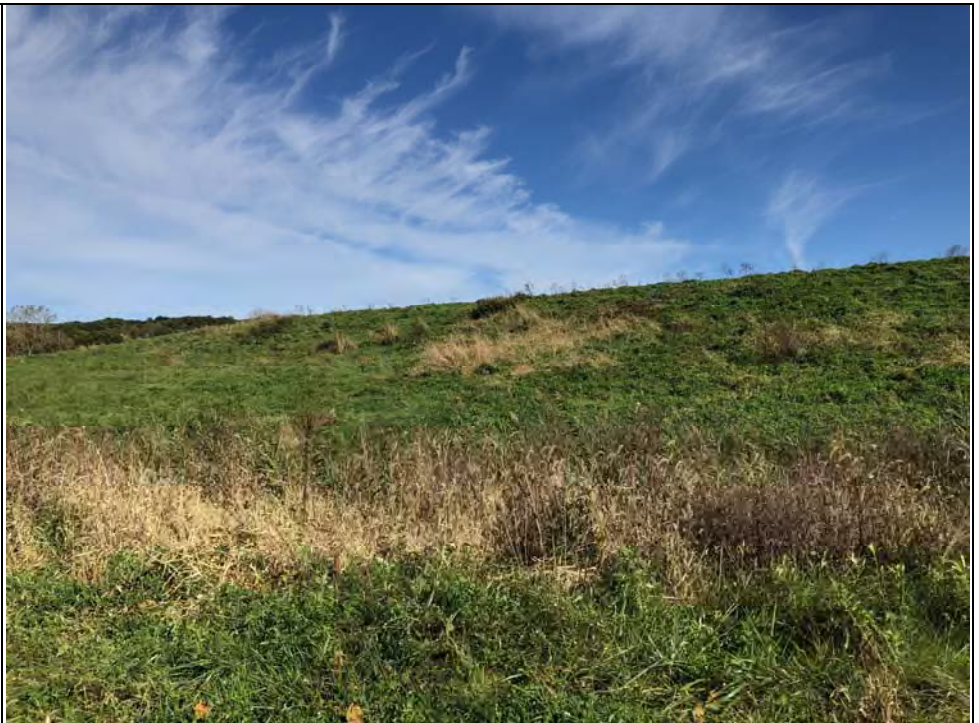
Image: 2559
Date: 10/23/2018
Time: 1:33 PM
Direction: Northeast

Final Cover on Stage 5 sideslopes is in good condition with no evidence of damage from erosion, animals, or sloughing or stability issues.

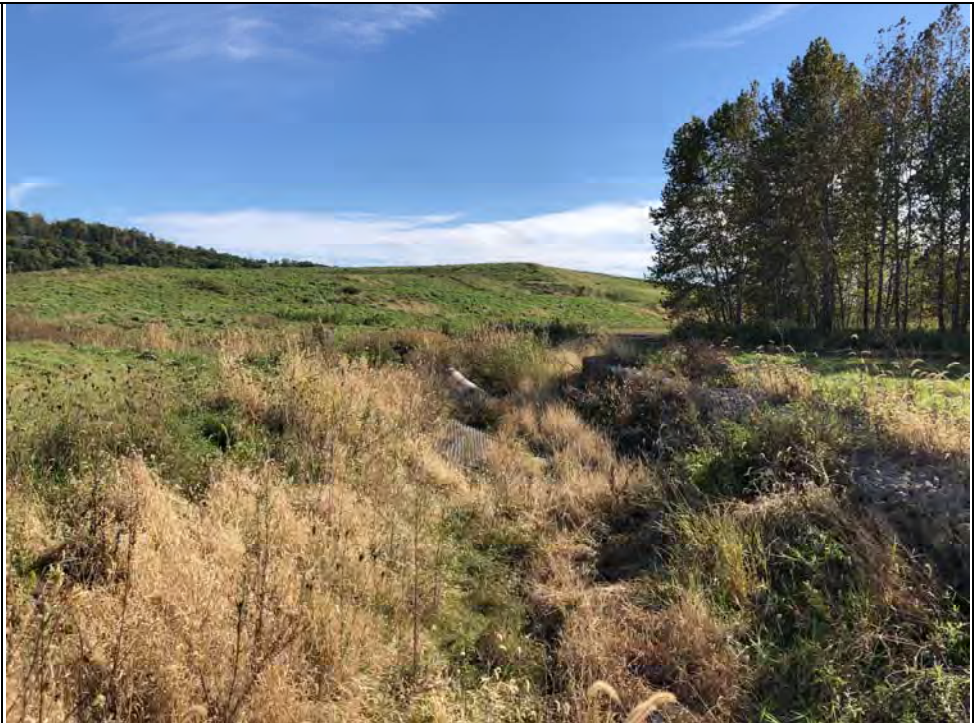
Image: 2561
Date: 10/23/2018
Time: 1:34 PM
Direction: Southeast

Stormwater ditch is in good working order.

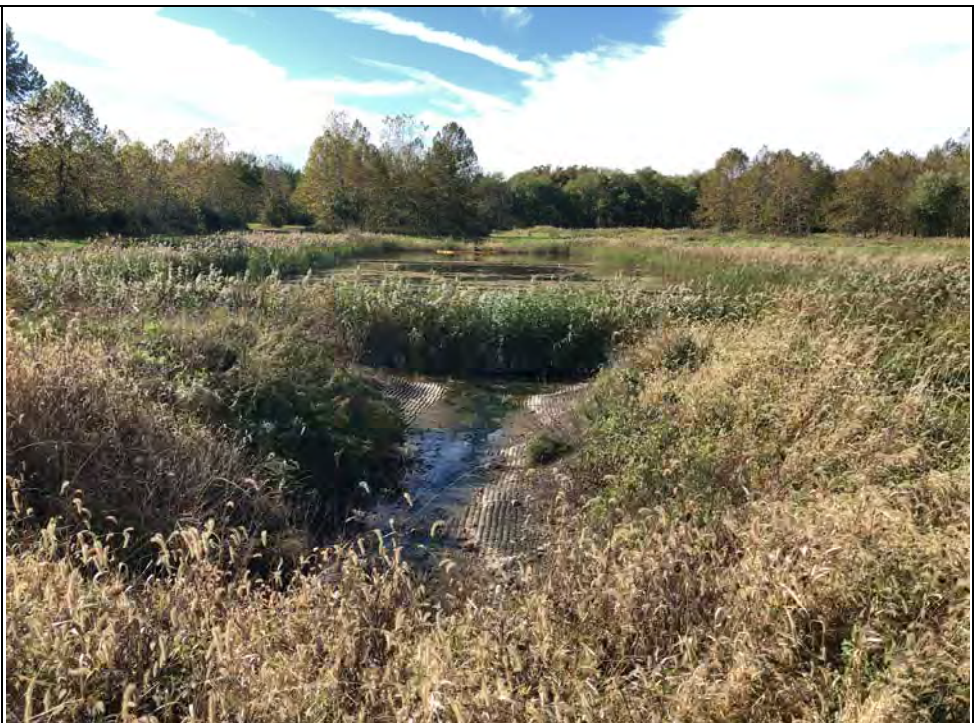
Image: 2563
Date: 10/23/2018
Time: 1:35 PM
Direction: West

Inlet to Leachate Pond.

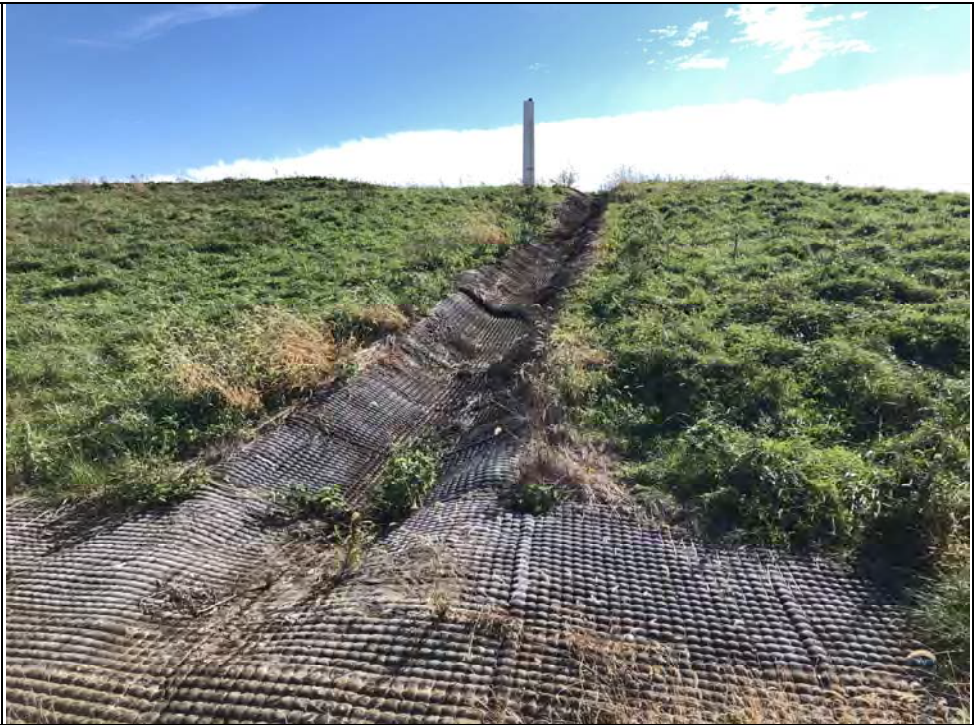
Image: 2567
Date: 10/23/2018
Time: 1:37 PM
Direction: South

Non-contact stormwater downchute. Clear of obstructions. Revetment is in good condition. Functioning as intended.

Stage 5 final cover is in good condition with no signs of stability. No animal burrows noted. Vegetation is healthy.

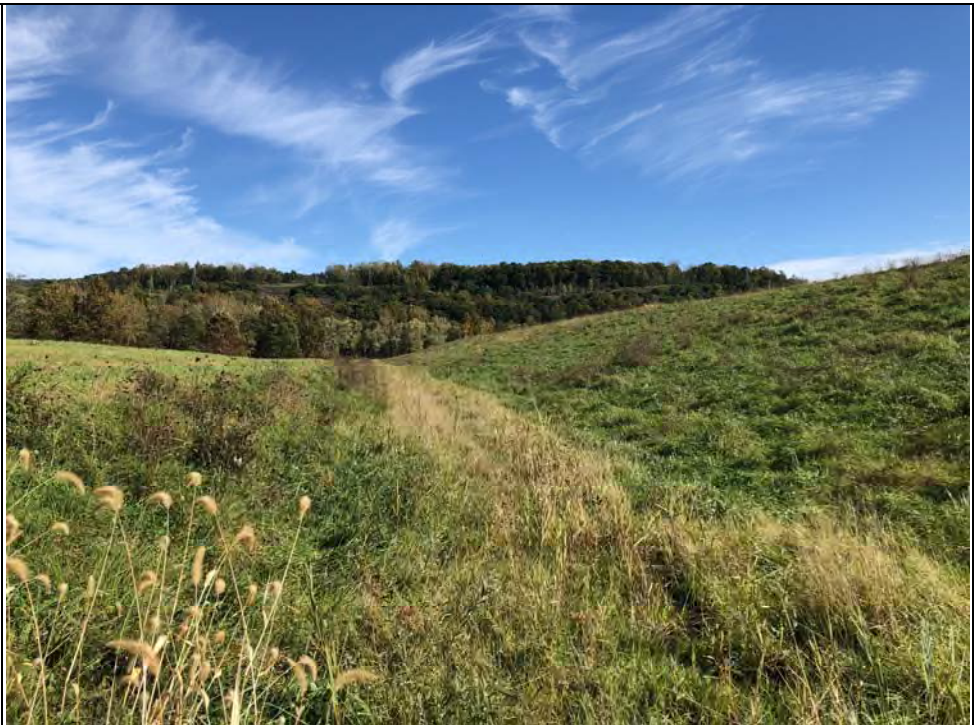
Image: 2569
Date: 10/23/2018
Time: 1:38 PM
Direction: East

Stormwater swale is in good condition. Well maintained with healthy vegetation. No debris or obstructions.

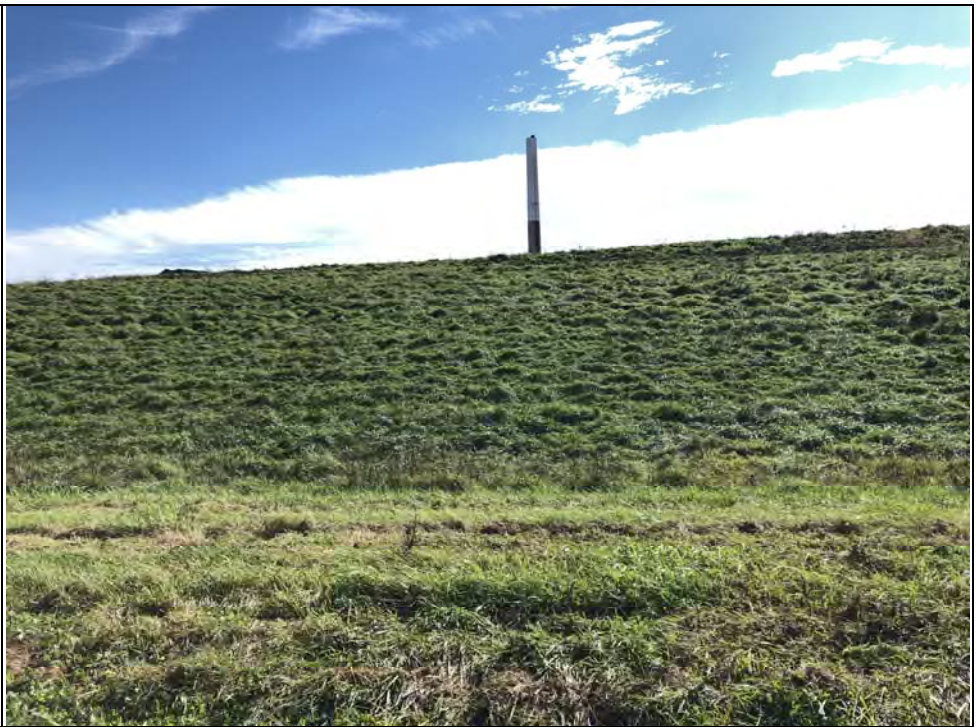
Image: 2571
Date: 10/23/2018
Time: 1:39 PM
Direction: South

Stage 5 final cover is in good condition with no signs of stability. No animal burrows noted. Vegetation is healthy.

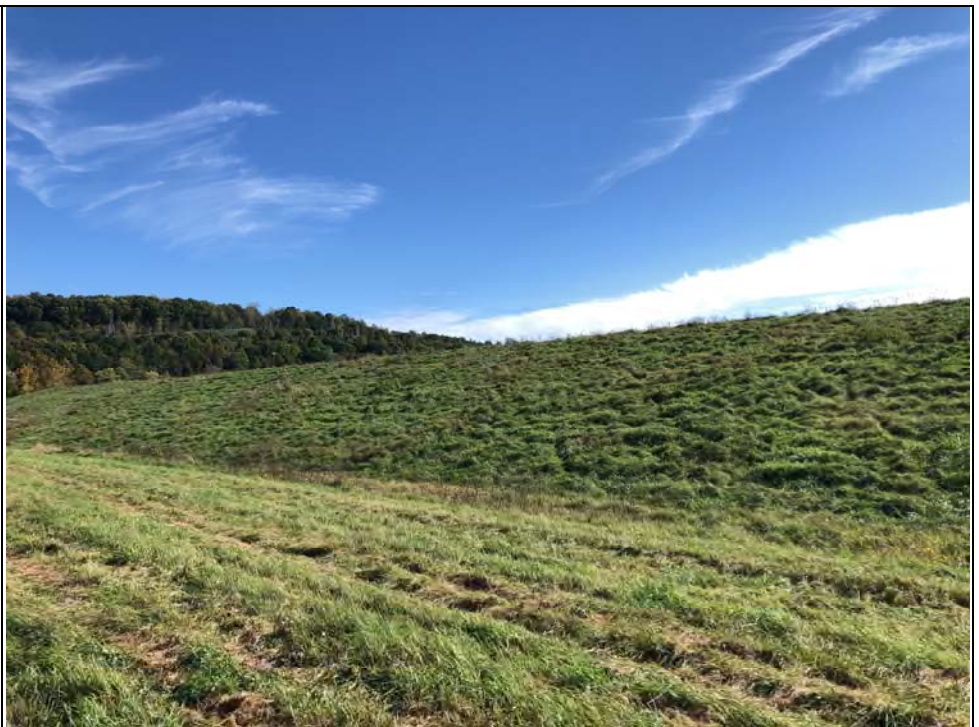
Image: 2573
Date: 10/23/2018
Time: 1:39 PM
Direction: Southeast

Stormwater swale is in good condition. Well maintained with healthy vegetation. No debris or obstructions.

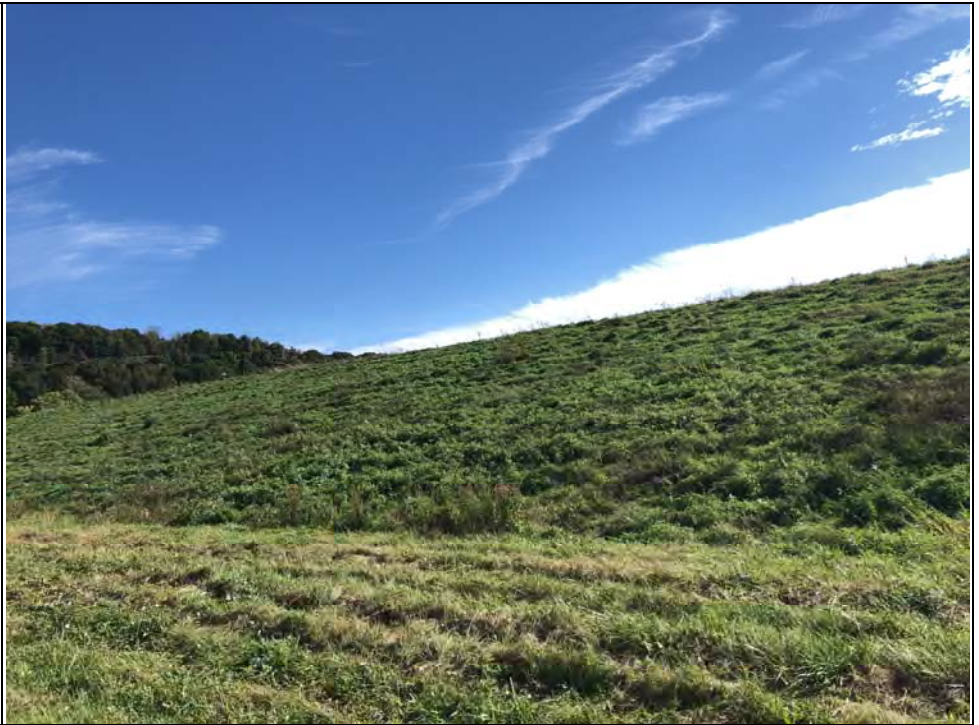
Image: 2575
Date: 10/23/2018
Time: 1:40 PM
Direction: Southeast

Stage 5 final cover is in good condition with no signs of stability. No animal burrows noted. Vegetation is healthy.

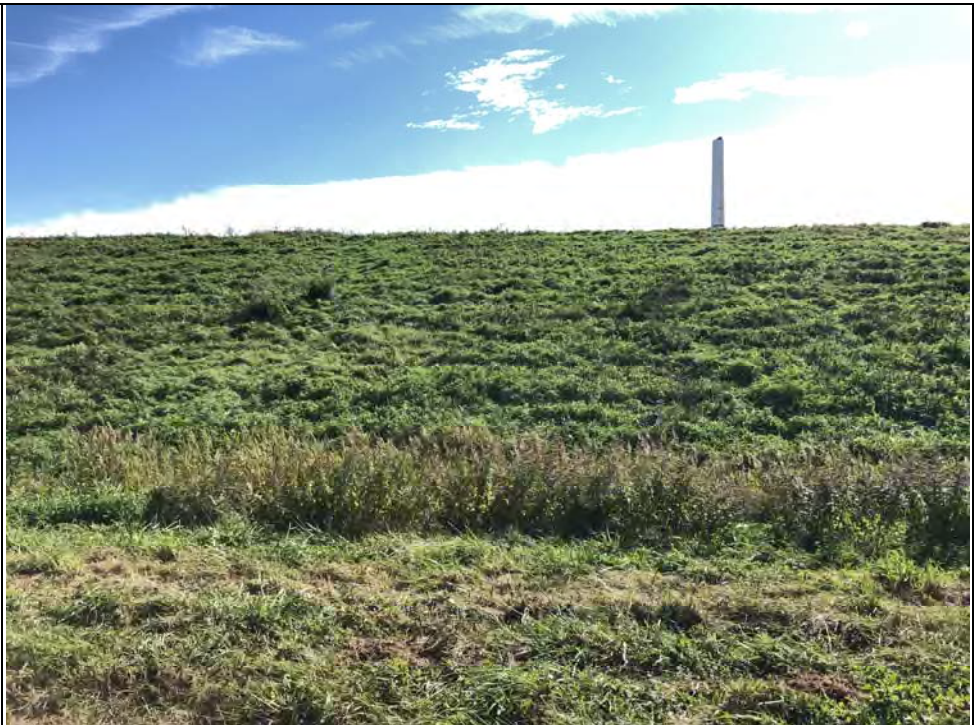
Image: 2577
Date: 10/23/2018
Time: 1:40 PM
Direction: South

Stage 5 final cover is in good condition with no signs of stability. No animal burrows noted. Vegetation is healthy.

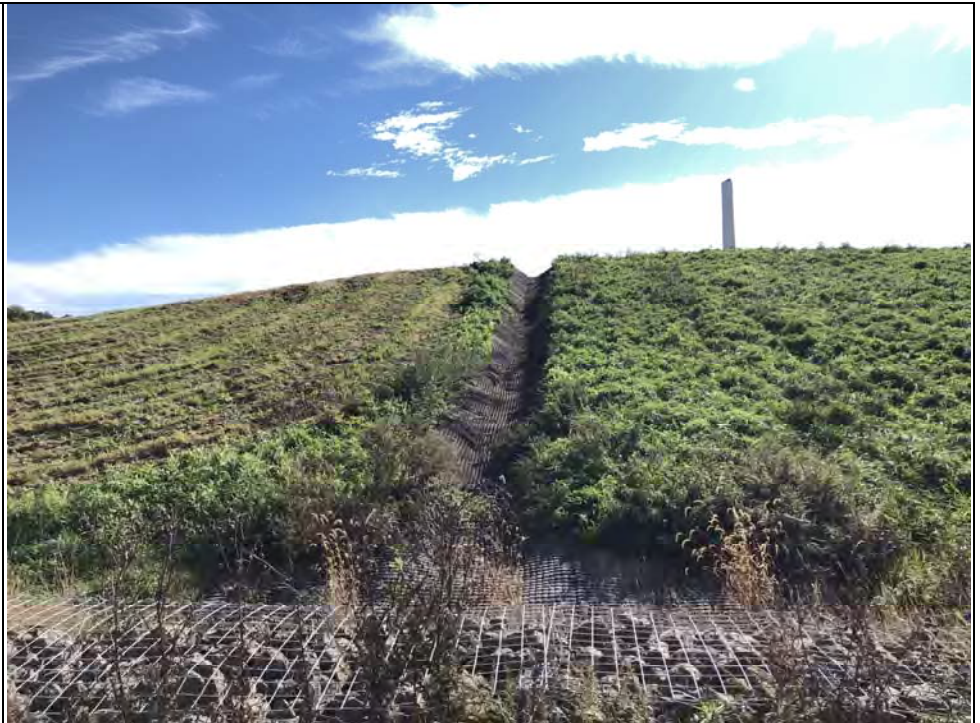
Image: 2579
Date: 10/23/2018
Time: 1:41 PM
Direction: South

Non-contact stormwater downchute. Clear of obstructions. Revetment is in good condition. Functioning as intended.

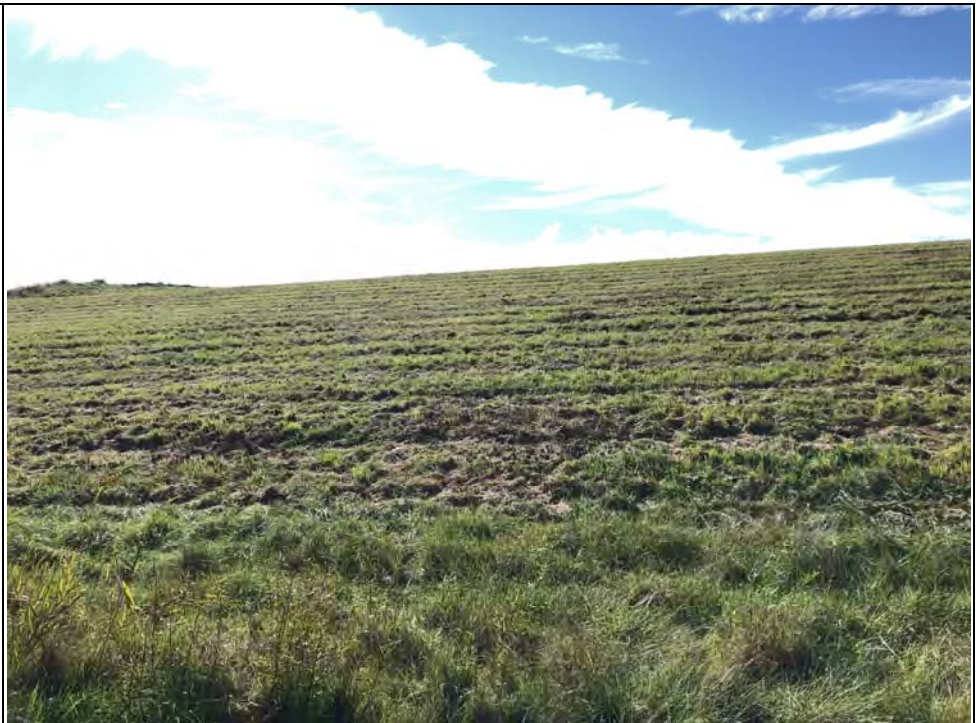
Image: 2583
Date: 10/23/2018
Time: 1:42 PM
Direction: West

Stage 5 final cover is in good condition with no signs of stability. No animal burrows noted. Vegetation is healthy.

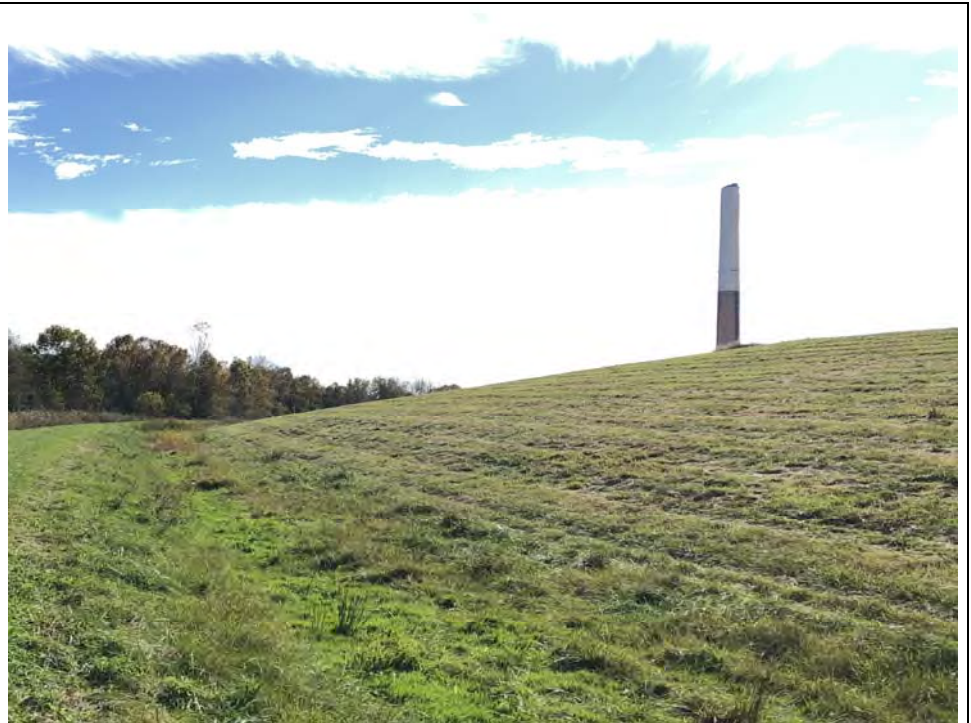
Image: 2585
Date: 10/23/2018
Time: 1:42 PM
Direction: South

Perimeter ditch around Stage 5 is free of obstructions and well maintained.

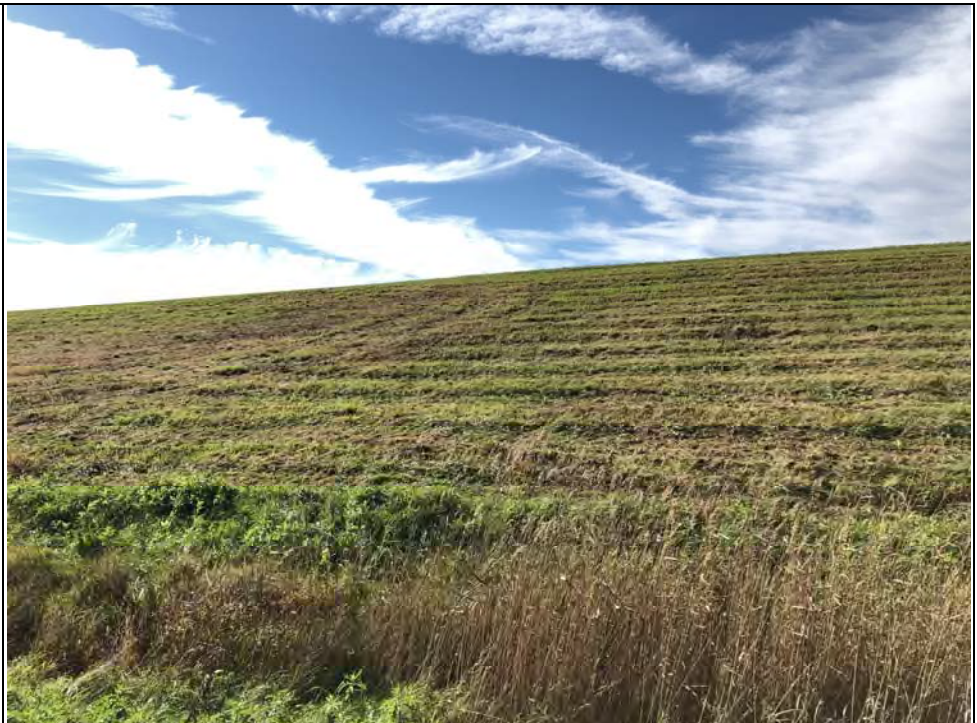
Image: 2591
Date: 10/23/2018
Time: 1:43 PM
Direction: West

Stage 6 final cover is in good condition with no signs of stability. No animal burrows noted. Vegetation is healthy.

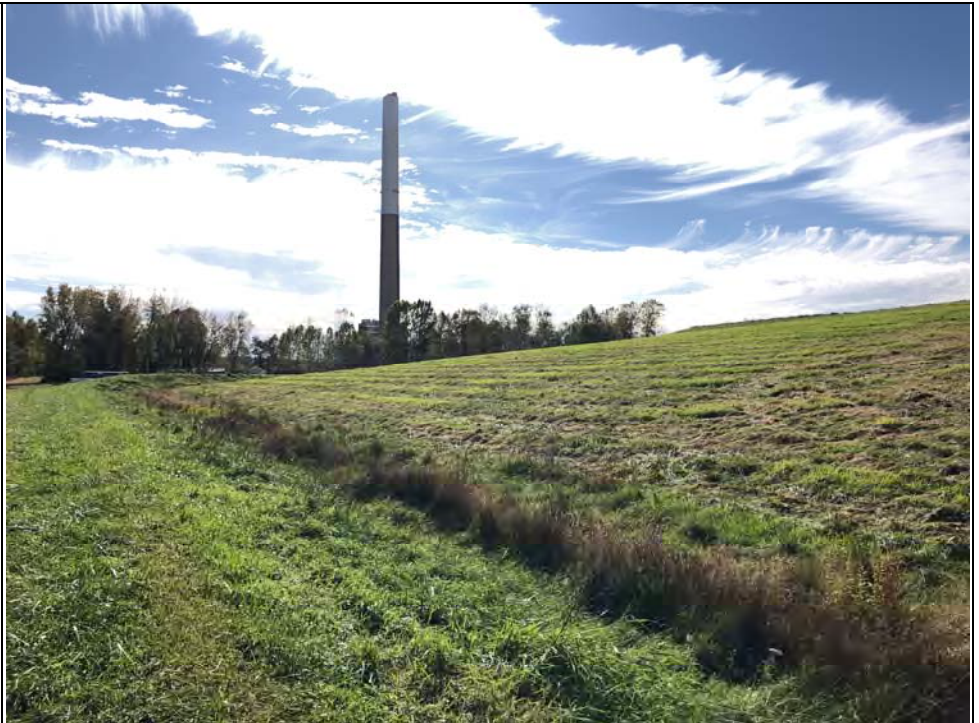
Image: 2595
Date: 10/23/2018
Time: 1:44 PM
Direction: South

Perimeter ditch around Stage 6 is free of obstructions and well maintained.

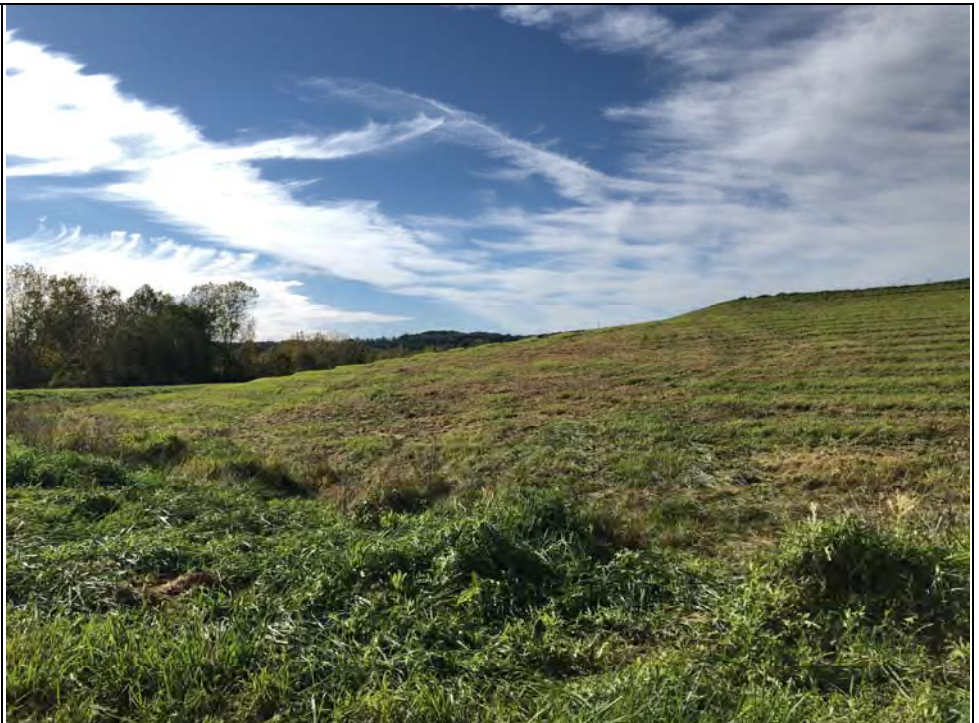
Image: 2597
Date: 10/23/2018
Time: 1:45 PM
Direction: West

Stage 6 final cover is in good condition with no signs of stability. No animal burrows noted. Vegetation is healthy.

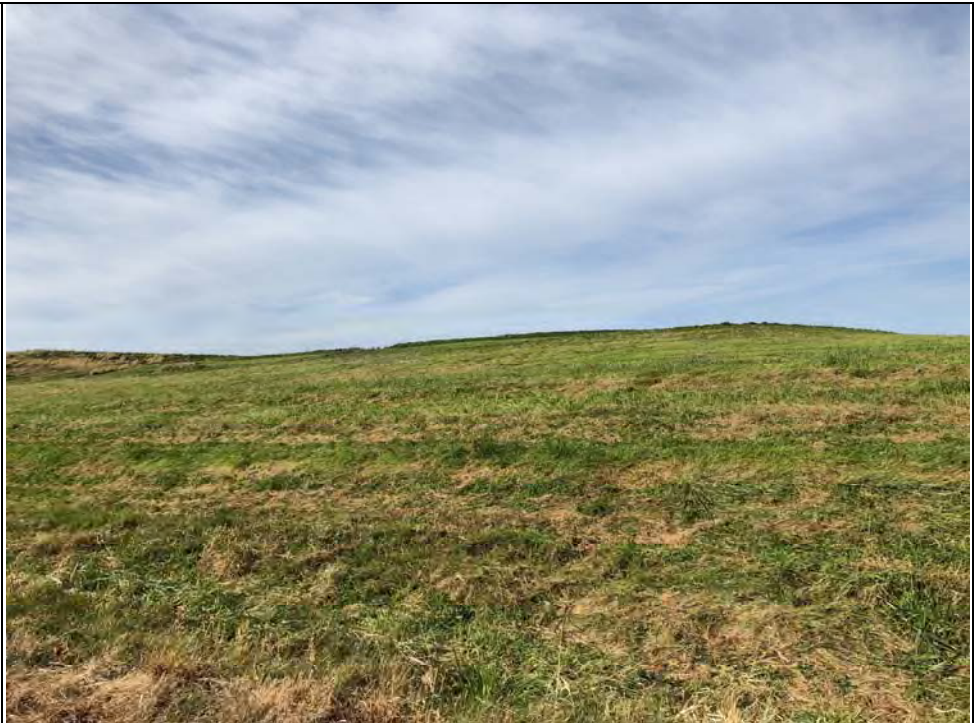
Image: 2599
Date: 10/23/2018
Time: 1:46 PM
Direction: Northwest

Stage 6 final cover is in good condition with no signs of stability. No animal burrows noted. Vegetation is healthy.

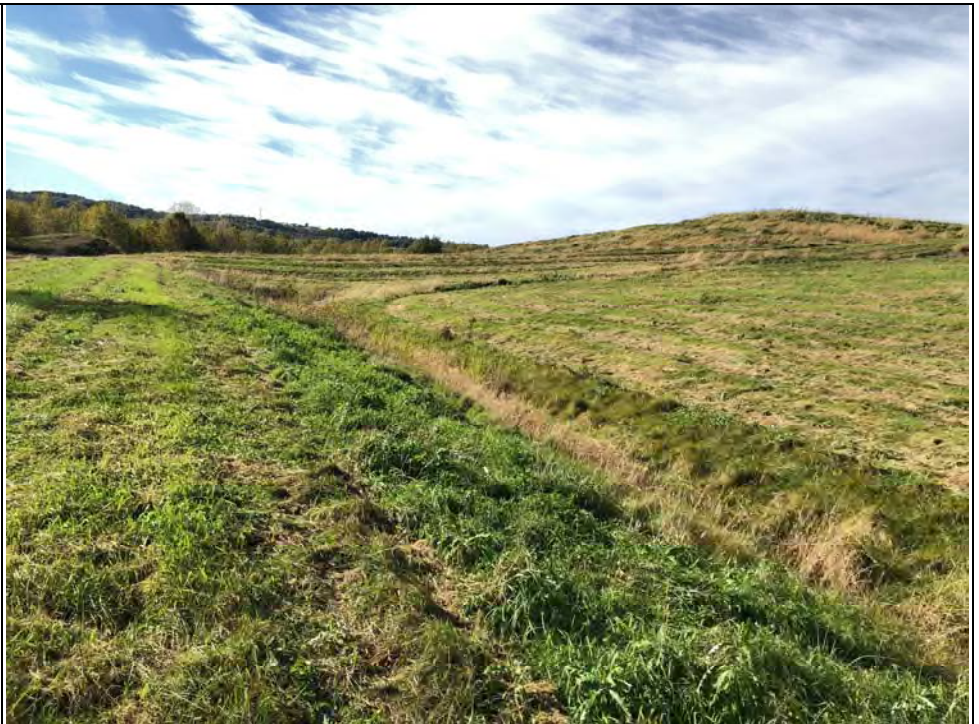
Image: 2601
Date: 10/23/2018
Time: 1:46 PM
Direction: West

Perimeter ditch around Stage 6 is free of obstructions and well maintained.
