CCR RULE COMPLIANCE

BOTTOM ASH PONDS HAZARD POTENTIAL CLASSIFICATION INITIAL ASSESSMENT REPORT

NRG Power Midwest LP
Cheswick Generating Station
Springdale, Pennsylvania

October 2016

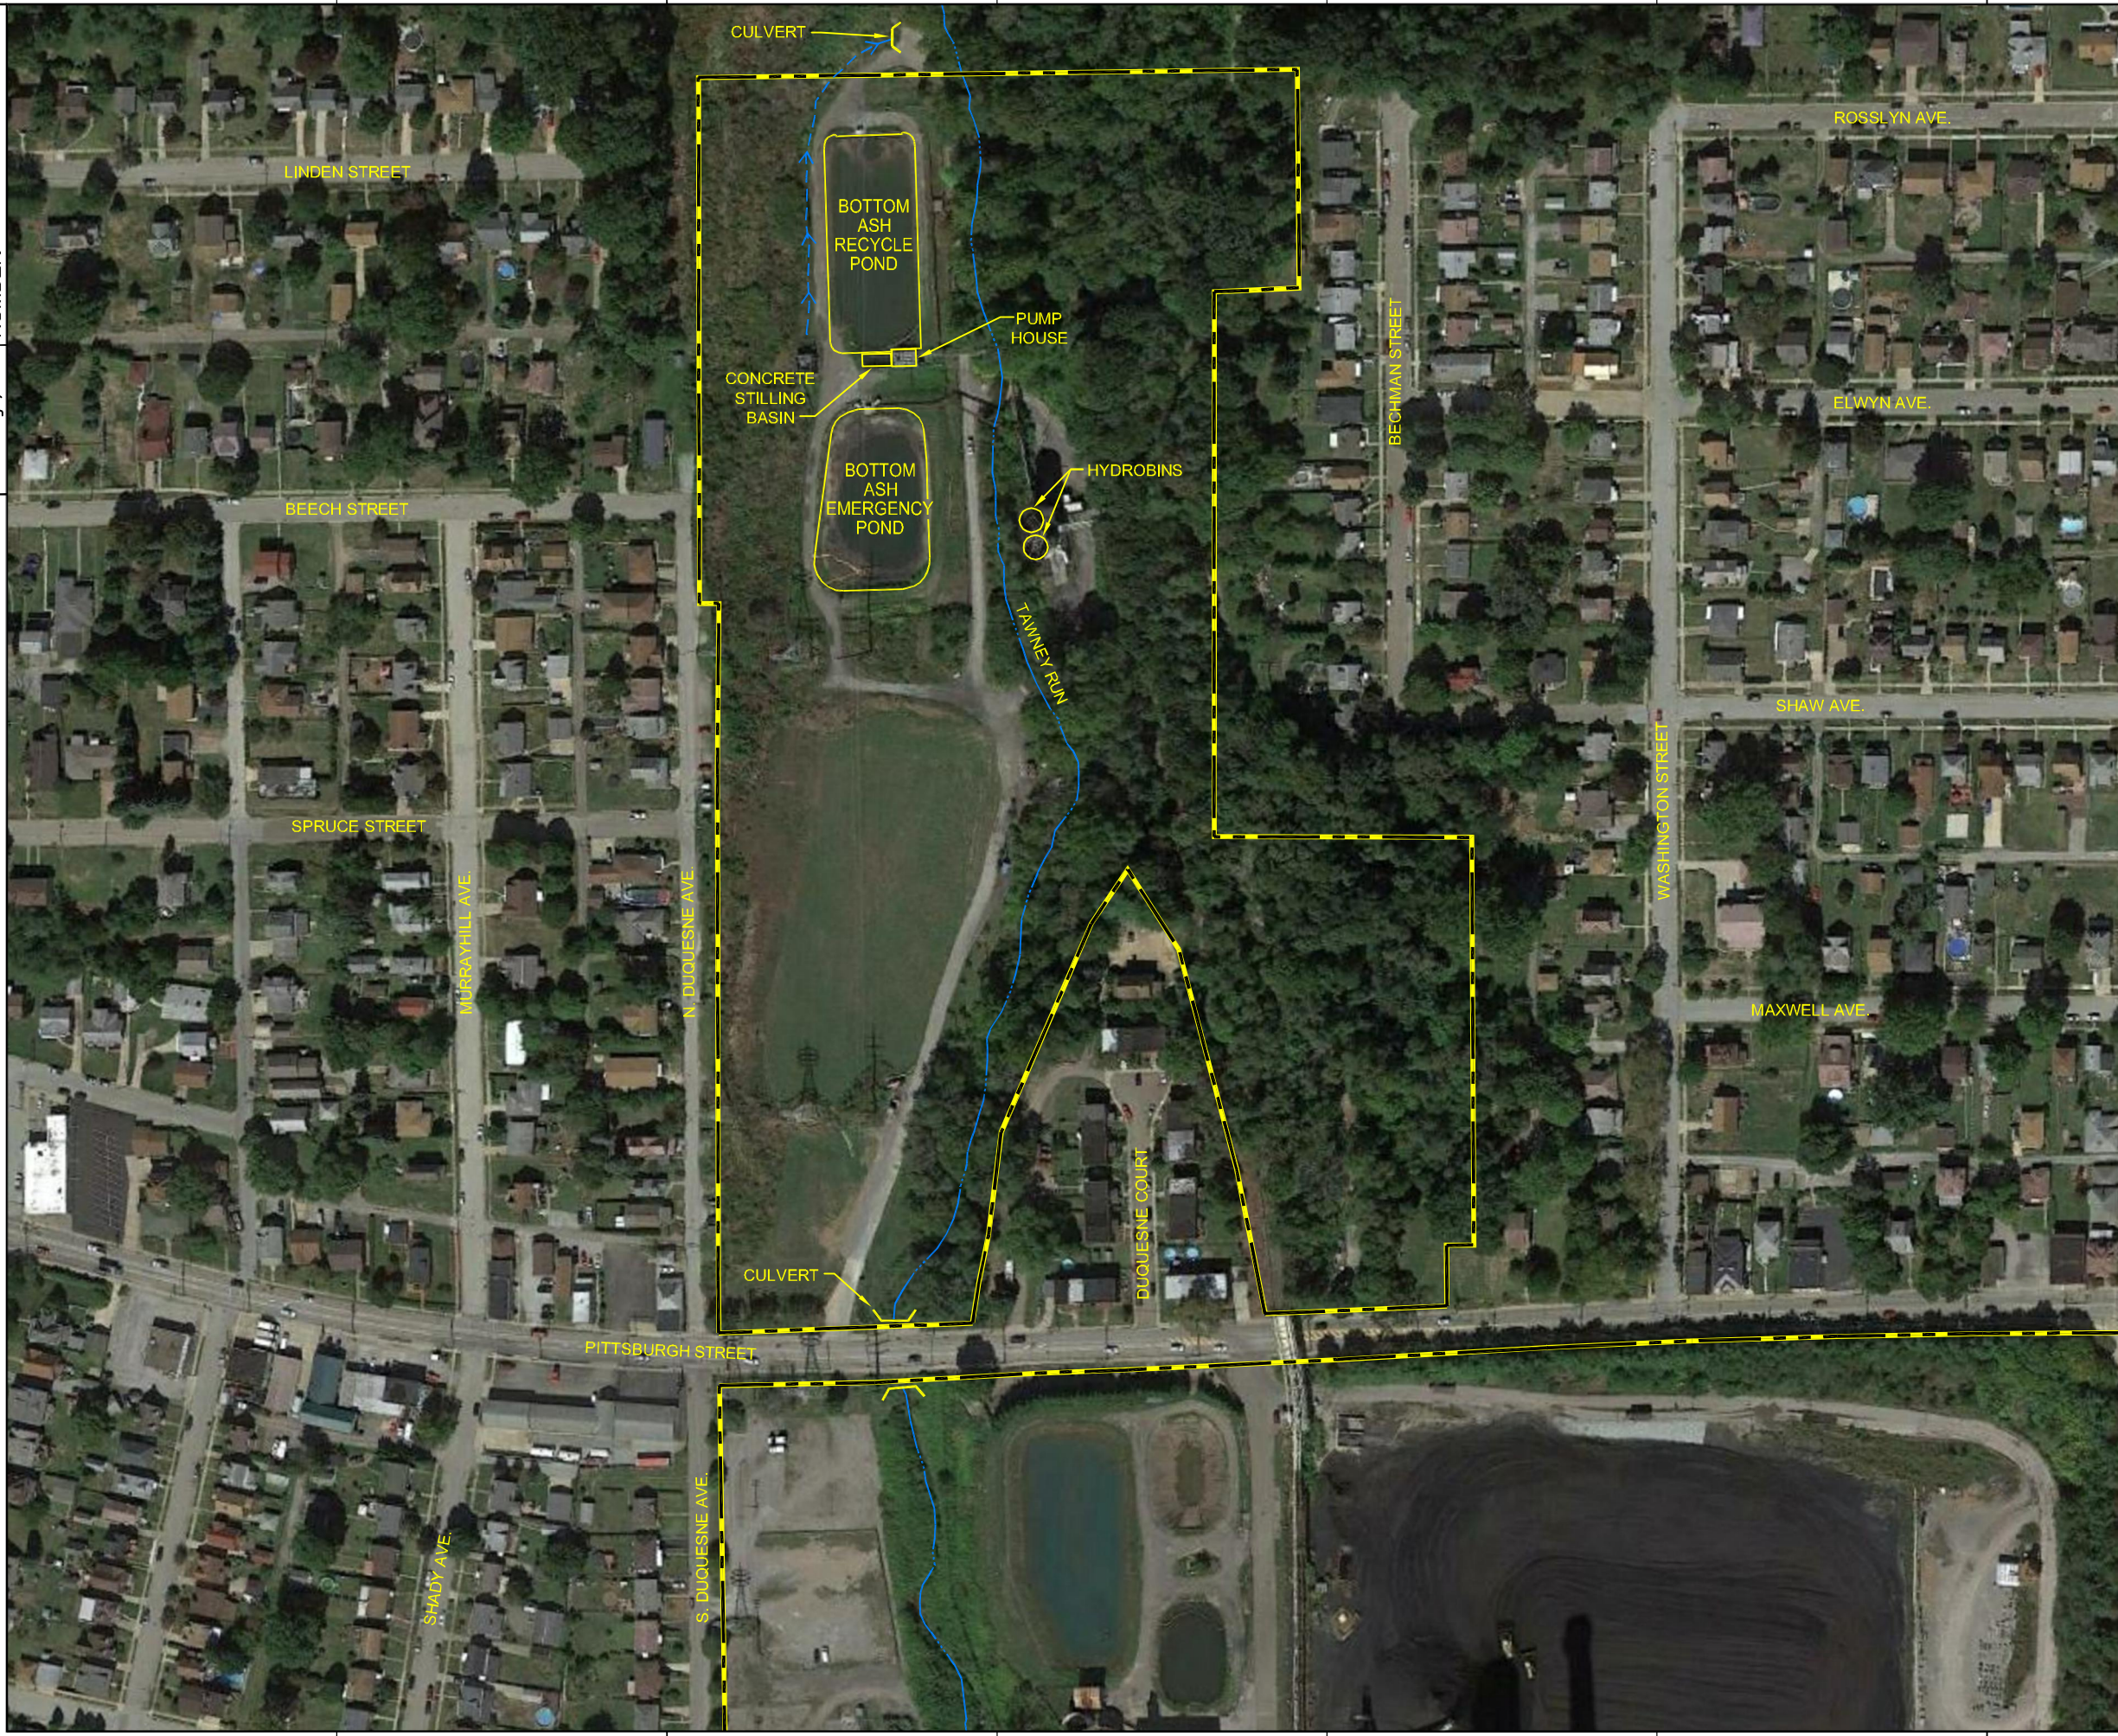
Figure 2 – Photographic Map

CB&I visually assessed the downstream conditions with special attention to structures, infrastructure, and above-ground utilities in relation to the likely path of pond contents in the event of a breach. A powerline was noted to be present along the slope to the west of the ponds, extending southward along Station property. The supports for this power line are generally at the edge or outside of the anticipated inundation area, and no impact to this feature is expected to occur as the result of a breach. The downstream properties and Pittsburgh Street as shown on the maps and aerial imagery were visually verified, and in general, appeared to be at elevations higher than the anticipated inundation area.
