# Coal Combustion Residuals Closure Certification Report

GenOn Power Midwest LP  
Cheswick Generating Station  
Bottom Ash Ponds Closure  
Springdale Borough, Allegheny County, Pennsylvania

GAI Project R200201.00  
April 2021

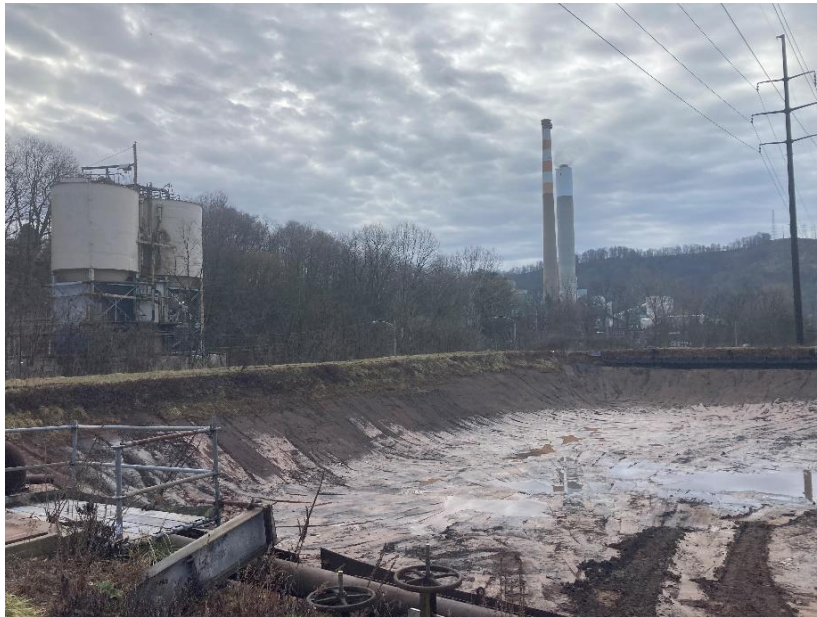
**Photograph 1: Emergency Ash Pond, facing Southeast.**  
Date: 3/24/2021

**Description: Southern and Eastern embankments of Emergency Ash Pond after CCR removal. The sideslopes and pond bottom were visually inspected and no CCR was observed.**

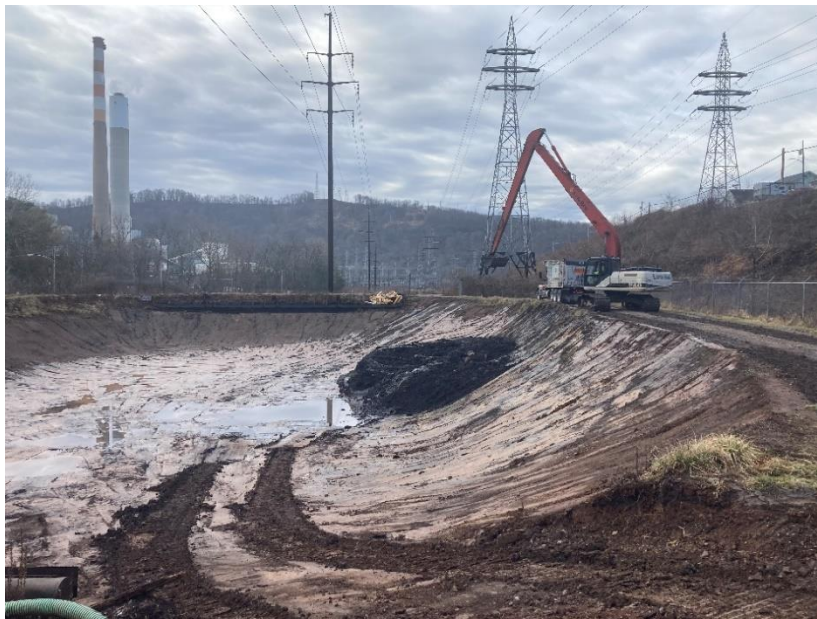
**Photograph 2: Emergency Ash Pond, facing South.**  
Date: 3/24/2021

**Description: Southern and Western embankments of Emergency Ash Pond during CCR removal. CCR shown in picture was removed on 3/24/2021.**

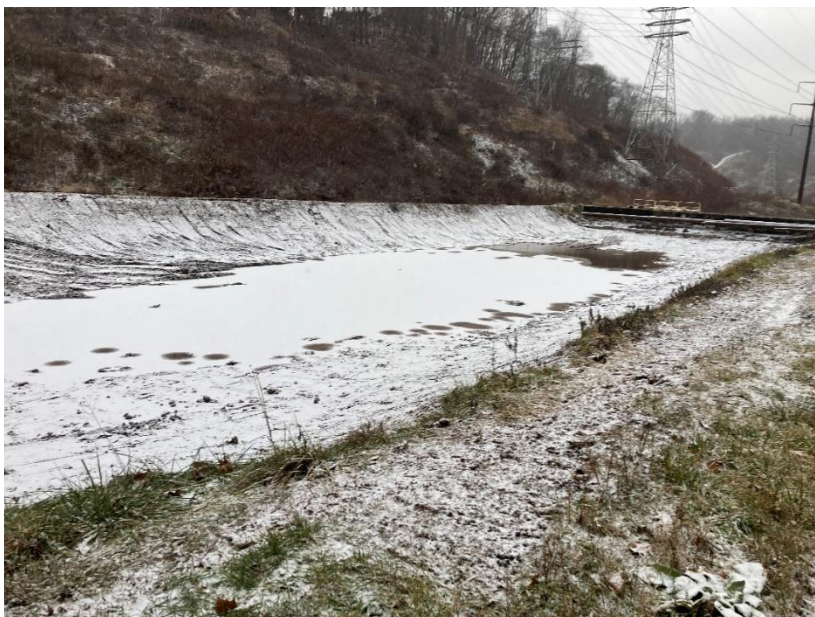
**Photograph 3: Bottom Ash Recycle Pond, facing Northwest.  
Date: 12/16/2020  
Description: Bottom Ash Recycle Pond following CCR removal.**
